SuperKEKB Accelerator Status

Makoto Tobiya
KEK Accelerator Laboratory
(on behalf of SuperKEKB Accelerator Team)

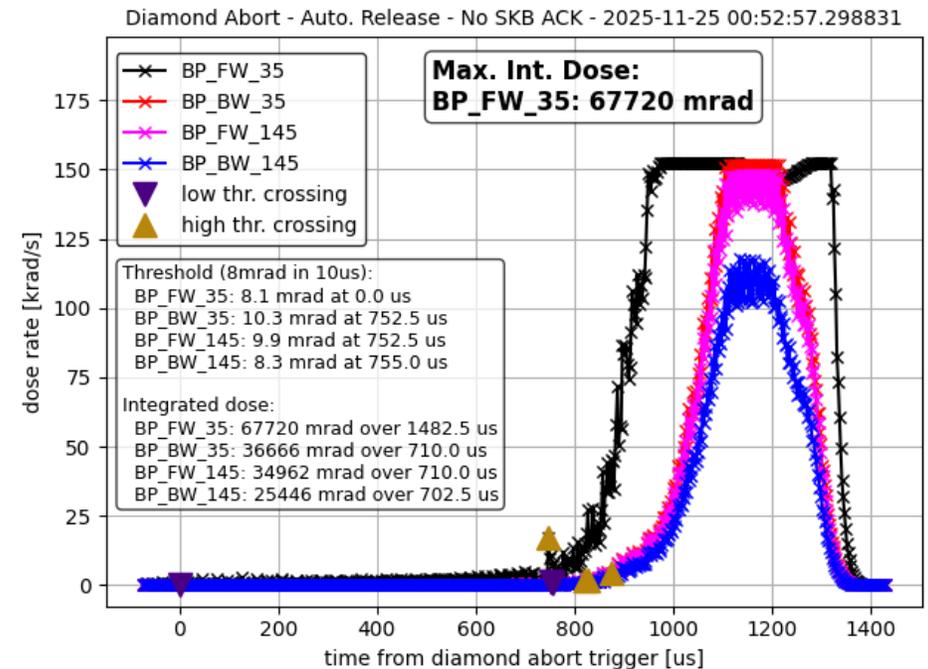
- Due to weak-bends cutoff, a large beam orbit primarily in the horizontal direction emerged with a time constant of 0.1 seconds, resulting in catastrophic beam loss.
- Simulation suggests more than 80% beam loss in the IR direction.
 - Large xy coupling.
 - Shrunk RF separatrix.
- The QCS on the L side caused a quench in all magnets, taking about 7 hours to restore the liquid level.

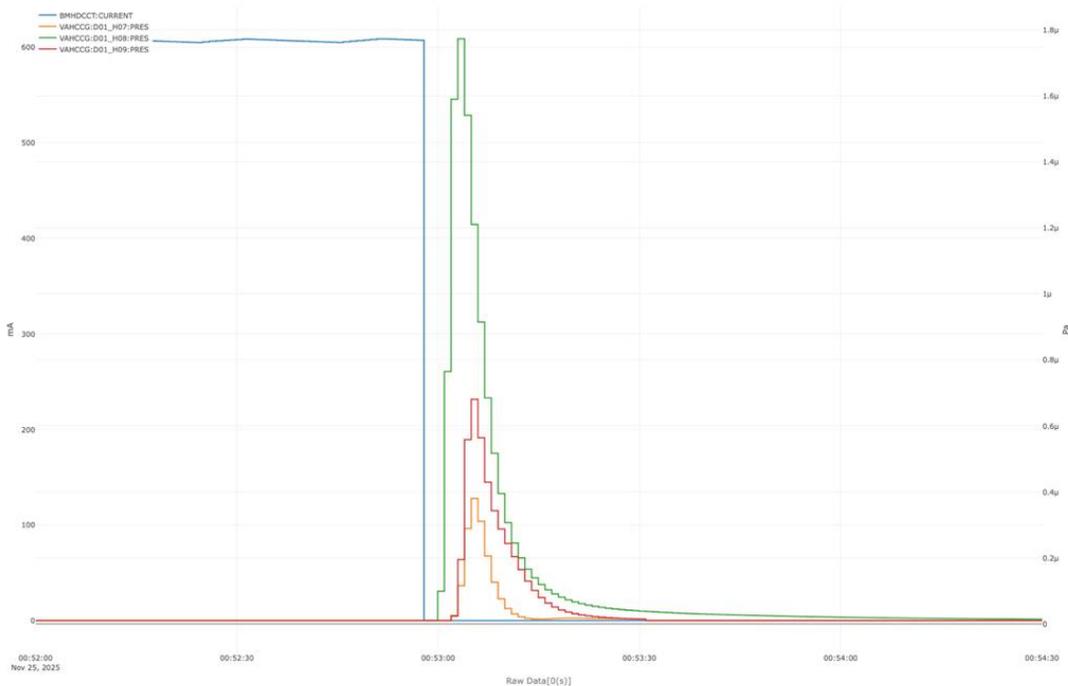
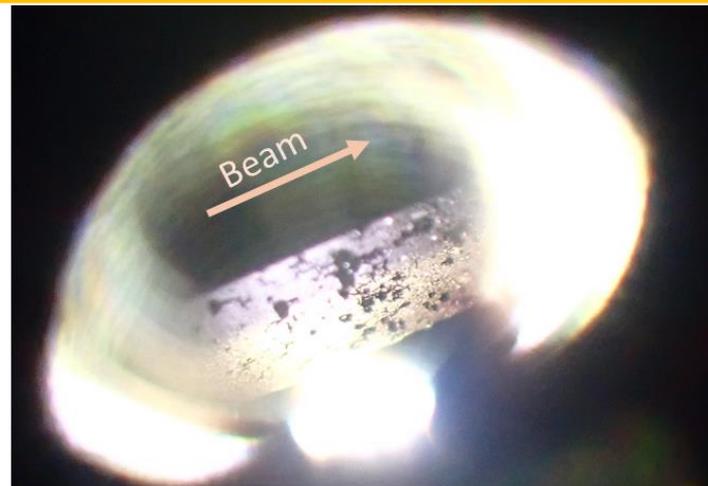
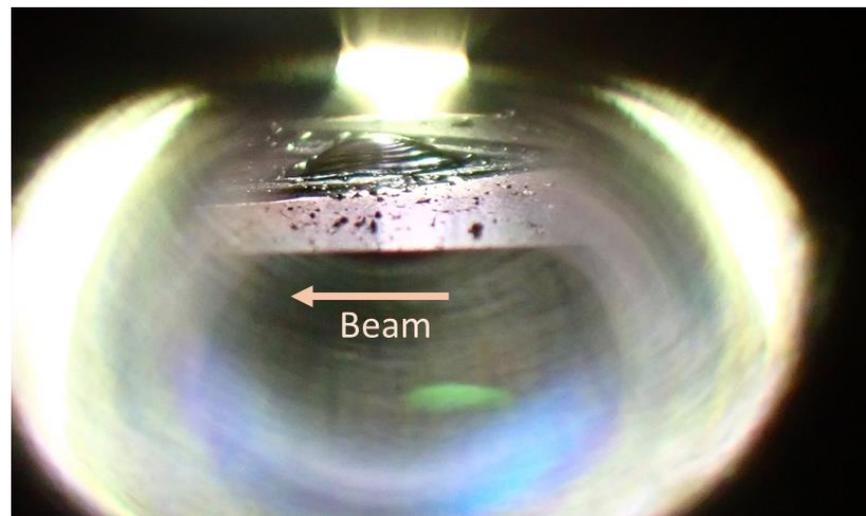
D1V1 collimator head has been damaged

D01V1 BOTTOM

- By moving the damaged vertical collimator 1.5 mm horizontally and adjusting the other vertical collimators, we are currently able to continue operation while keeping the background to the Belle II detector within acceptable limits.
- However, this situation results in the vertical collimator being significantly narrowed, considerably reducing the HER's injection efficiency.

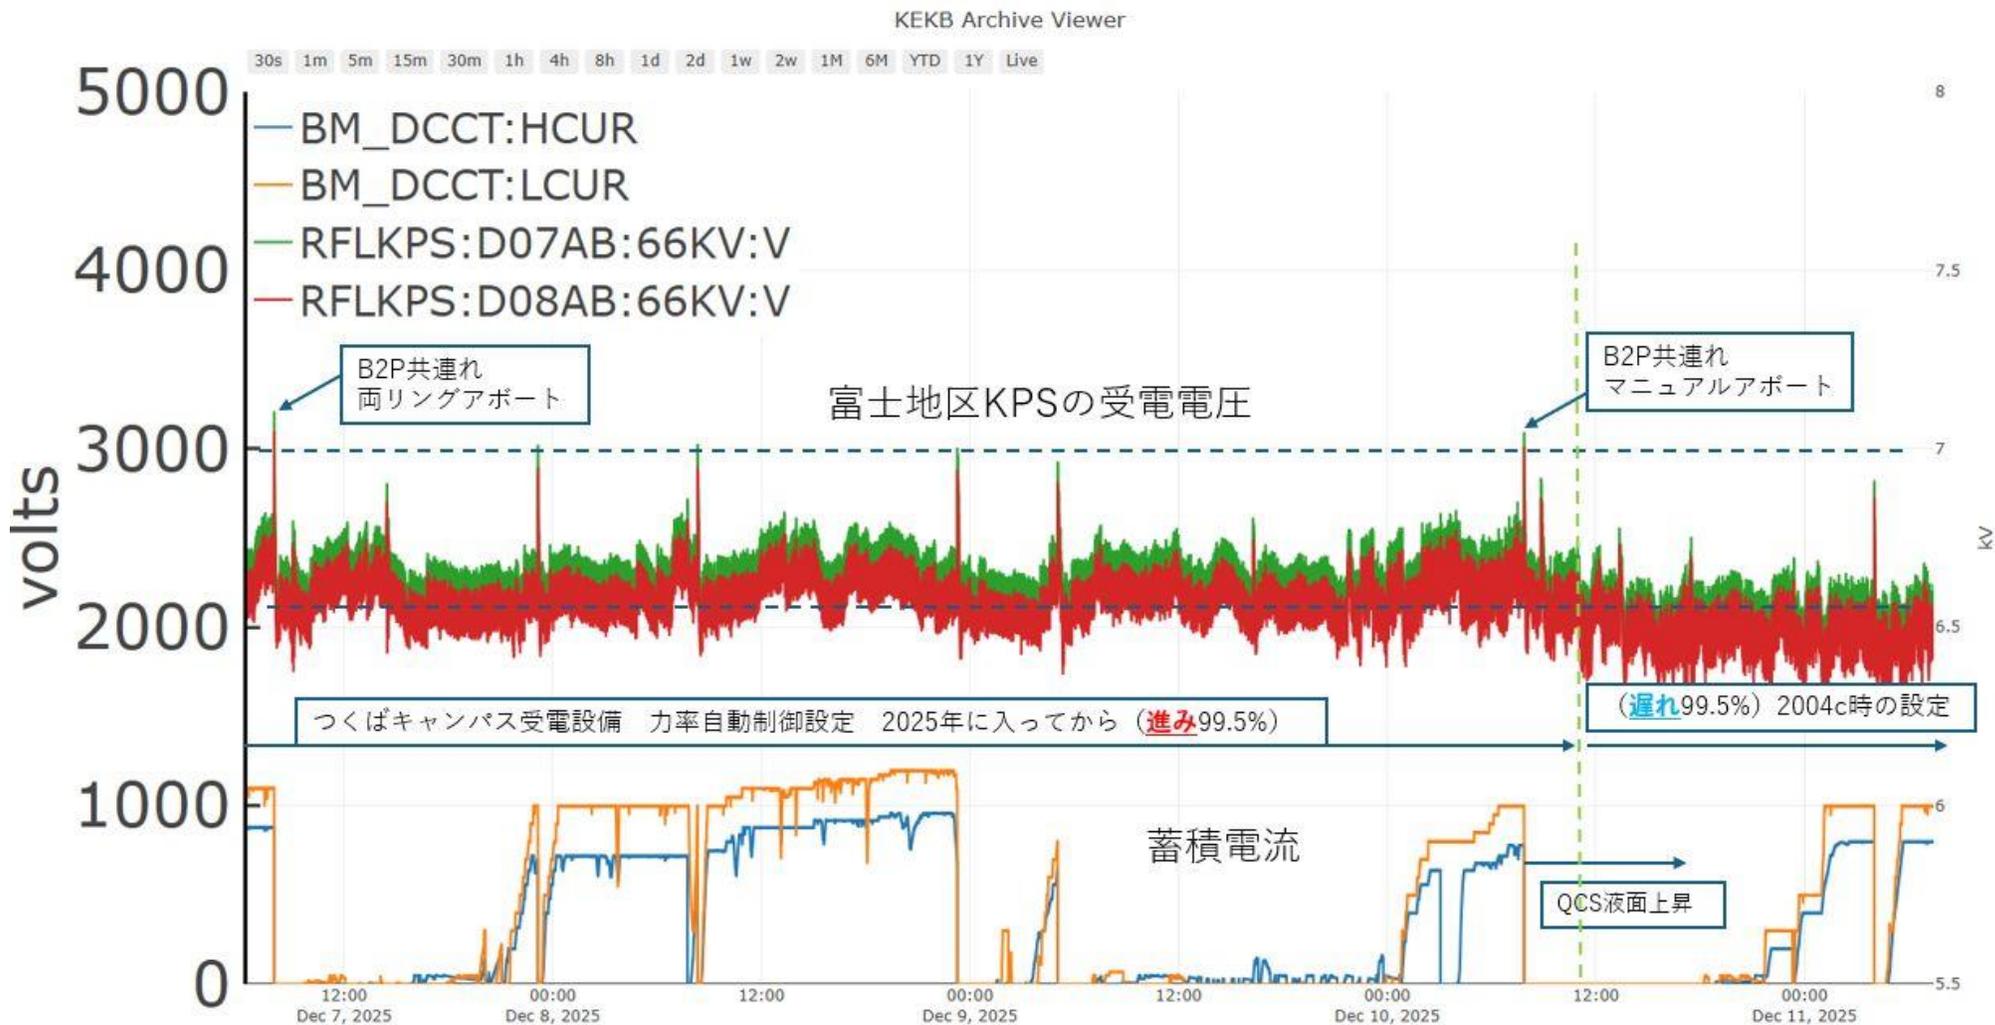
B2P power supply down due to overvoltage of the primary 6.6kV line

- The LER bending magnets power supply (B2P) tripped due to a primary voltage (6.6kV) overlimit interlock (occurred twice) caused by the trip of all RF sources of Fuji area due to beam abort.
- After investigating the cause with KEK's Facilities Department, it was determined that the settings for the power factor correction capacitors at KEK's power receiving section—intended to improve power efficiency—differed from those used in fiscal year 2024 (having been adjusted toward greater energy savings). These settings were reverted to their original configuration.
 - Efforts were also made on the RF side to reduce power consumption in the Fuji area.
 - After this, the B2P power supply is not interlocked.

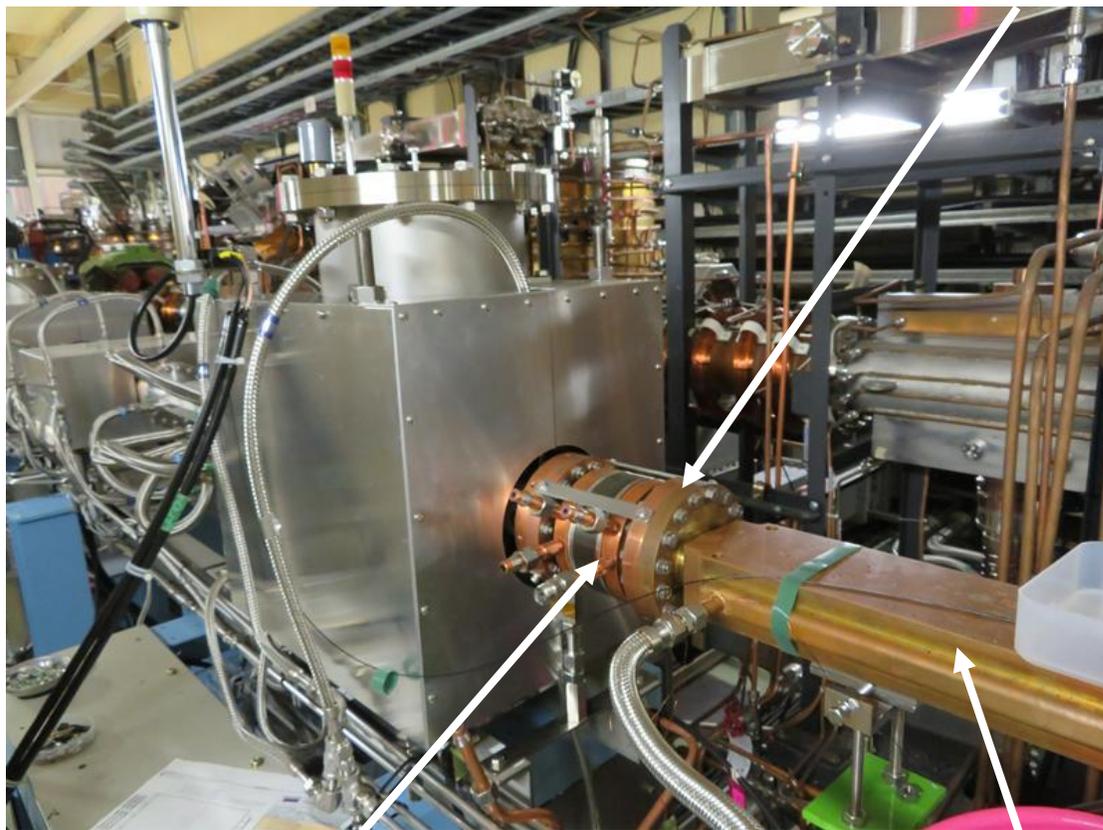
- Successfully with the detuned optics, but
 - Damage the vacuum chamber wall (and flange) around the beam dump due to the aborted beam, which resulted in a large vacuum leak after one day of operation.
 - The issue was temporarily resolved by re-examining the trajectory of the abort beam and modifying it to maintain sufficient distance from the chamber wall.

リーク箇所

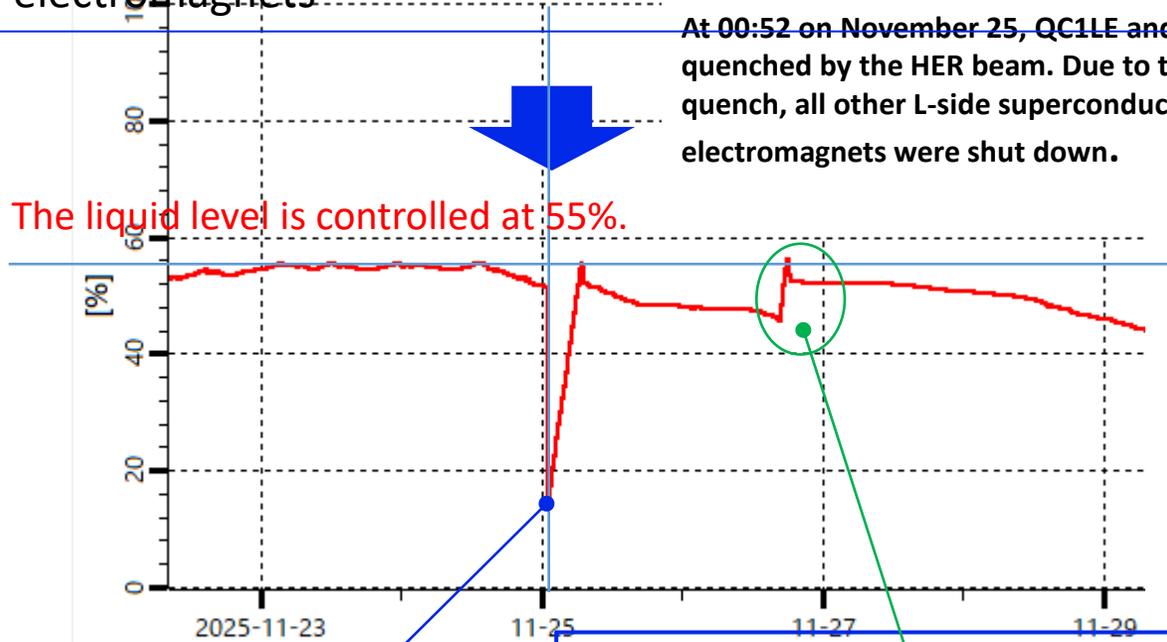
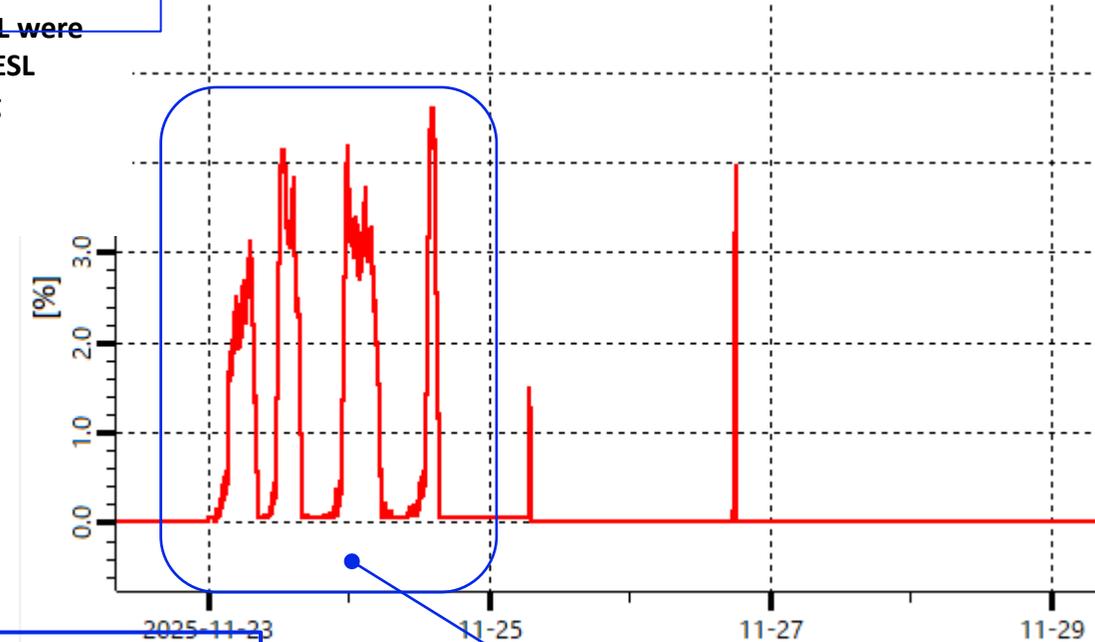
L-Side QCS Li-He reserve level

QCSL electromagnet quench reduced to 15%.

After system recovery from quench, the liquid level dropped to 46%. **Set all QCSL electromagnets to 0A and reduce the helium gas flow for current lead cooling to raise the liquid level.** (Reduce the heat load on the cryostat)

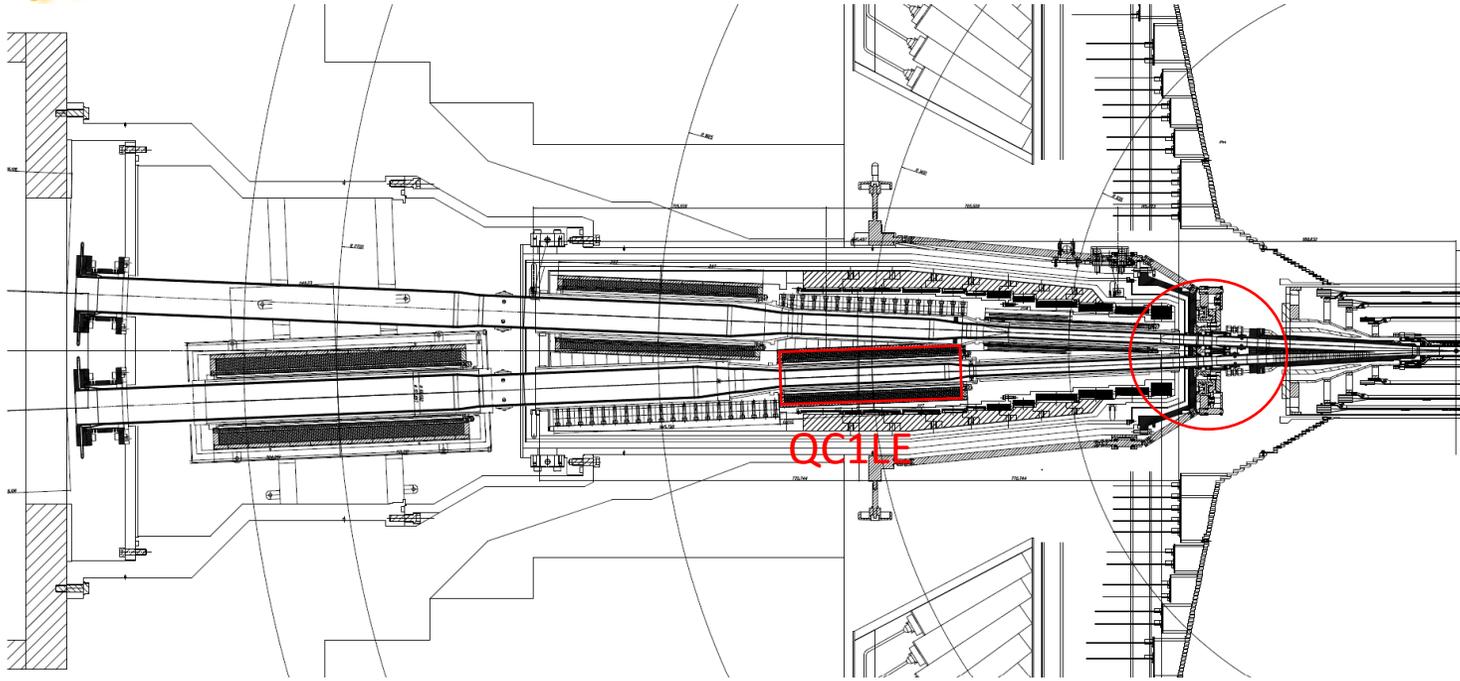
O-ring at the tip of cryostat

- The heat load of the QCS cryostat has increased.
 - Air leak in the thermal vacuum chamber.
 - Air leakage may have occurred due to deterioration of the O-ring at the cryostat tip, potentially causing air to condense on the surface of the liquid helium container.

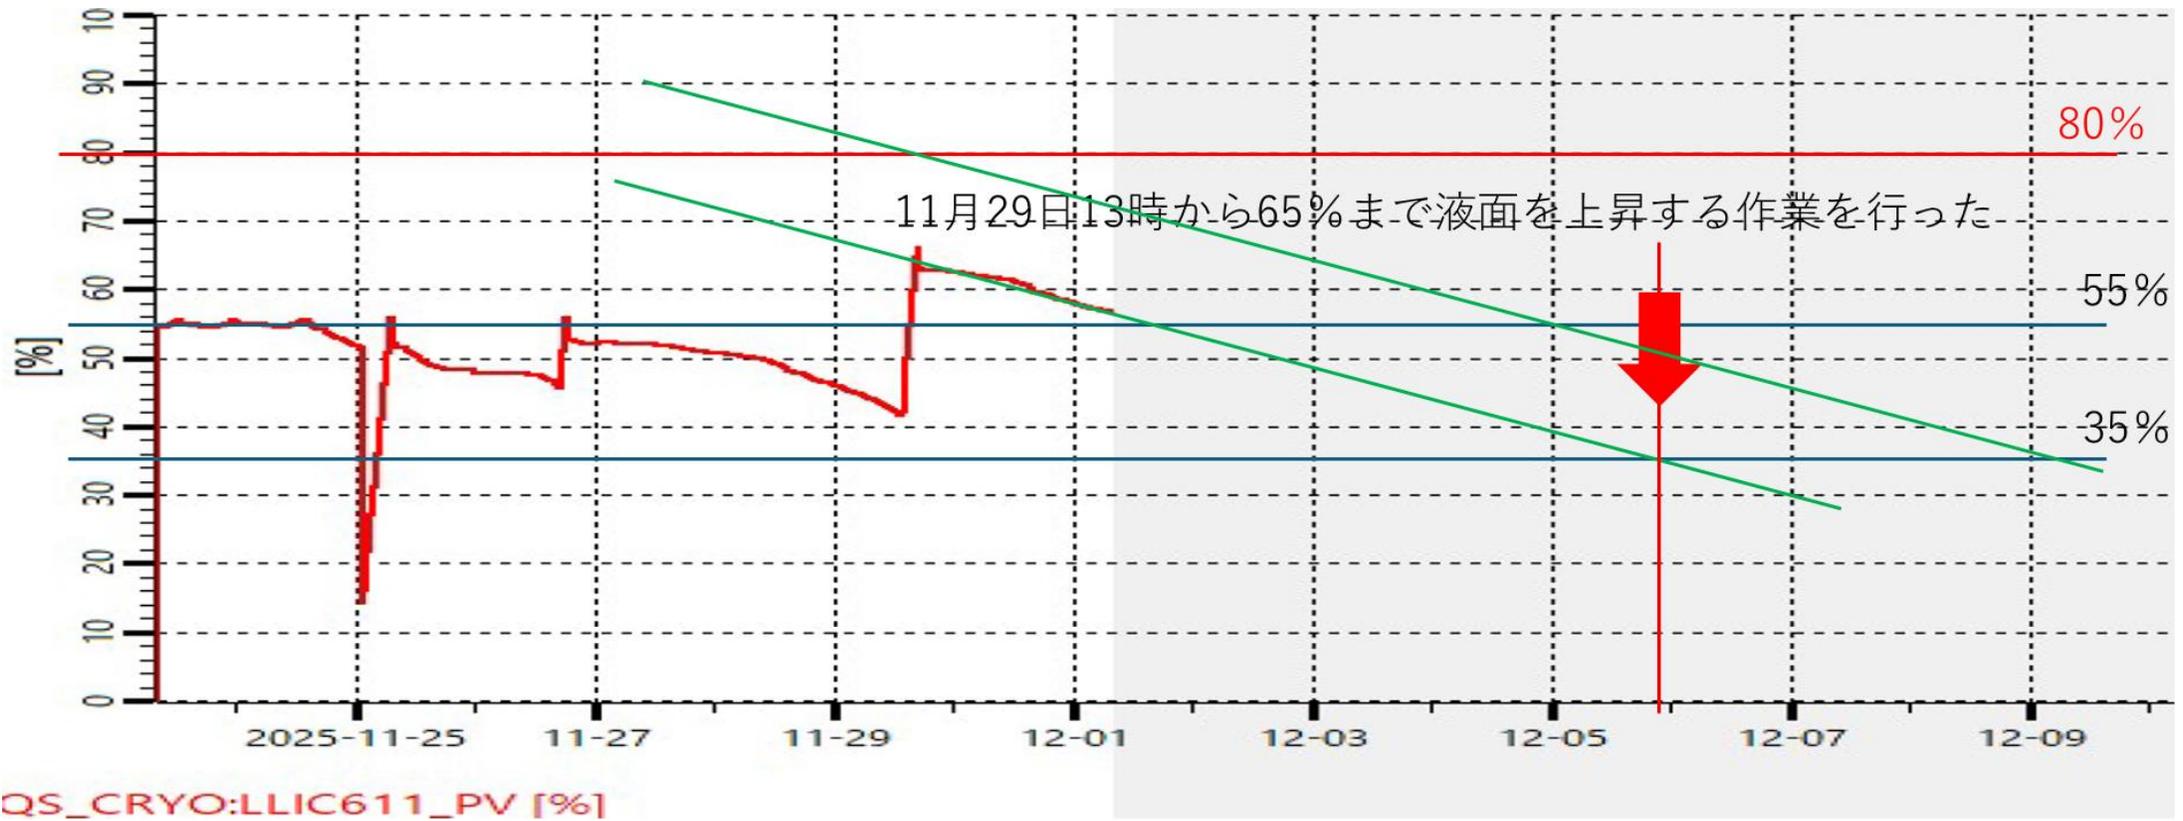
Power off the QCS magnets and raise the liquid He level

Needs roughly 8 hours to increase the Li-He level. After the process, we need to re-do the optics correction (8h)

- Following the liquid He level rise operation on December 16, we were able to keep the liquid He Level constant (82%) by tuning the Liquid He refrigerator. Consequently, the nearly weekly shutdowns of operations and the rise in liquid He level operations conducted since early December were no longer necessary.
- By the inspection of residual molecular components in the thermal insulation vessel after heating the cryostat, we have confirmed that there were no (additional) vacuum leaks in the thermal vessel.
- We will restart the operation as early as possible, starting 26/Jan
