# Prototype Troubleshooting

22/10/2025

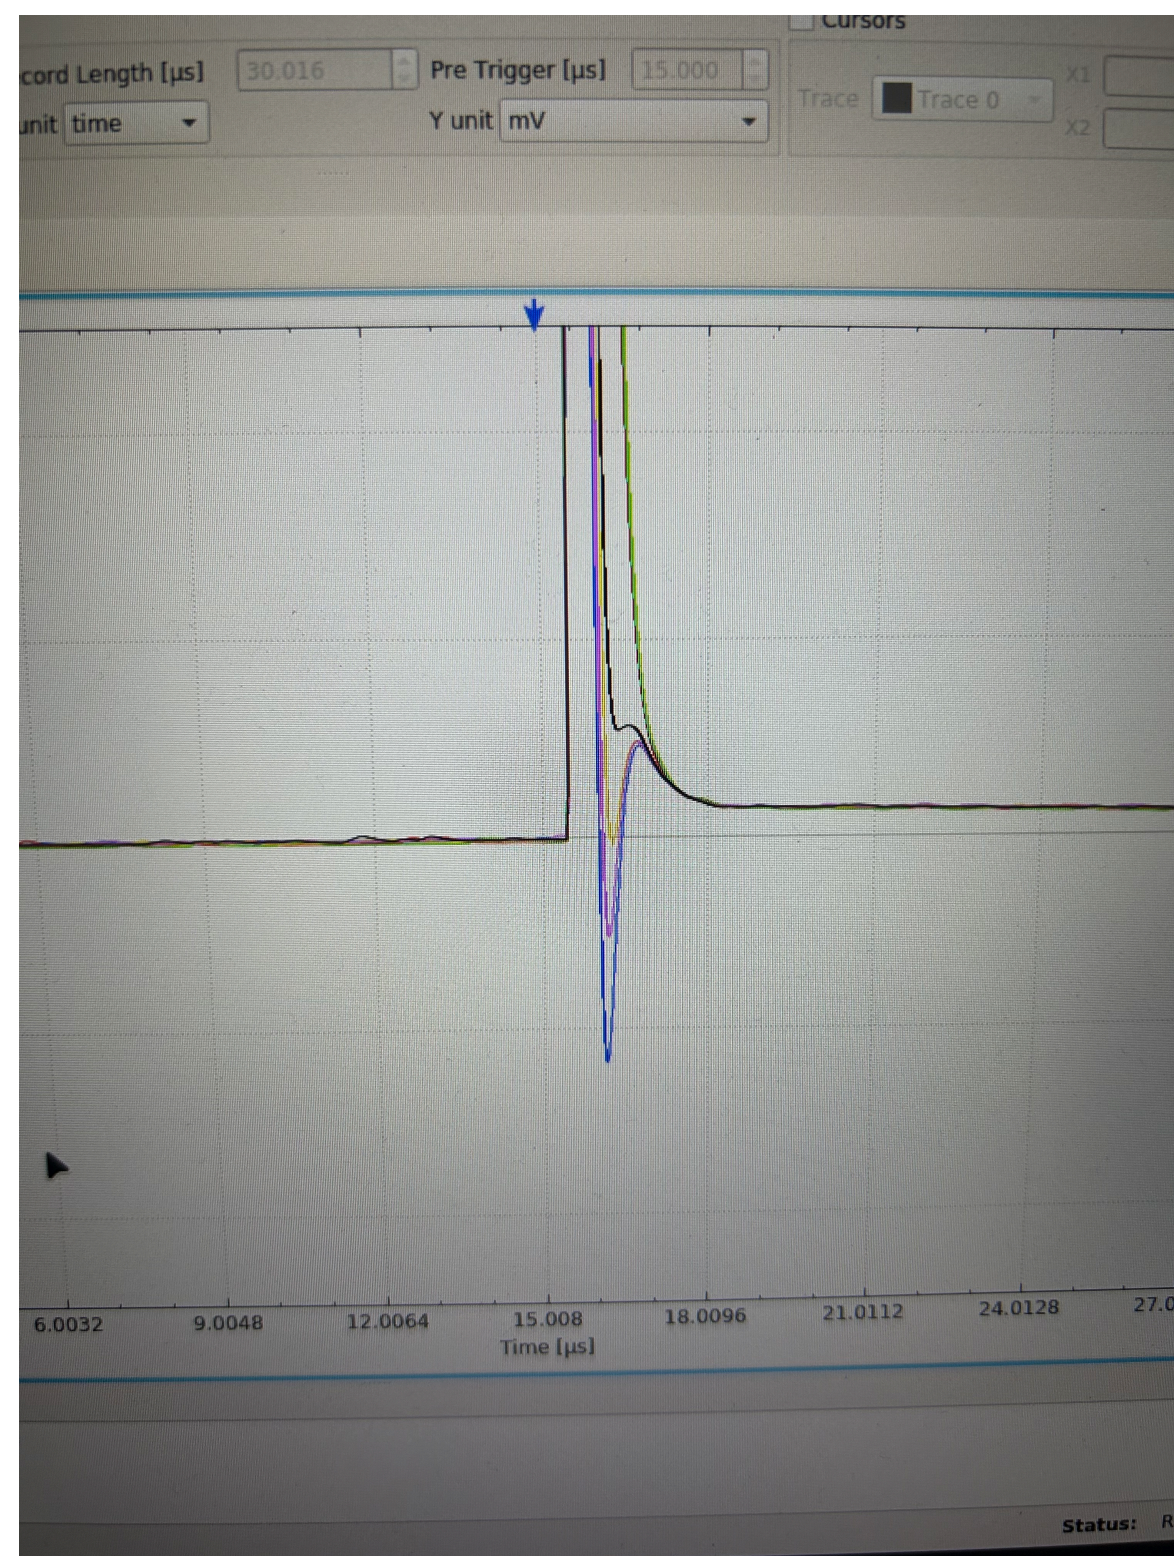
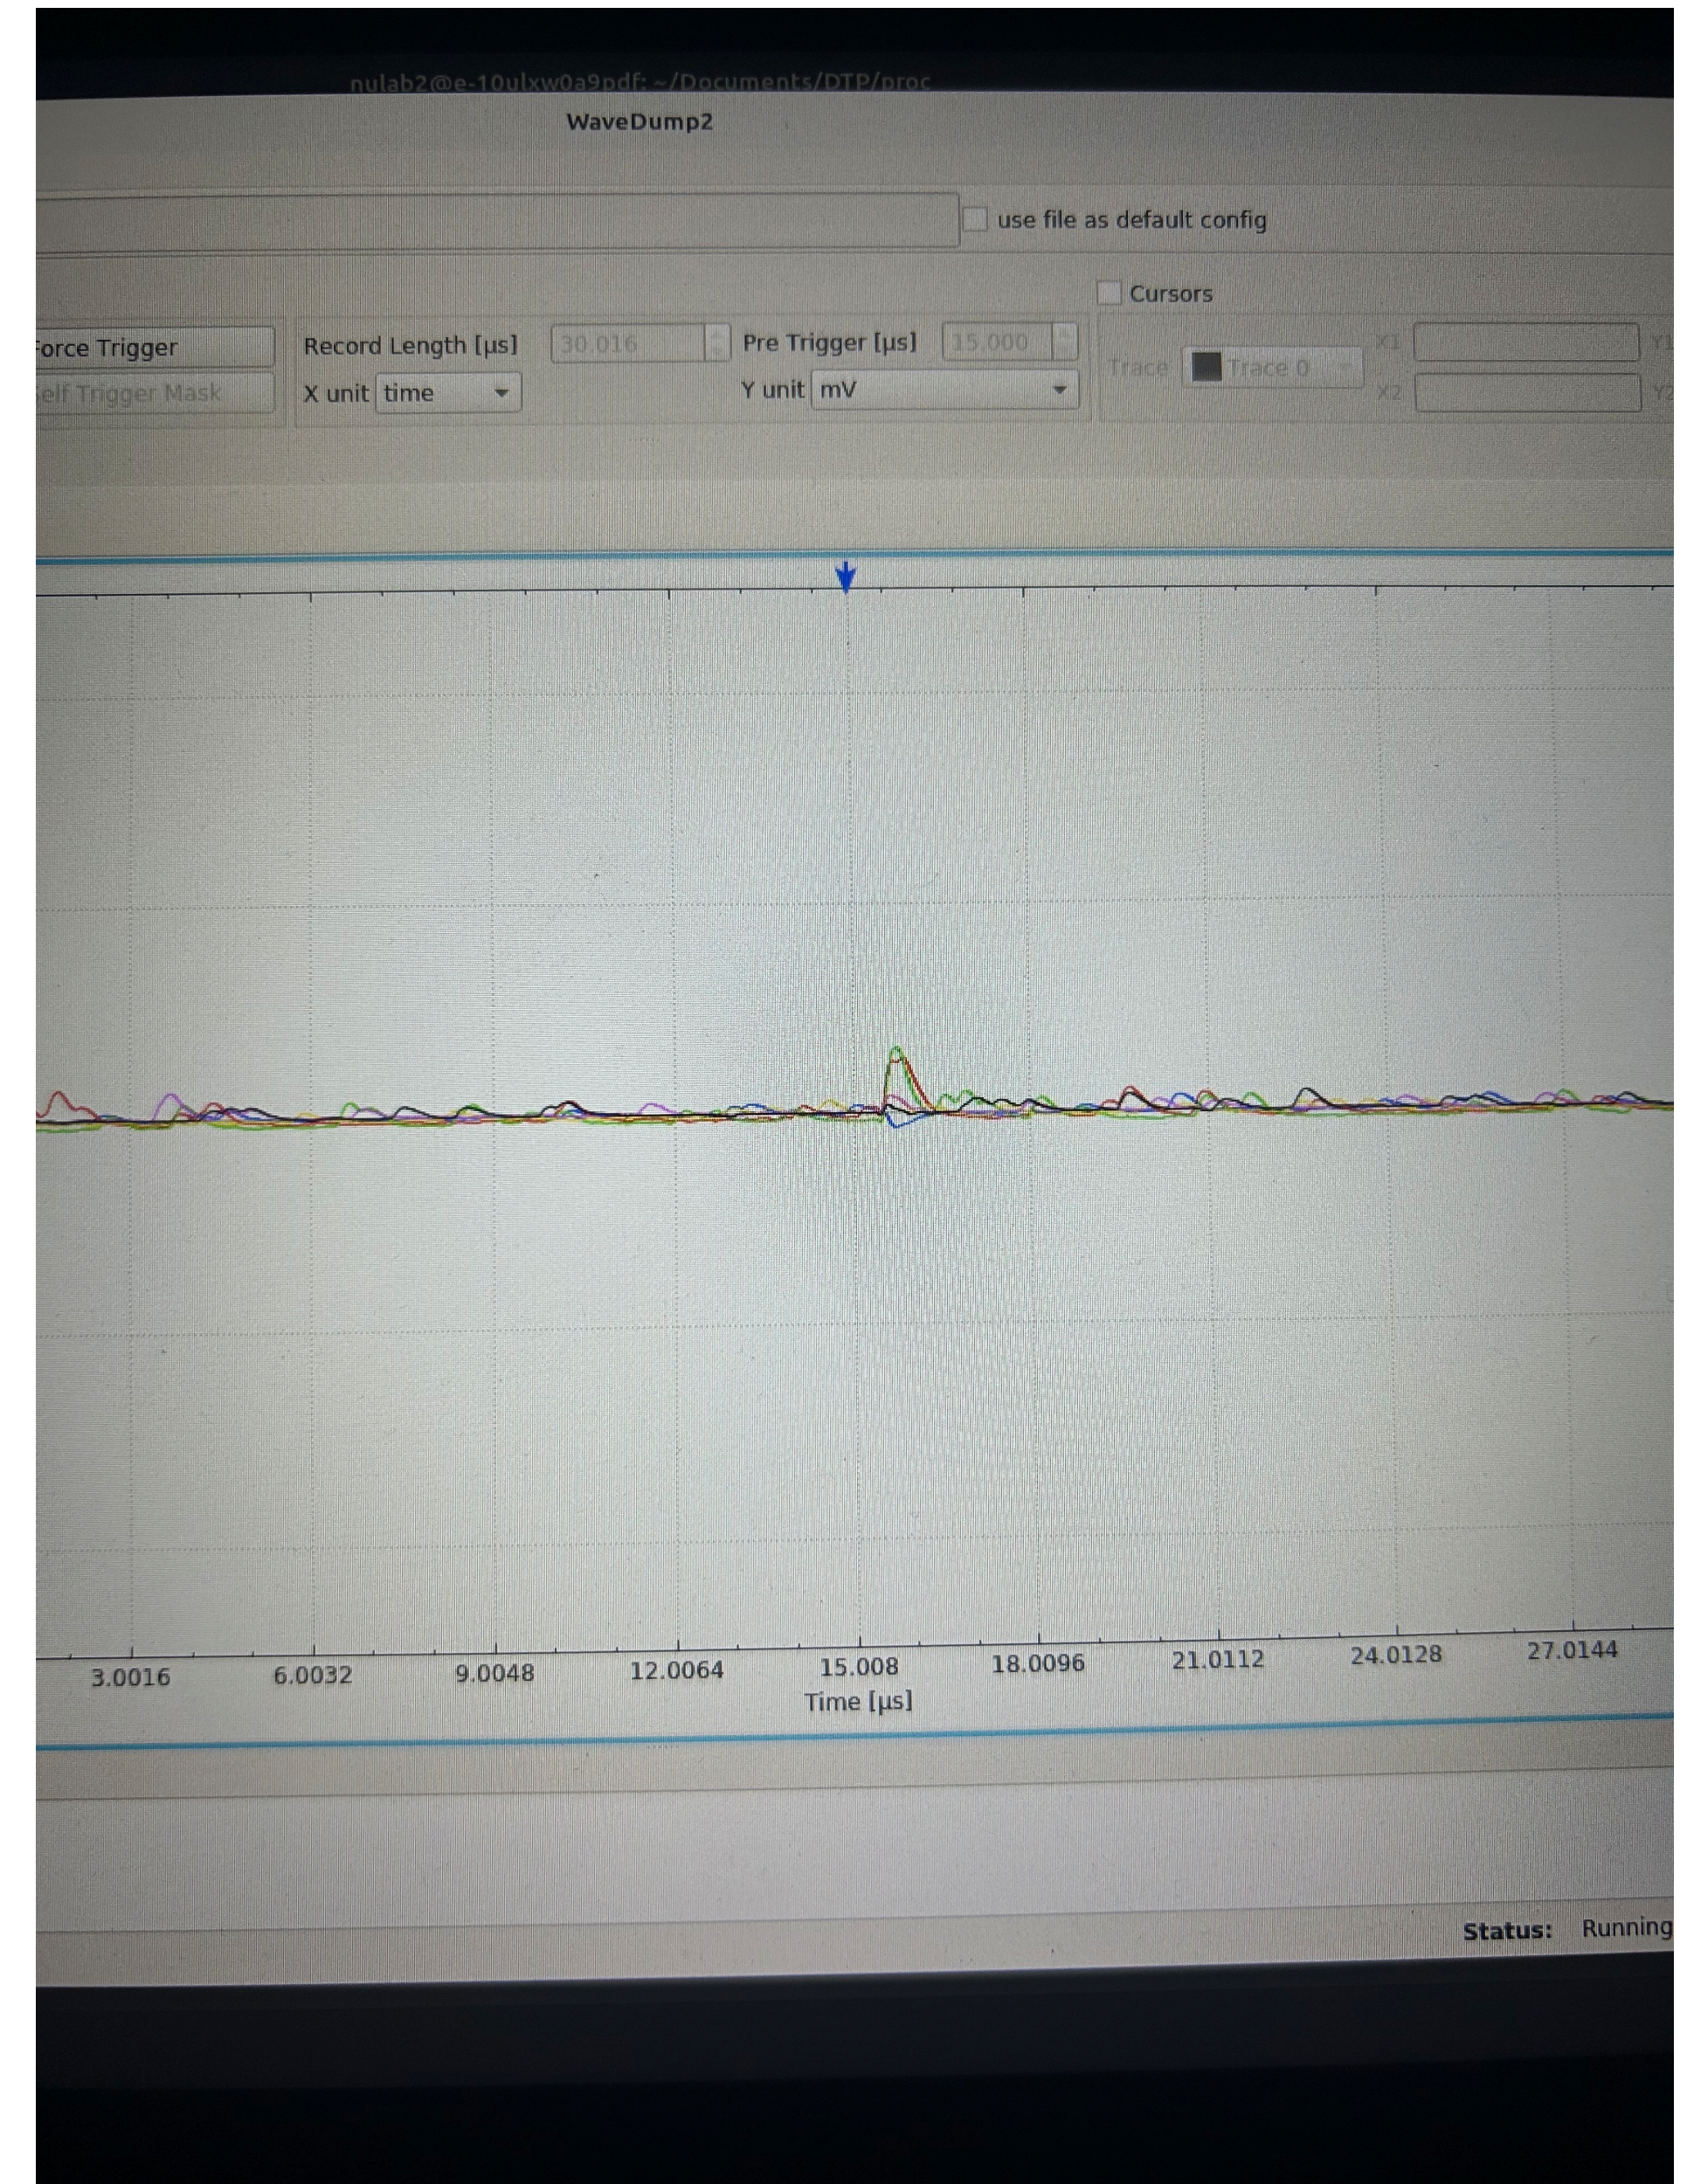
- Negative undershoot in some, seemingly random, channels when trying to take data with LED

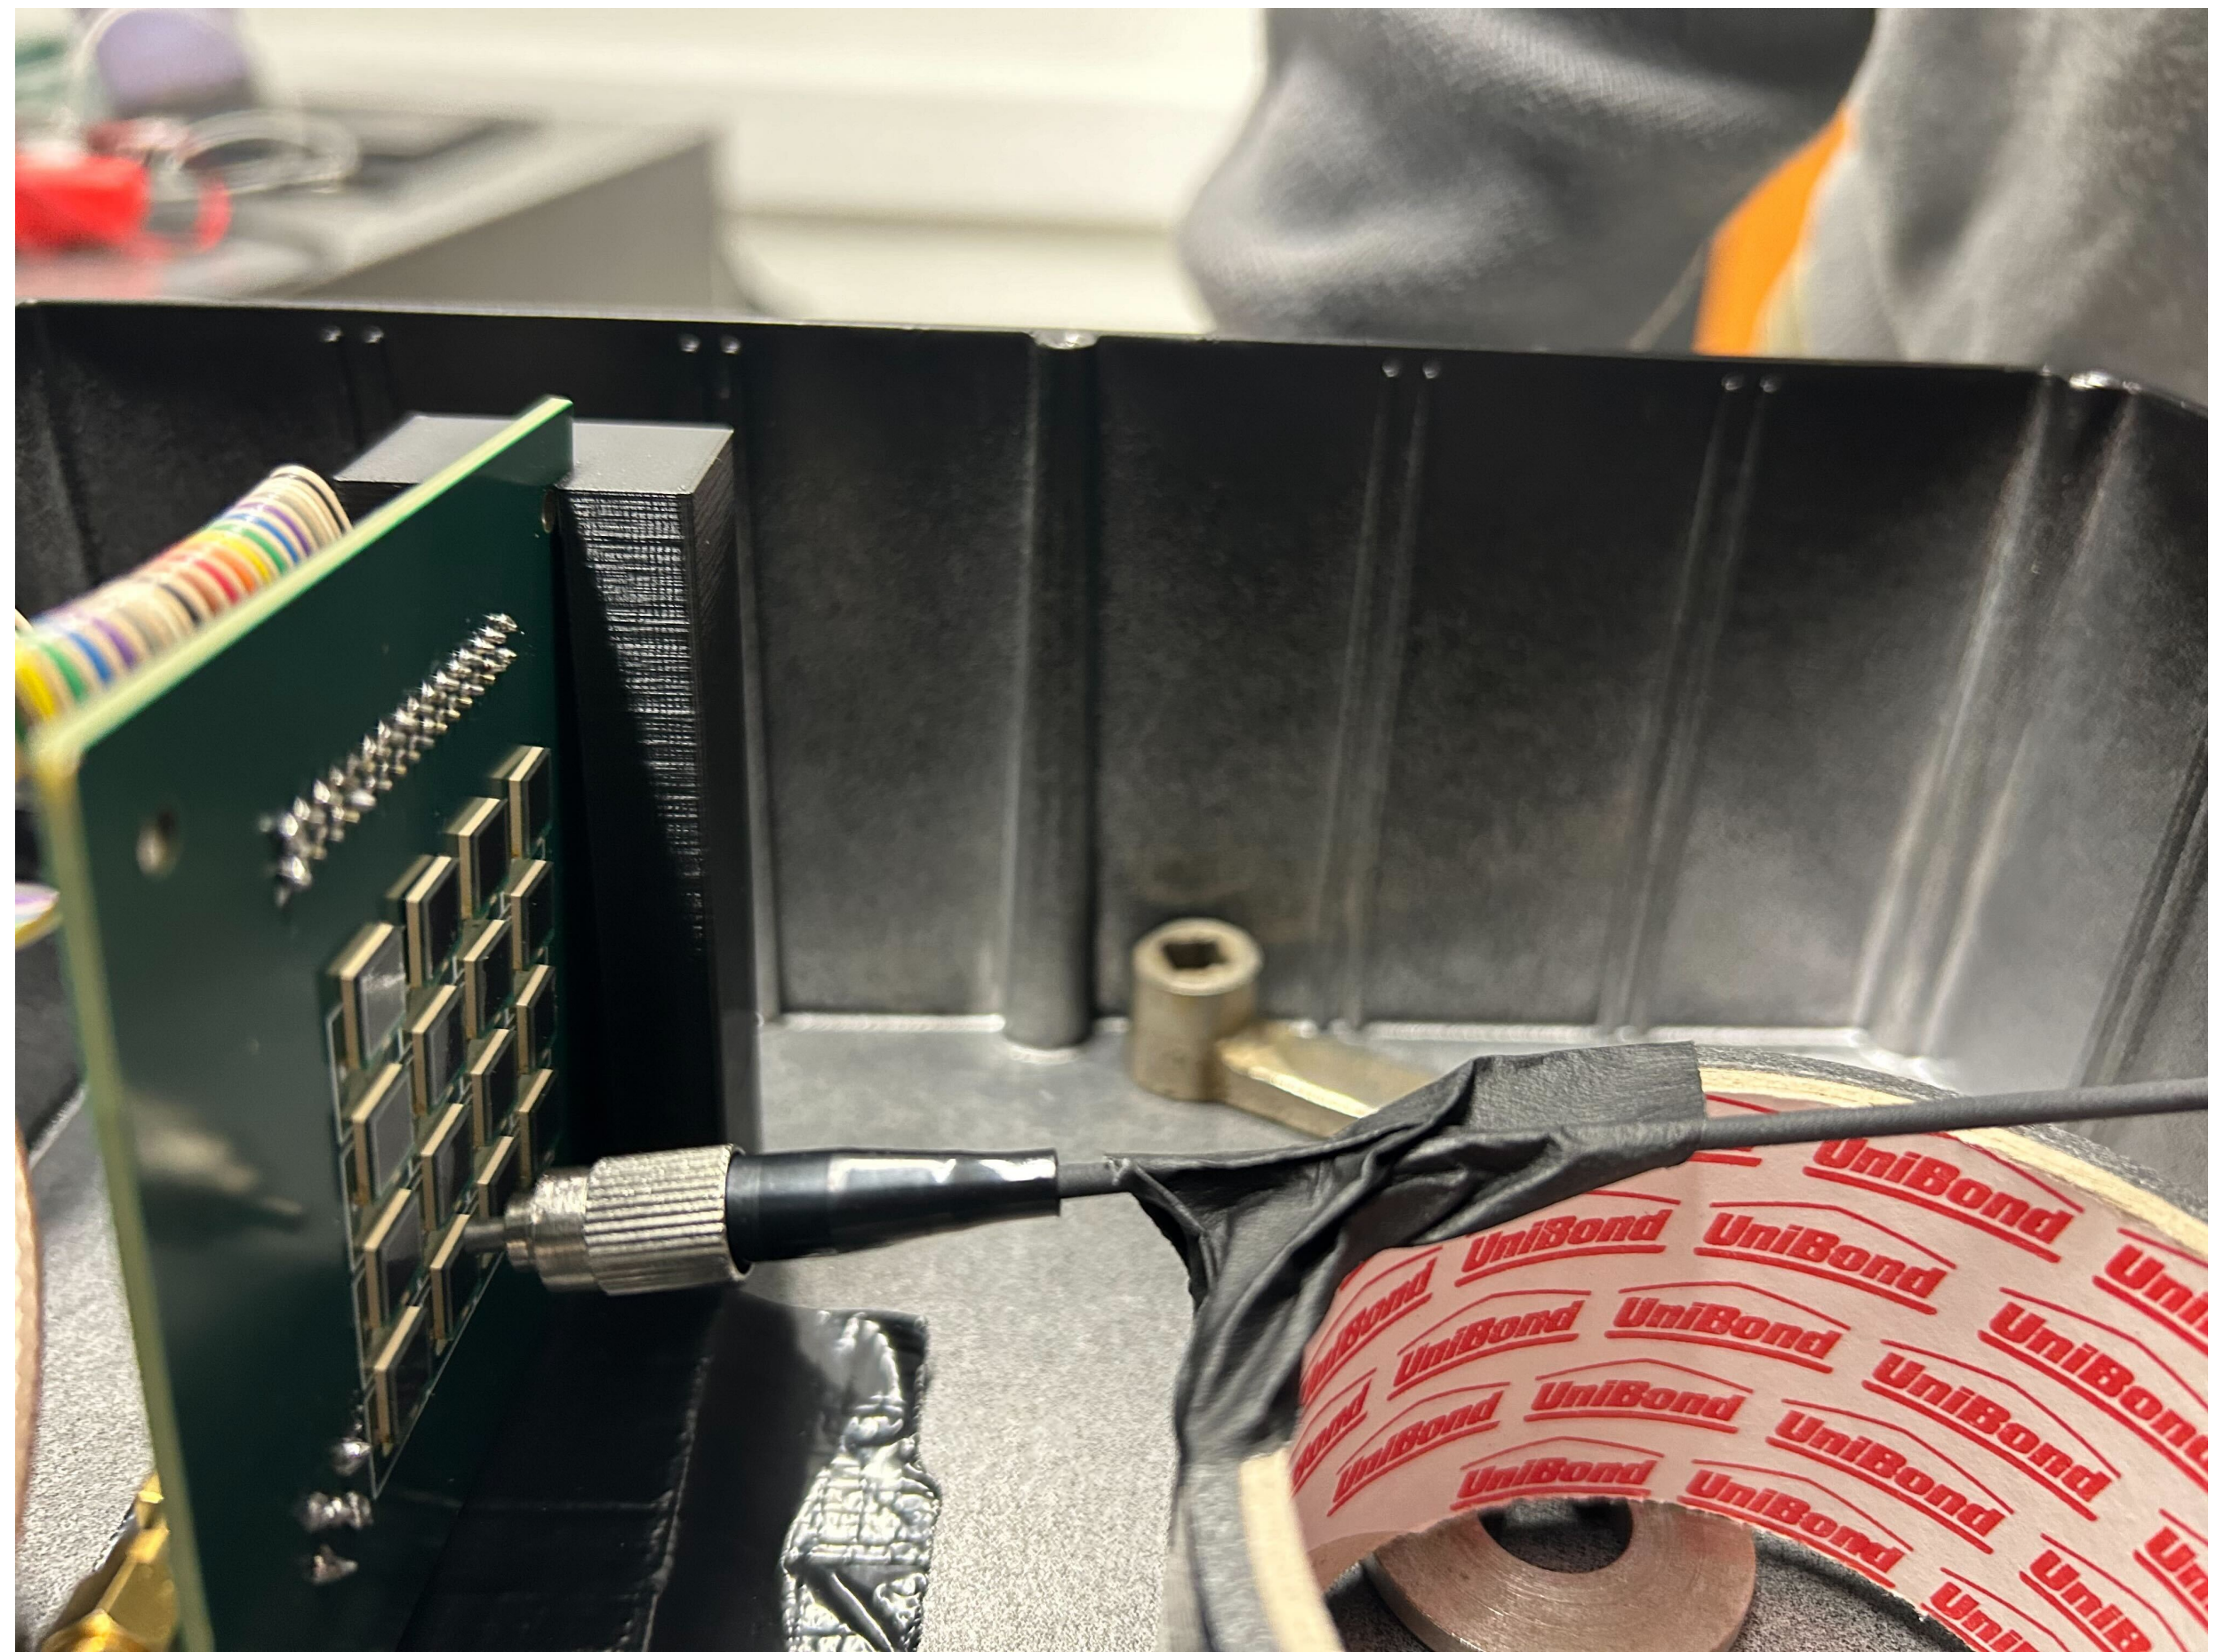
- Direct the fiber optic at a single SiPM

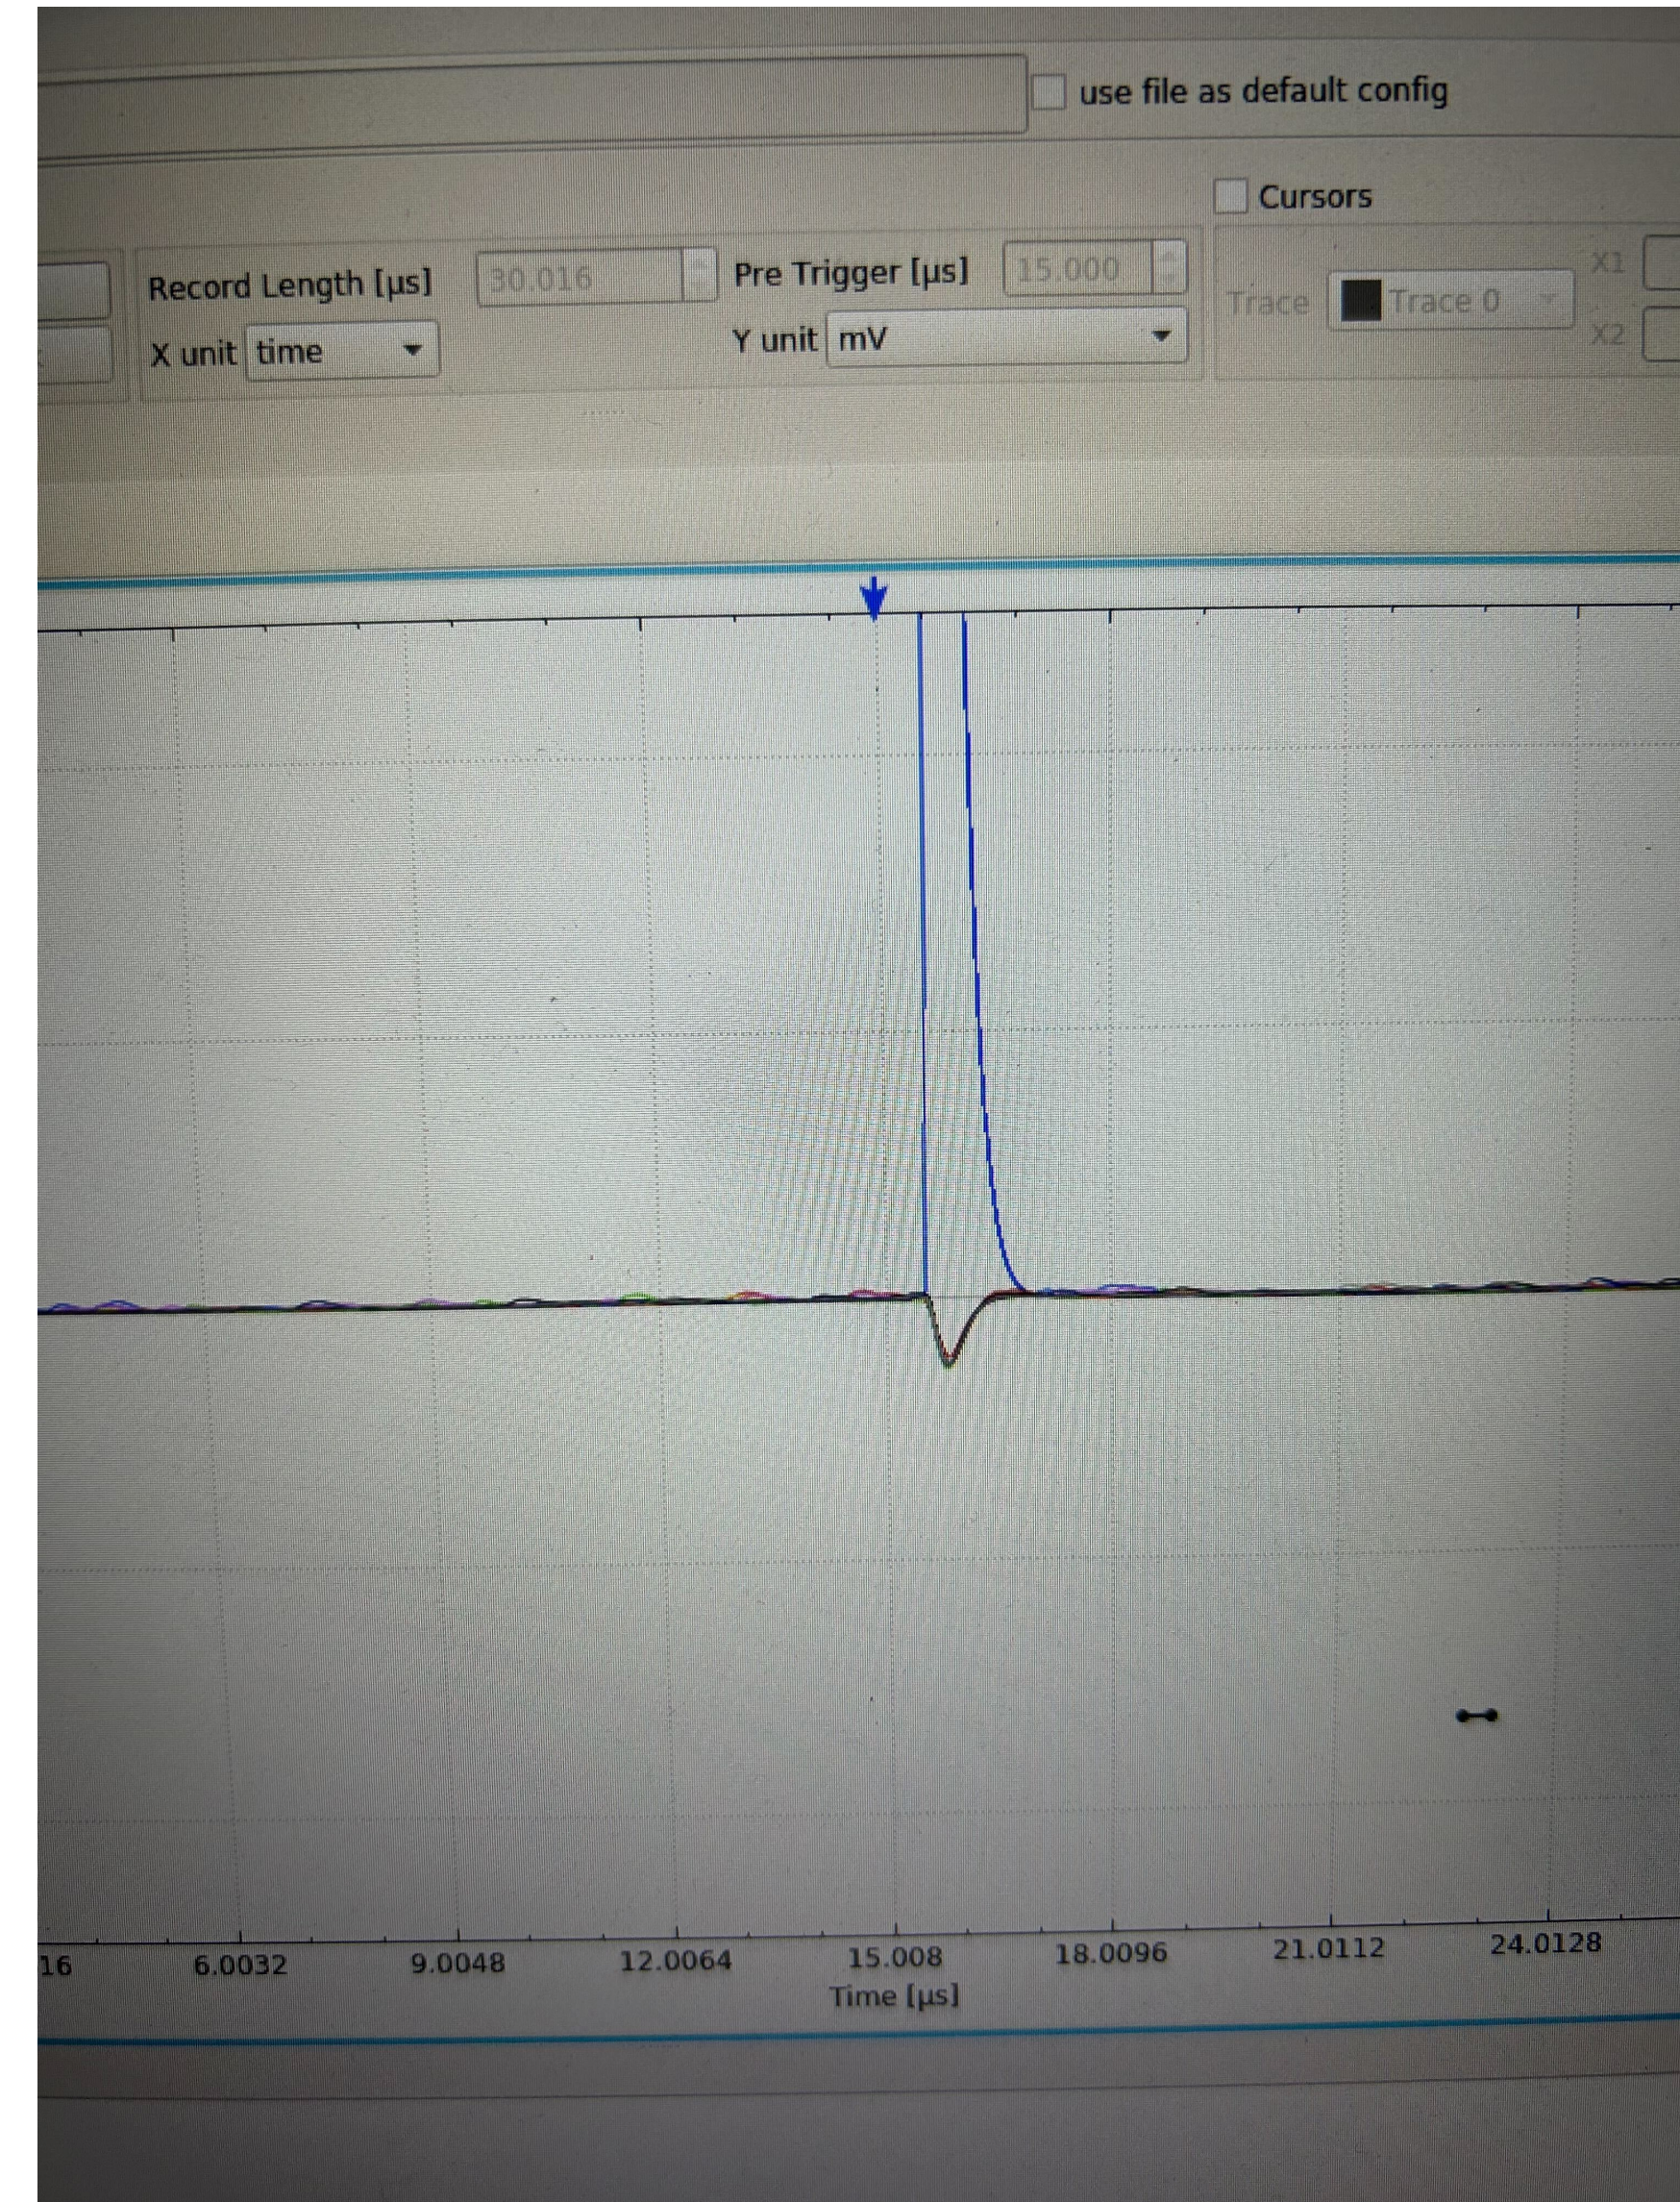
- Direct the fiber optic at a single SiPM
- The SiPM in question shows an expected positive signal, whereas all other channels give a negative

- Need to determine where the crosstalk is happening
- Take the illuminated SiPM and one other
- Replace the ribbon cable with two coaxial cables, kept separate from each other
- The output signal should give us a strong indication whether the cross talk is in the board or the cables
- Report this to the engineers?
- Any other thoughts?
