# X-ray Irradiation Studies of ITk Pixel Modules Affected by the Core-Column Problem

NICOLO SALIMBENI | 18 JUNE 2026

# Core-Column problem

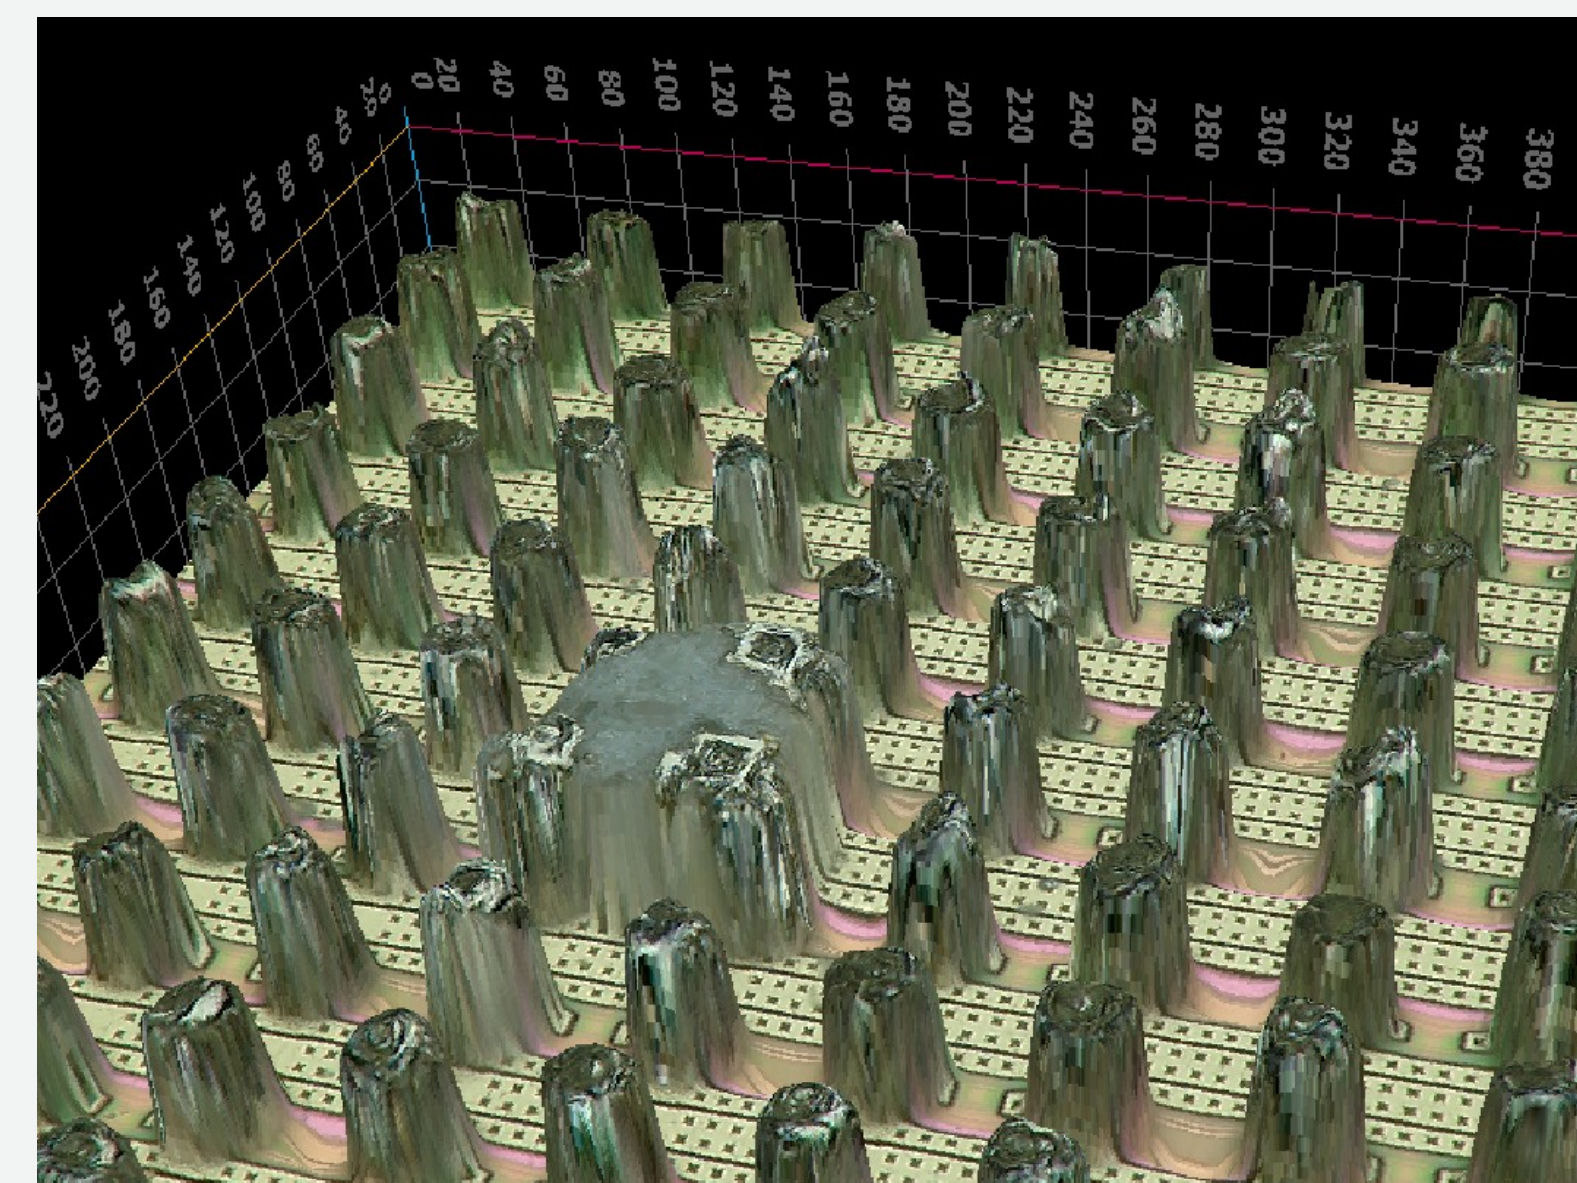
It is not a chip issue - otherwise it would have been caught in wafer probing → suspect mechanical damage during sensor dicing or module assembly (picture on the right).

High resolution picture of a FE chip disassembled from a module affected by the CC problem from [here](#). Silicon debris has been found between the bonds used to read the pixels.

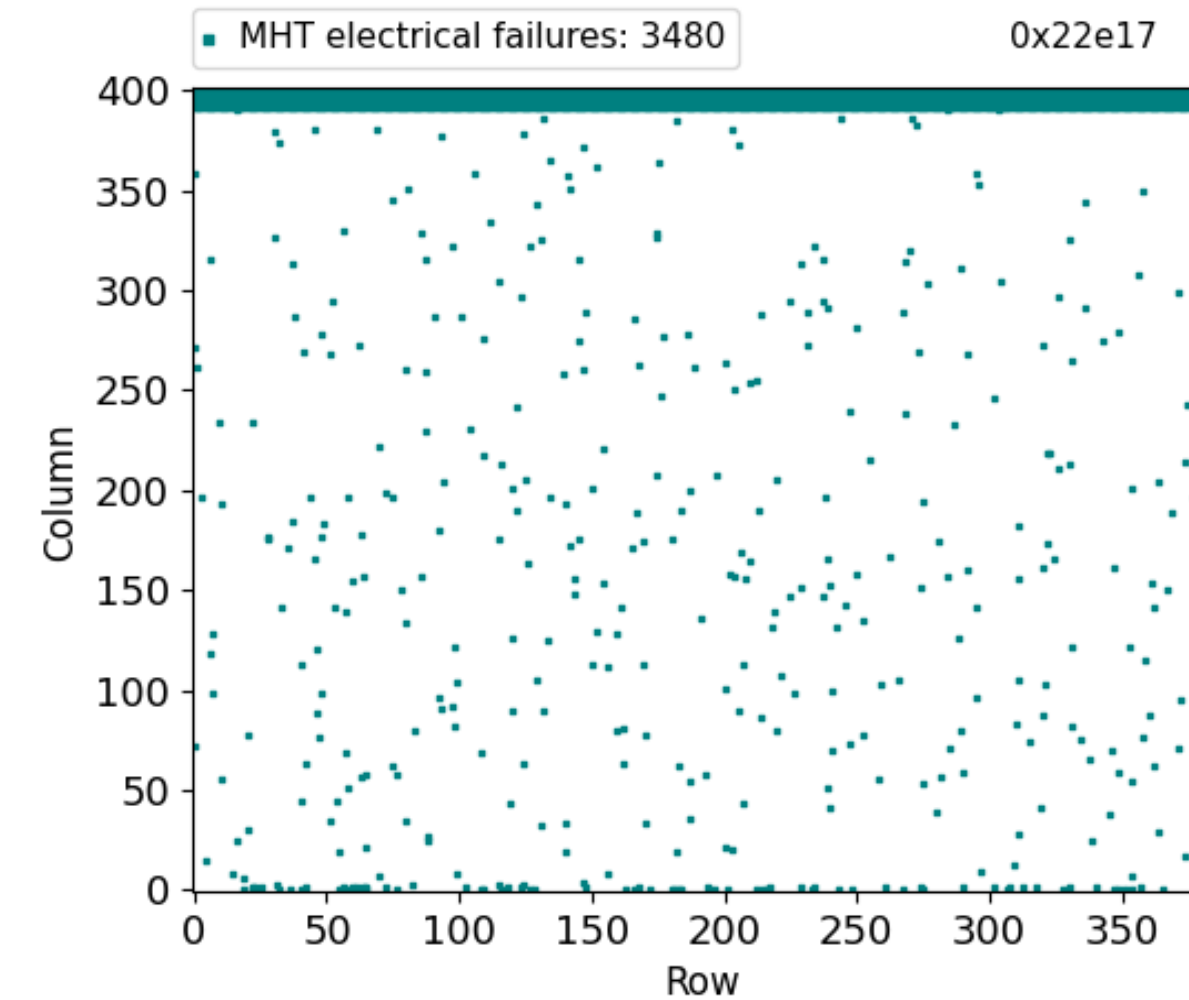
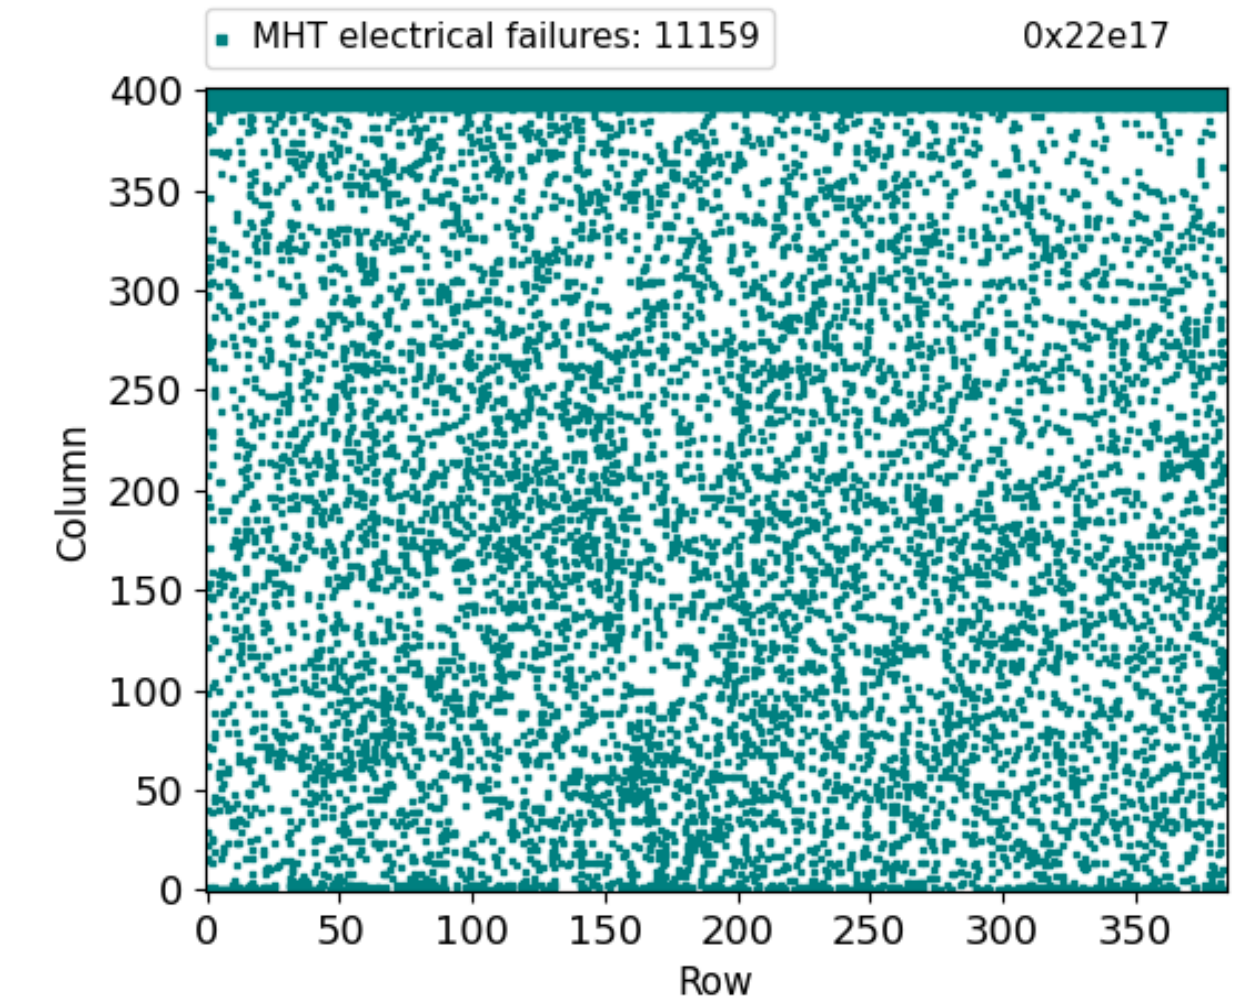
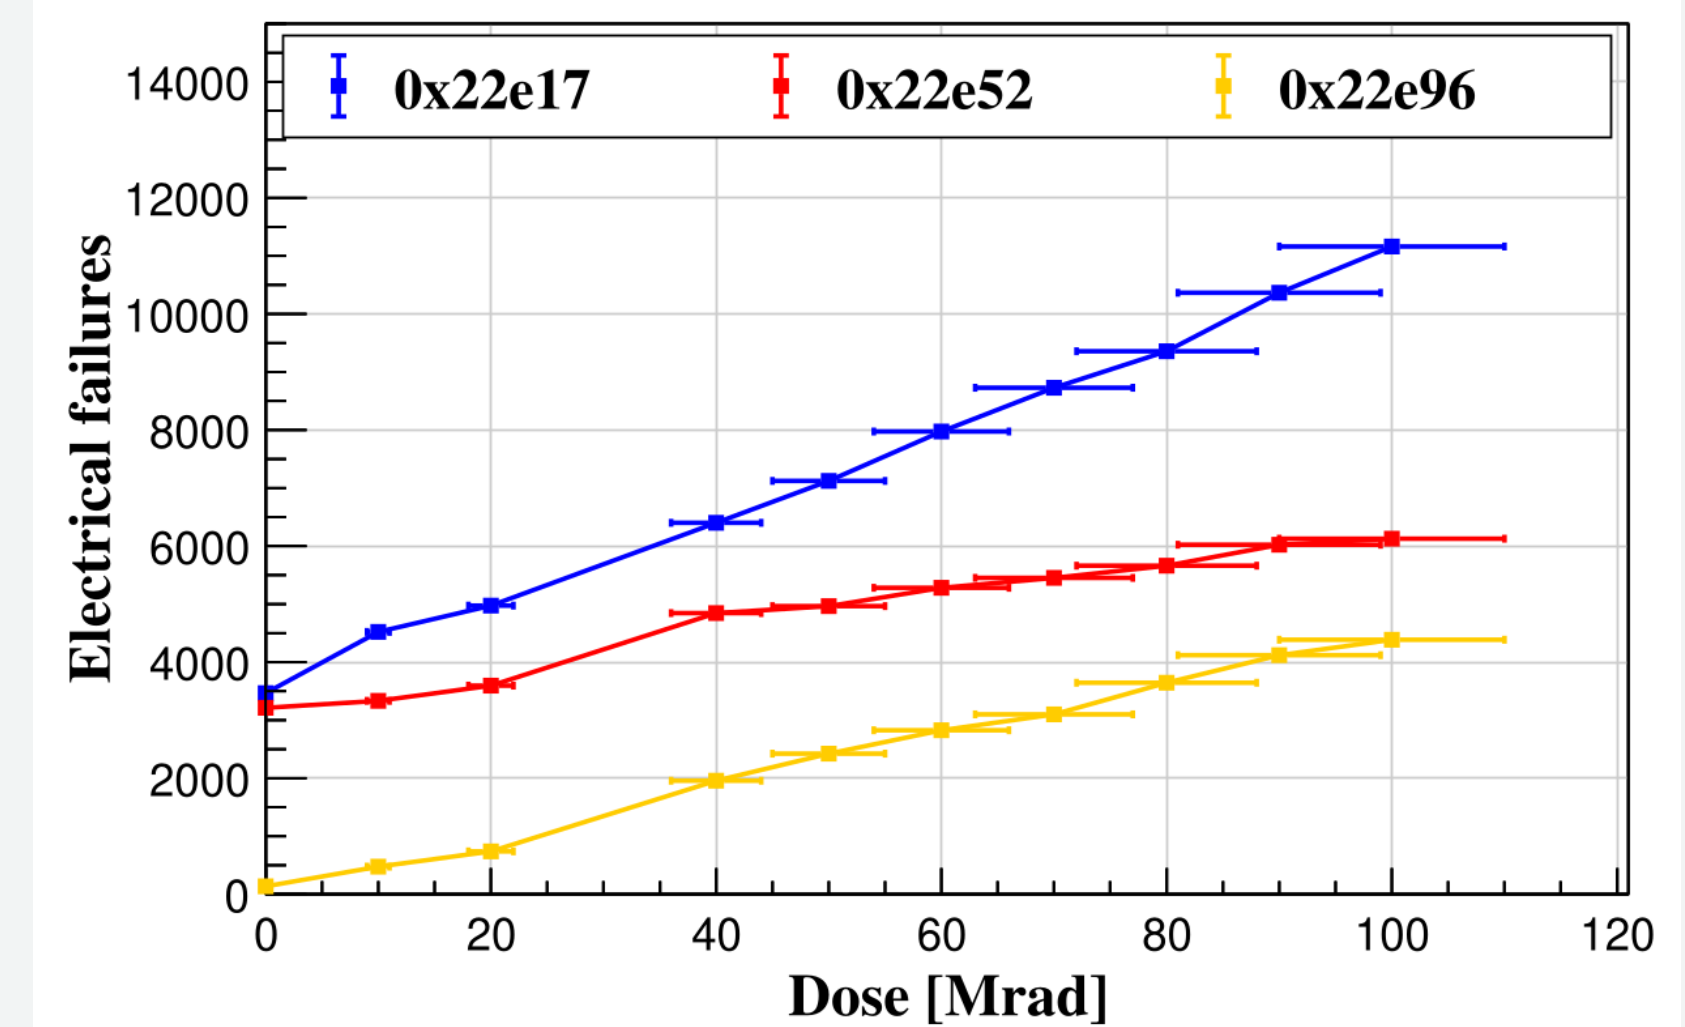
- In all the chips studied so far the number of electrical failures increased, but no new CC issues appeared
- Up to ~75% of the failures can be recovered after retuning
- For 3 chips the evolution of the failures as a function of the dose has been tracked (plot on the bottom)

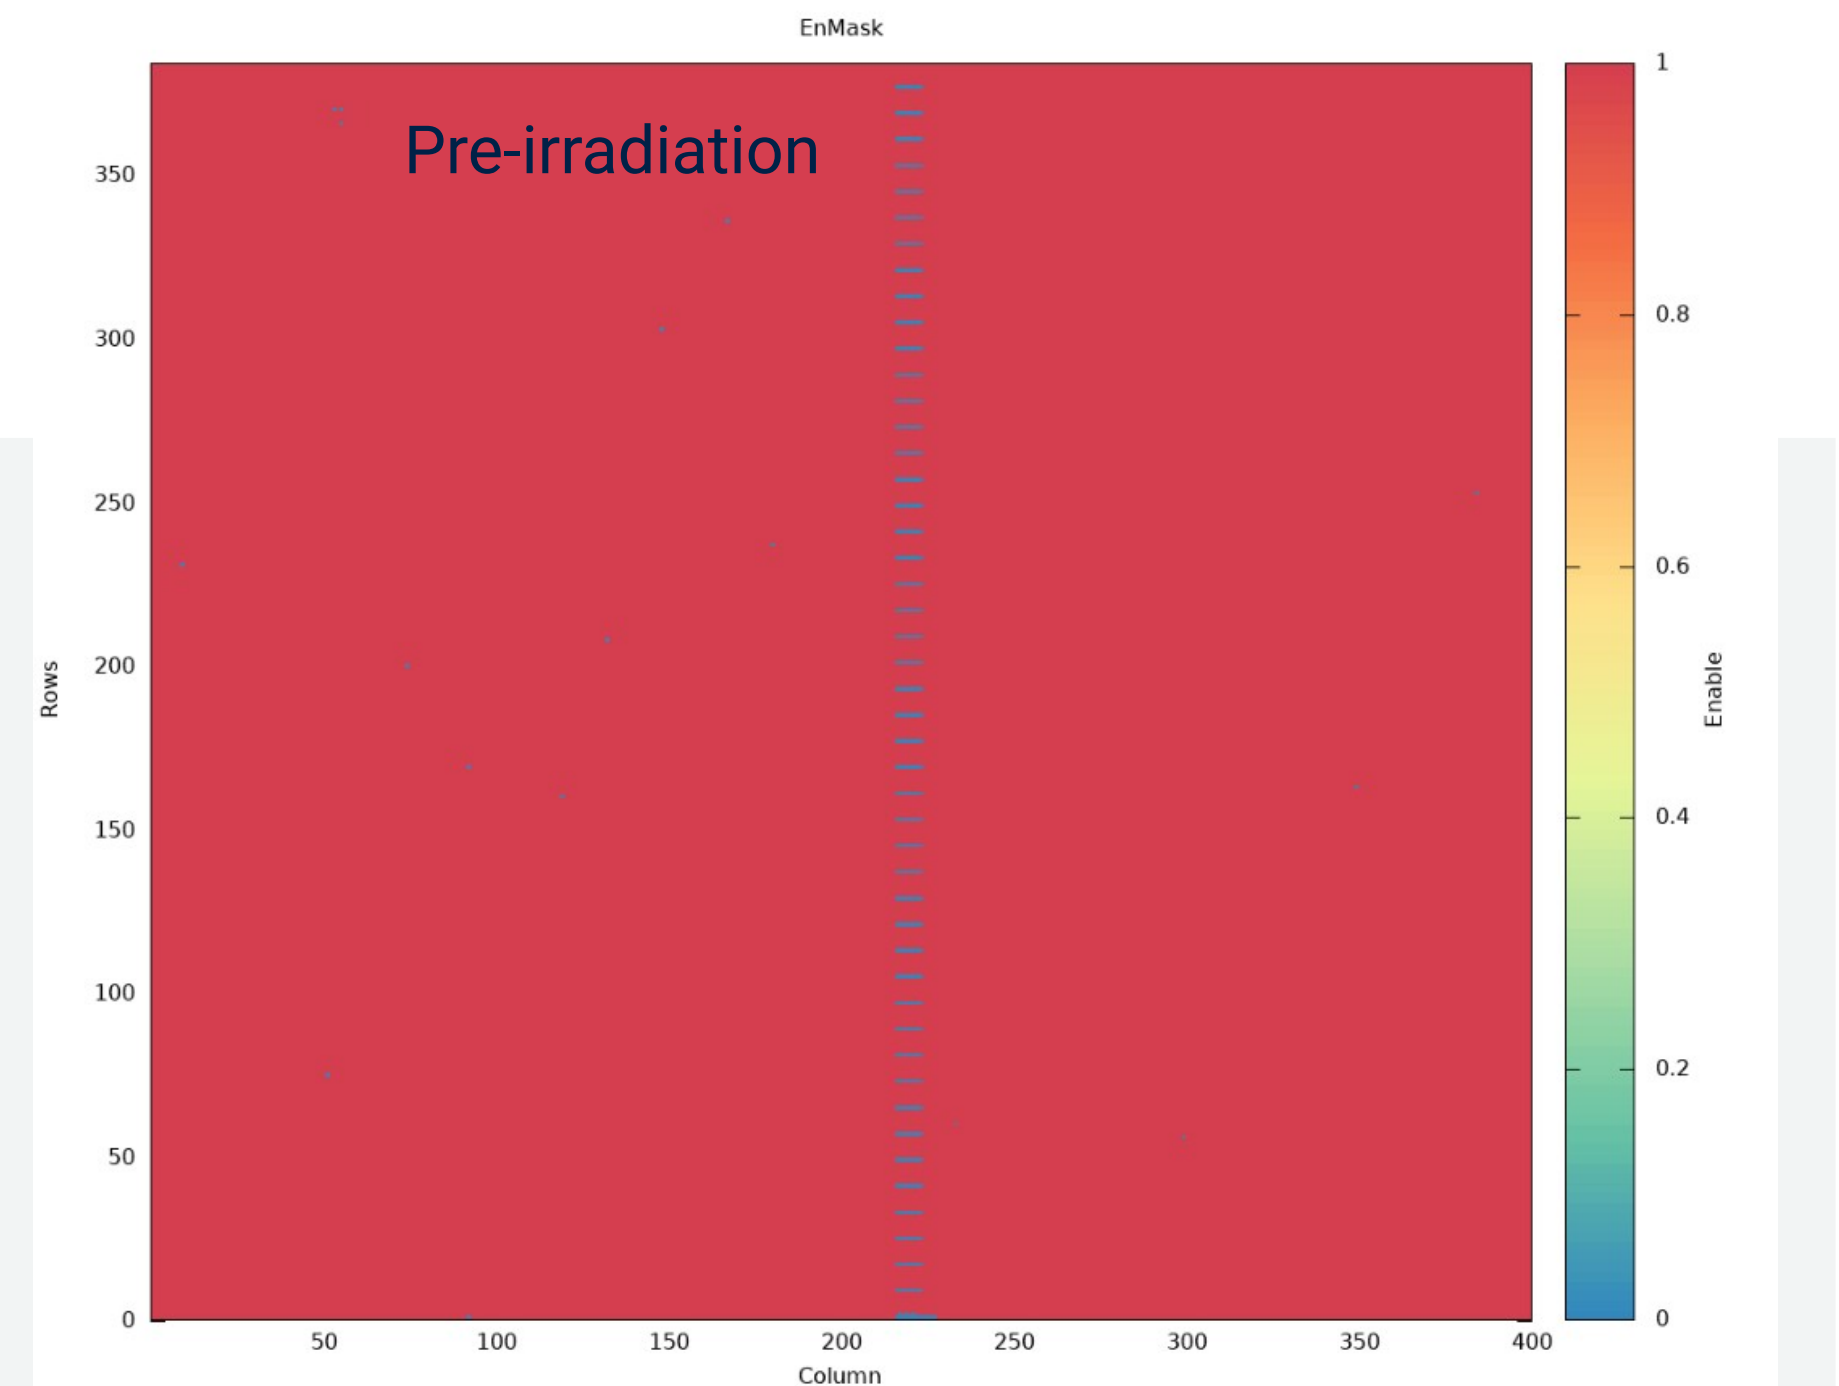
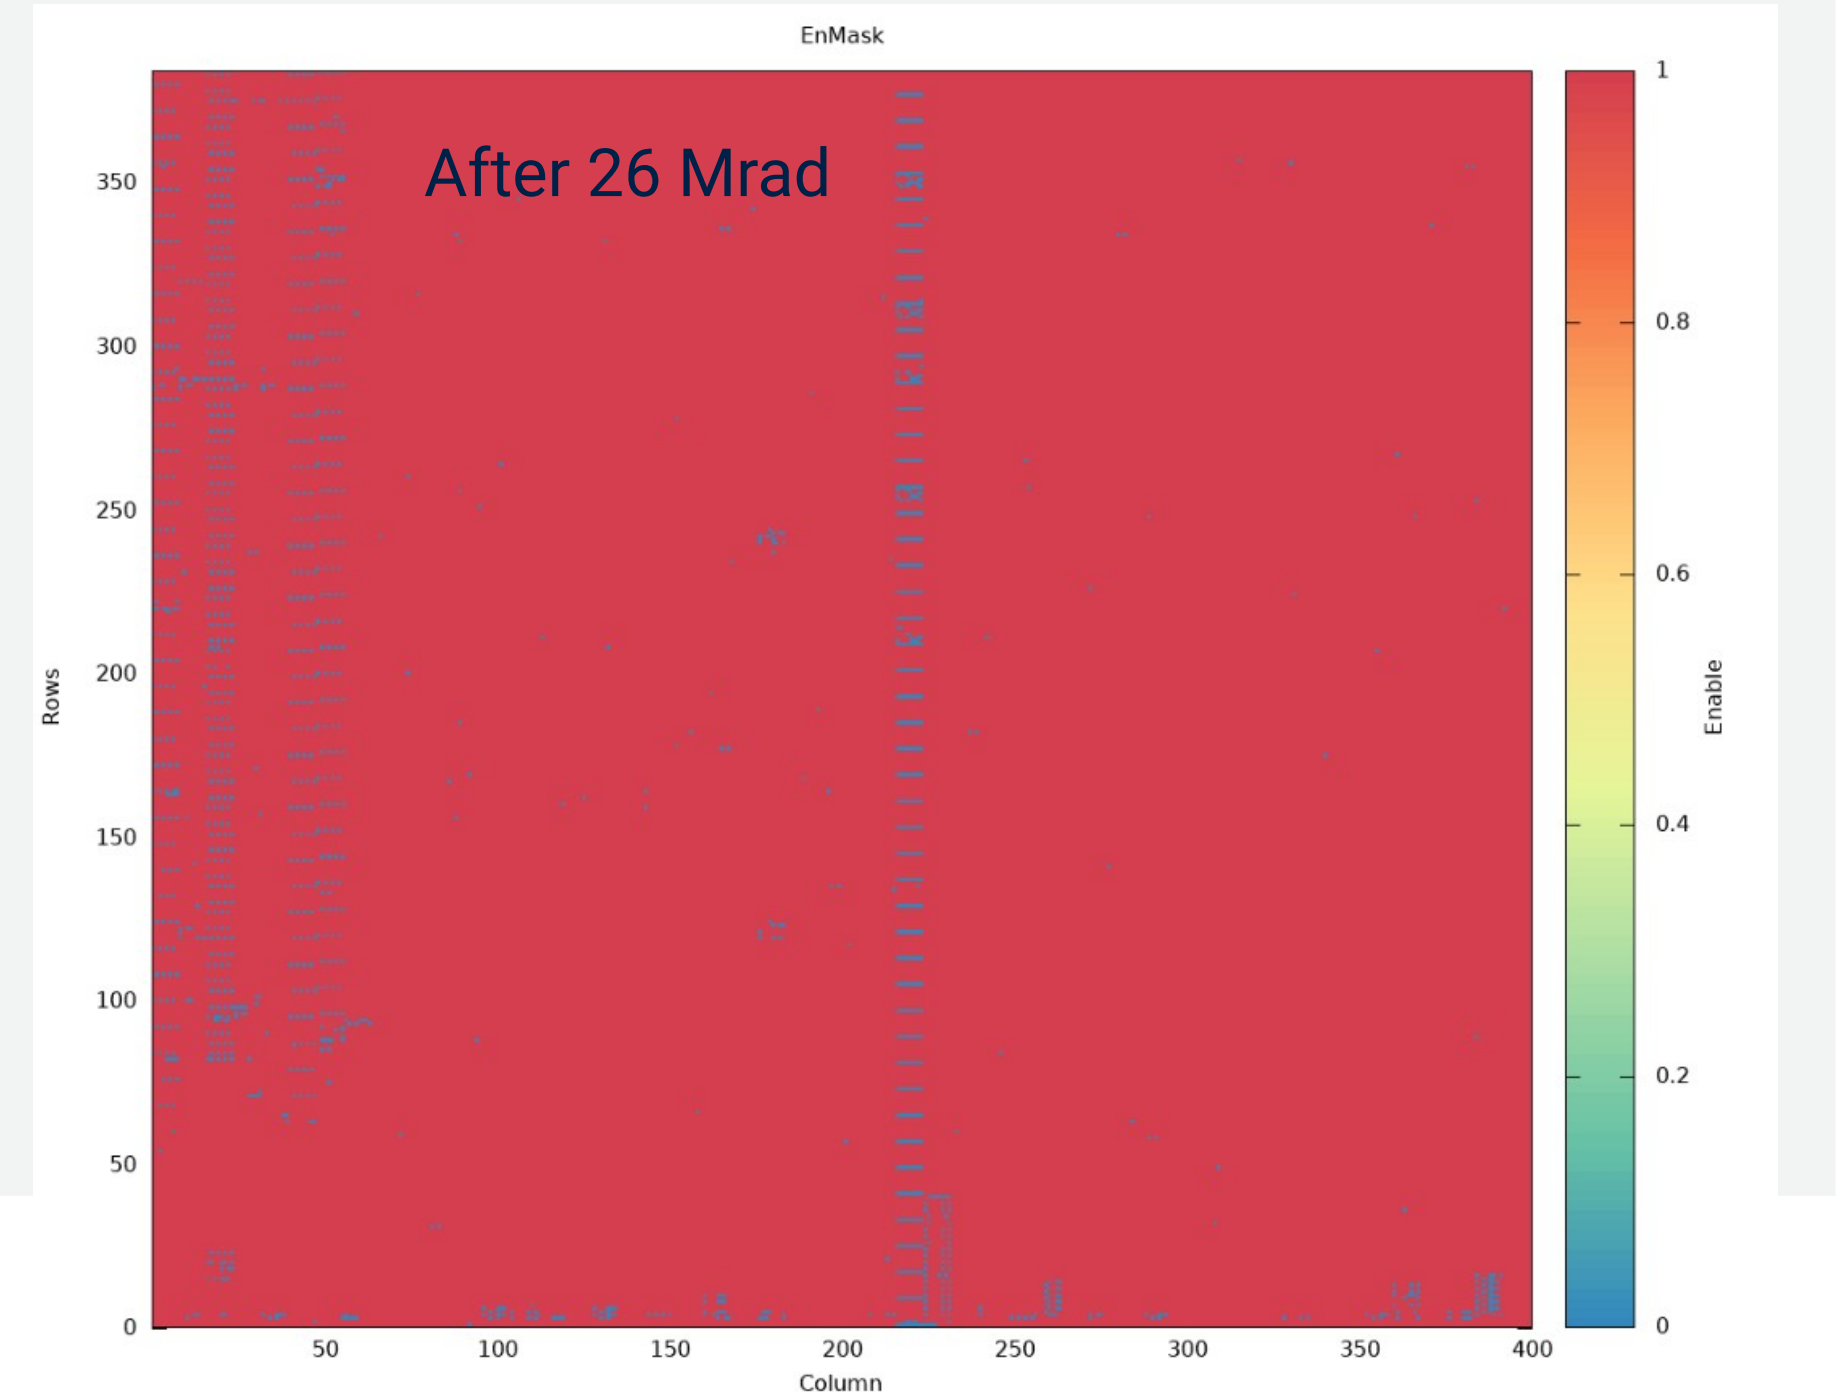
In these plots (“EnMask”), bad pixels are shown in blue and good pixels in red.

- The chip that exhibited a CC issue from the beginning appears to degrade with irradiation
- After 26 Mrad, it shows more bad pixels on one side
- The good chips, instead, do not show new CC issues

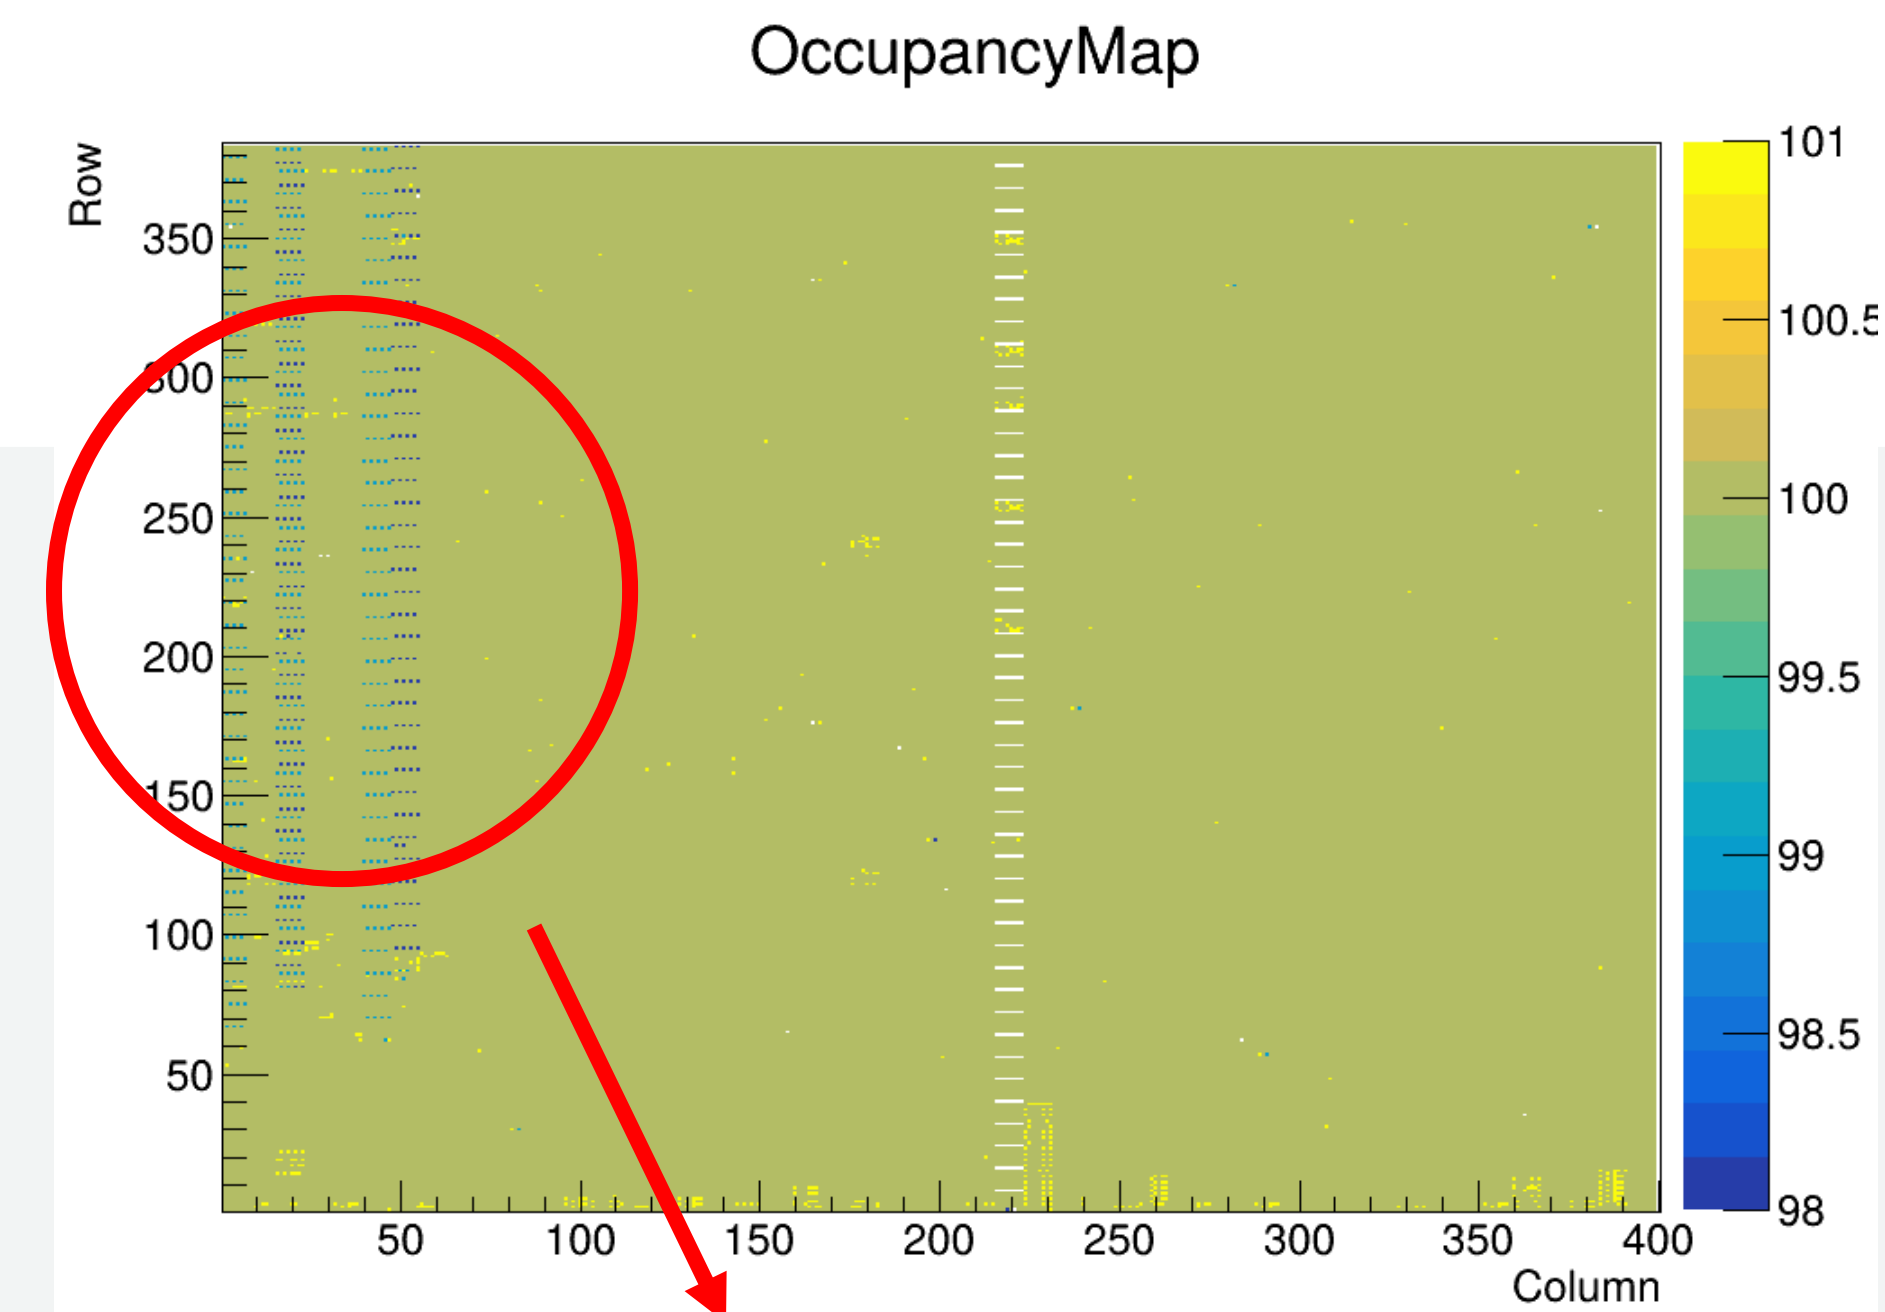
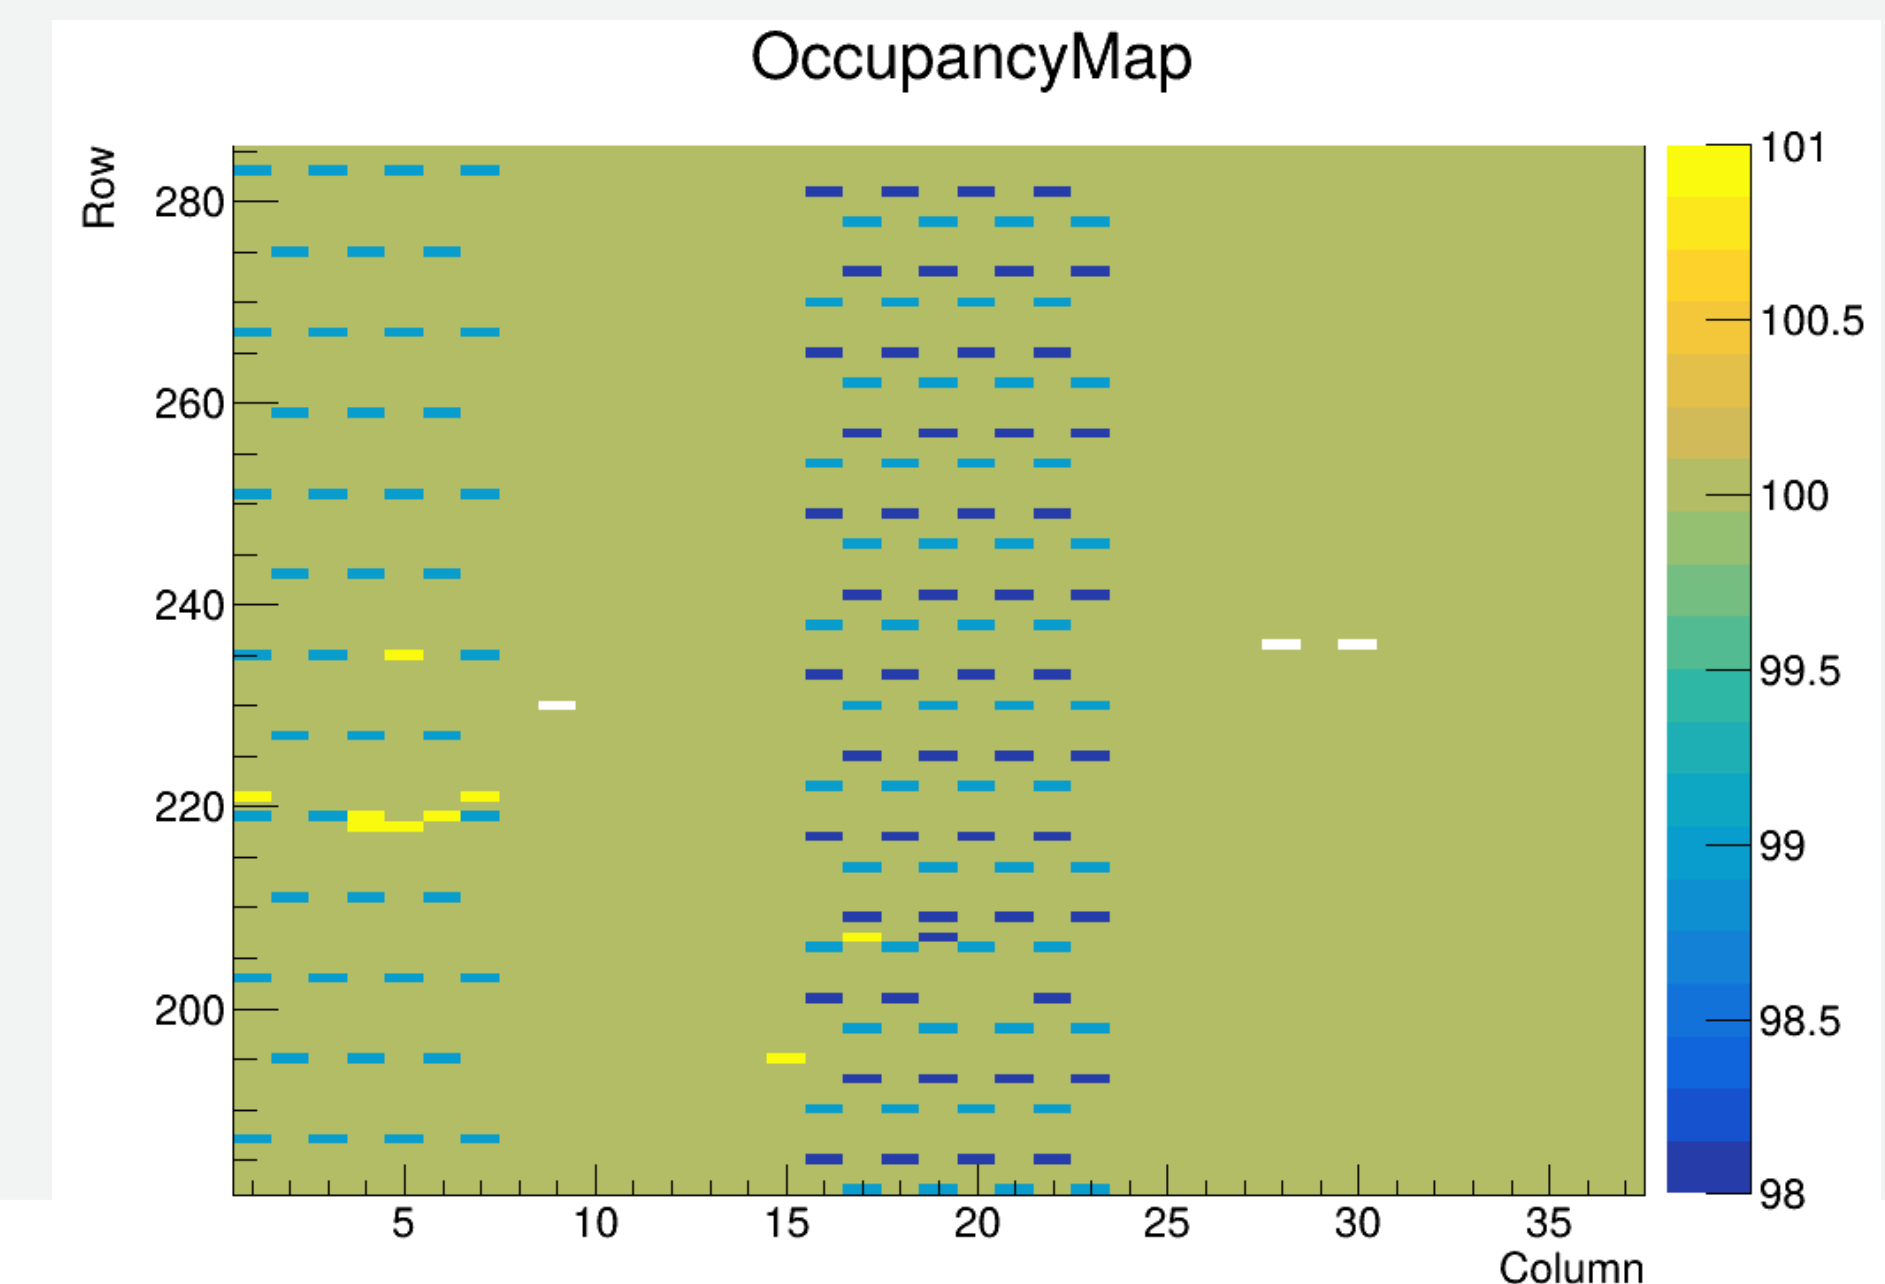
- The occupancy map for 100 injections and triggers is shown in the top-right plot
- The “original core column” appears dead, with no hits recorded
- In the “new” problematic pixels, 98–99 hits are observed (see zoomed plot)
- Possible explanations:
  - Missing trigger commands
  - Data transmission errors
  - Other readout inefficiencies

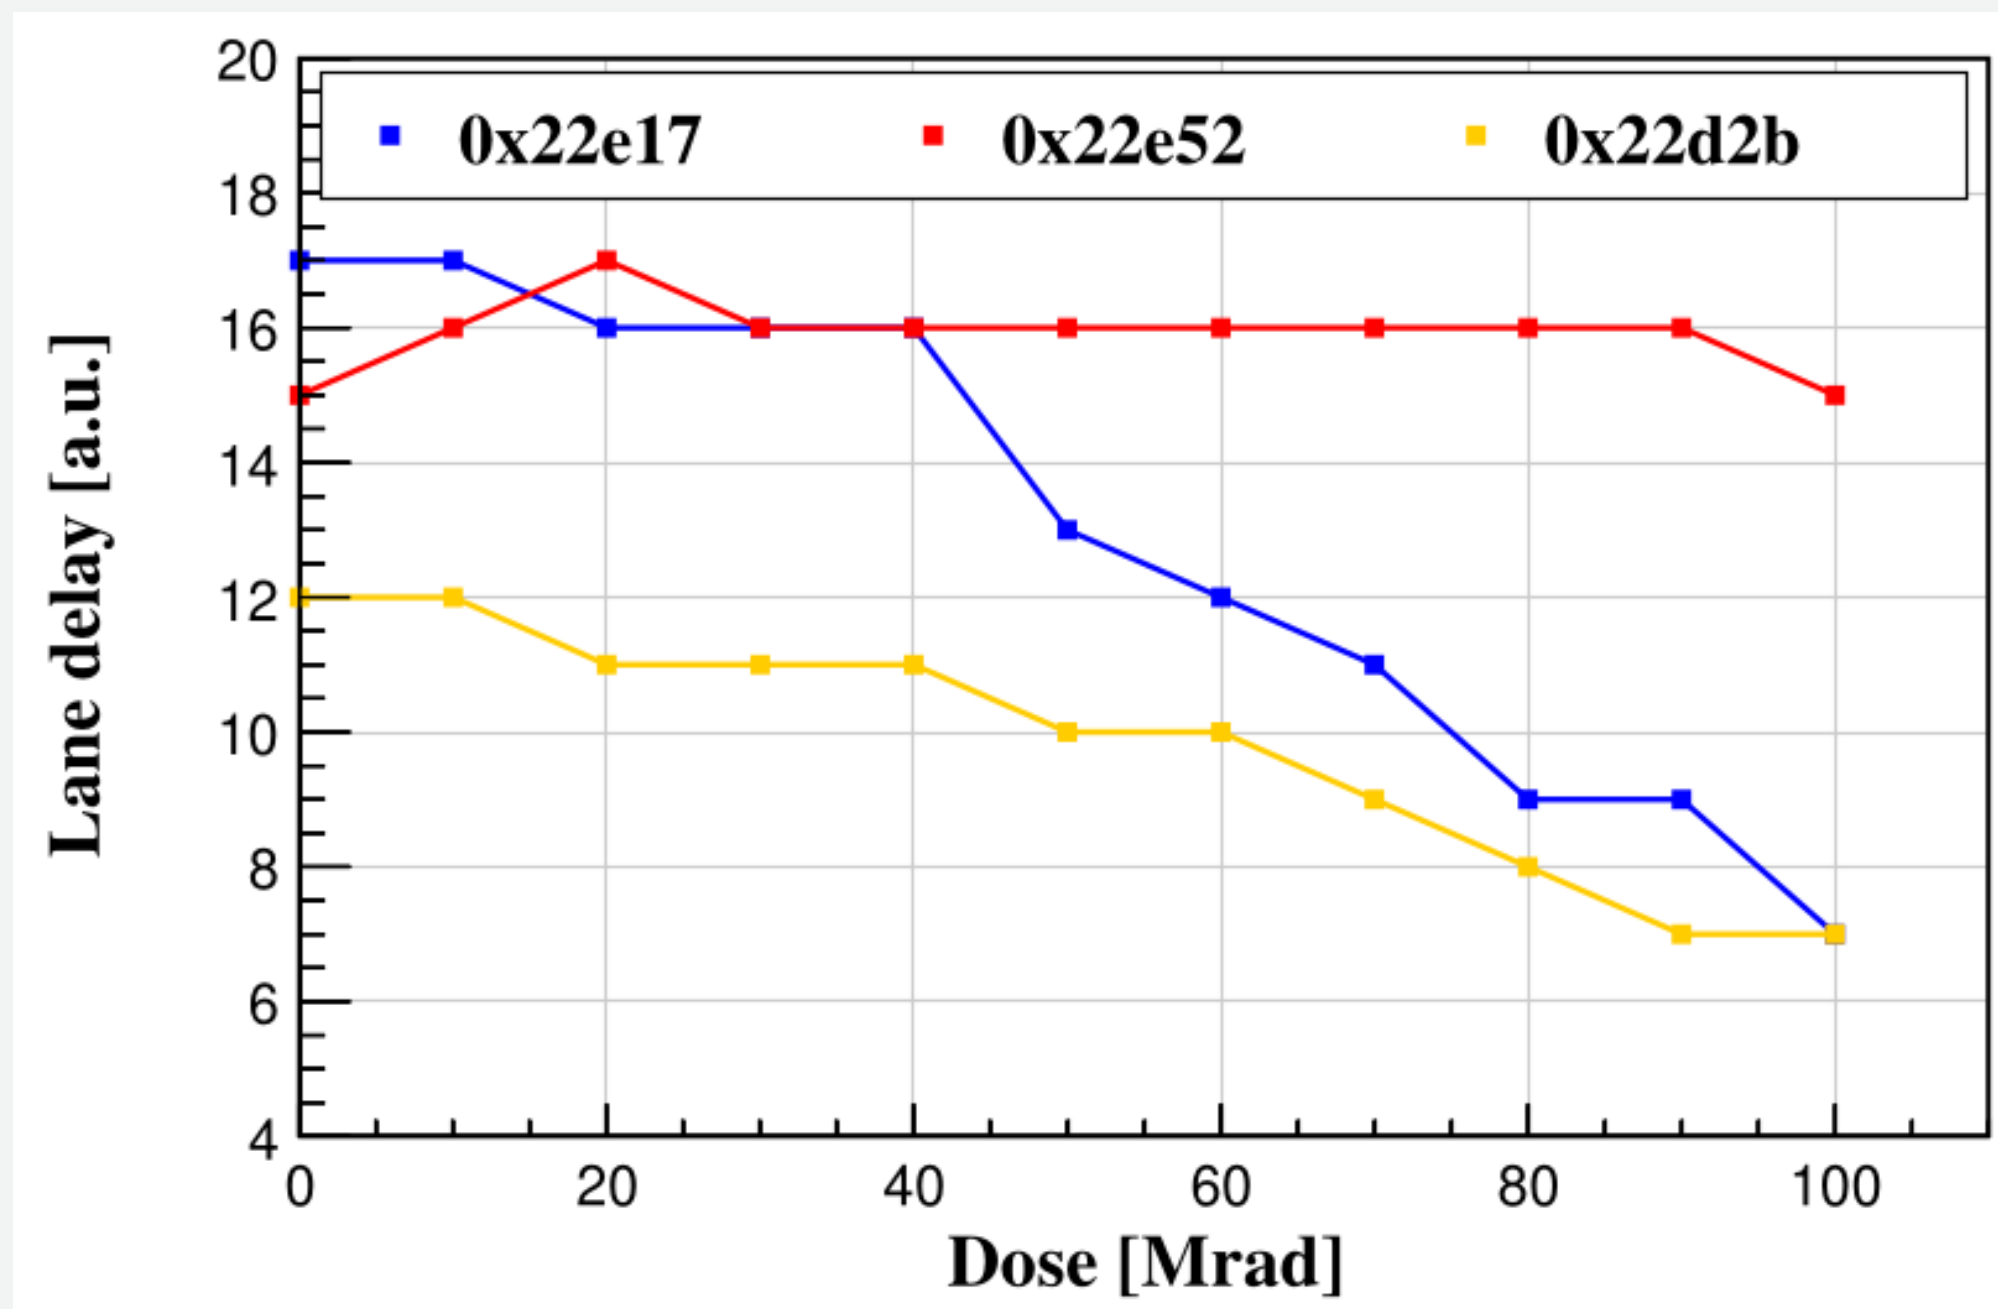
- One chip of the module was disabled → only three communication lanes were active.
- Two lanes show a change in the optimal delay
- This could explain why, in the first irradiation campaign, when the optimization was done only once at the beginning, some hits were missing. Commands could be lost between the PC and the module.
