Kalindi Gosine

Spring 2025 Updates

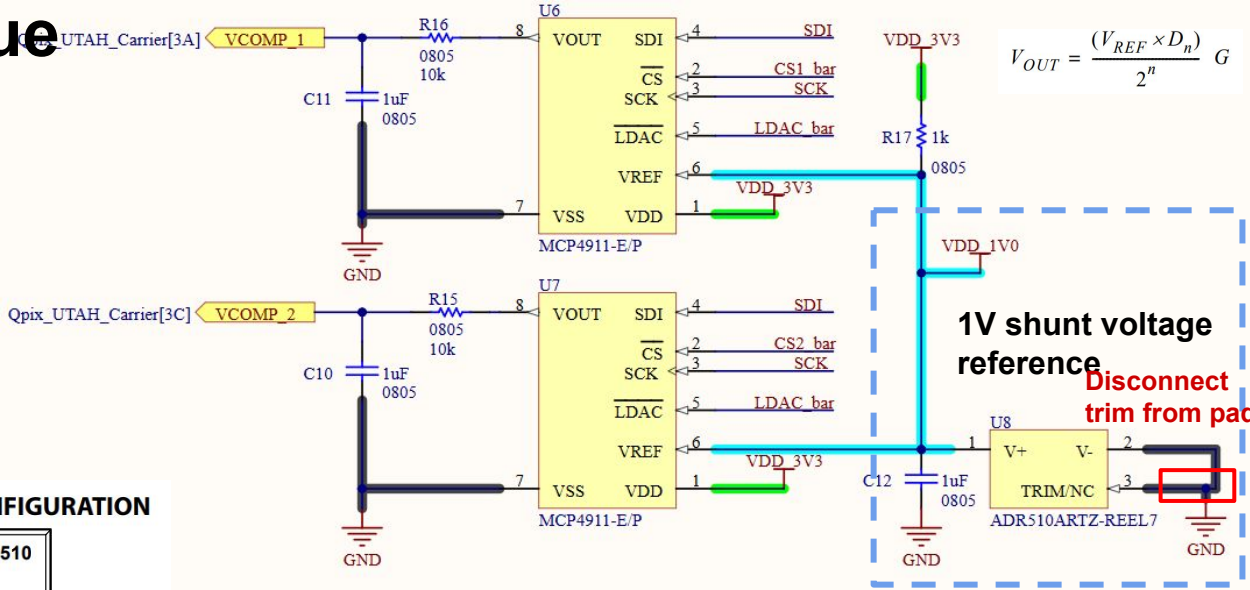
The VDD_1V0 Issue

VDD_1V0= 1.00V

Pin 3 on shunt voltage reference must be disconnected from pad (desoldered, kapton tape, resolder pins 1&2)

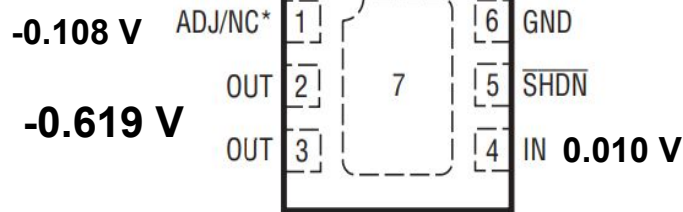
-2.6V only

Confirmed the stagnant voltage on V3p3 when only -2Vnn is ON varies linearly with the value of -2Vnn (-2Vnn=-2.6V, V3p3= -0.619 → -2Vnn= -1.8V, V3p3 = -0.500 V)

Finite resistance between -2Vnn and V3p3 (only -2Vnn powering board):

No resistor between 8-13MegOhms on Altium for HFA board. Unclear where this is coming from and why these points are not completely isolated

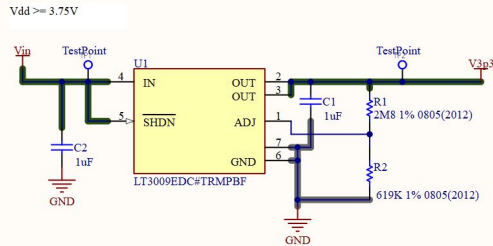
Troubleshooting V3p3

Confirmed R1 and R2 values are correct

Powered with only +5V and measured 3.324V pin3 and 0.602V at pin1

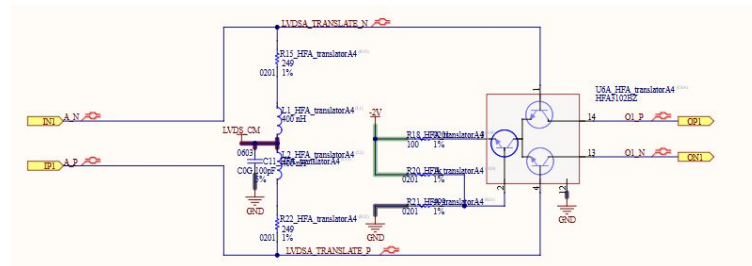
For a single ASIC board when connected to HFA, all ASIC voltages are shorted to ground

- When not connected to HFA, ASIC voltages are all isolated from board ground
- When connected to HFA, ASIC voltage test points on HFA are shorted to ground
- When HFA is powered from Carrier Board, ASIC voltage test points are correct
- When HFA is powered from Carrier Board and connected to ASIC board, all voltage test points are shorted to ground
- No issue with the other two ASIC boards with either of our 2 HFA boards
 - Confirmed diff pairs on HFA chips have correct resistances between them

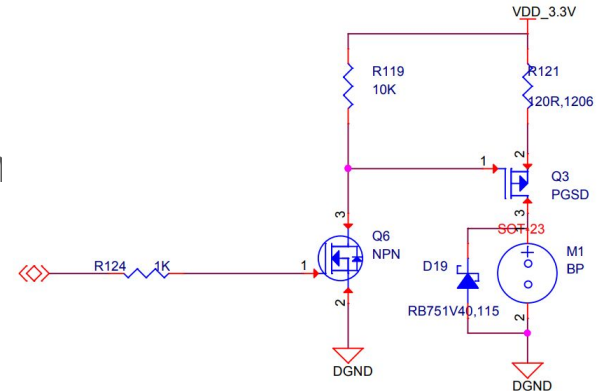
ZTurn Current Draw

No buzzing

Removed R121 (allowing current into buzzer)

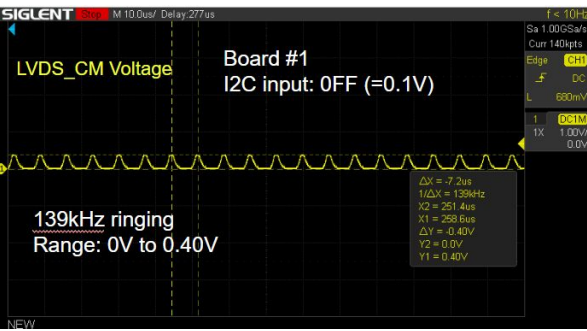
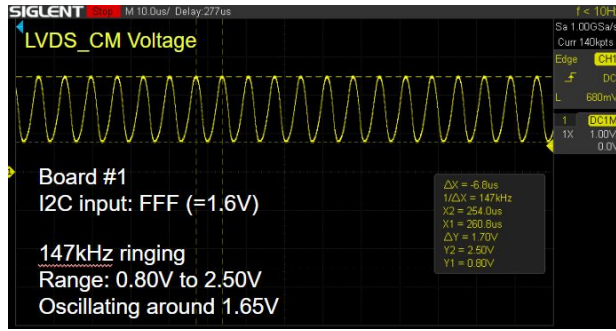
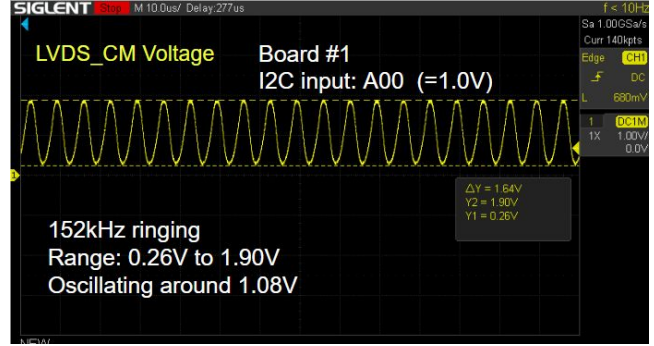
Re: LVDS_CM ringing, I2C Driver + HFA Test

Repeated our previous test of just I2C driver and HFA board to see LVDS_CM control.

When we tested this in Jan/Feb, we saw LVDS_CM (and VCM1 and VCM2) voltages controlled well by the driver. The issue is that we tested using a multimeter, making us blind to the ringing which does time average to the correct voltage.

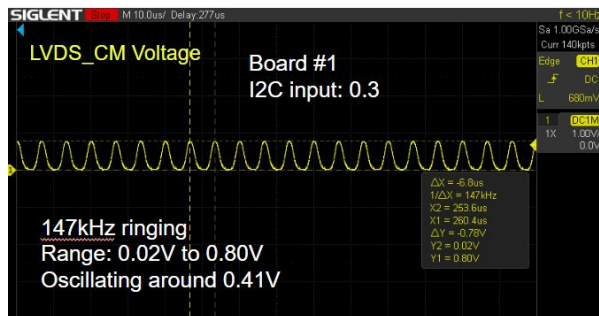
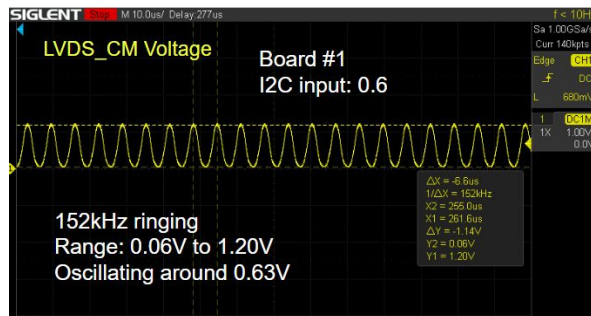
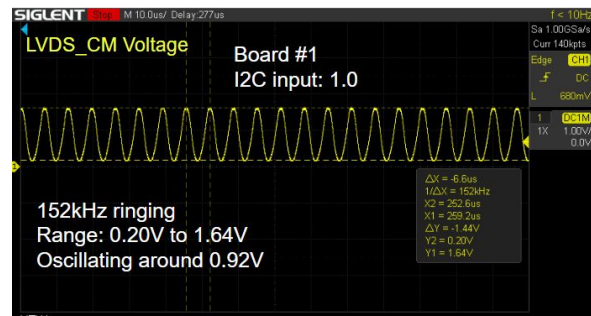
Re: LVDS_CM ringing, Carrier(+5V)+Zturn+HFA

Ringings is identical when controlled via carrier and zturn (only +5V) is supplied

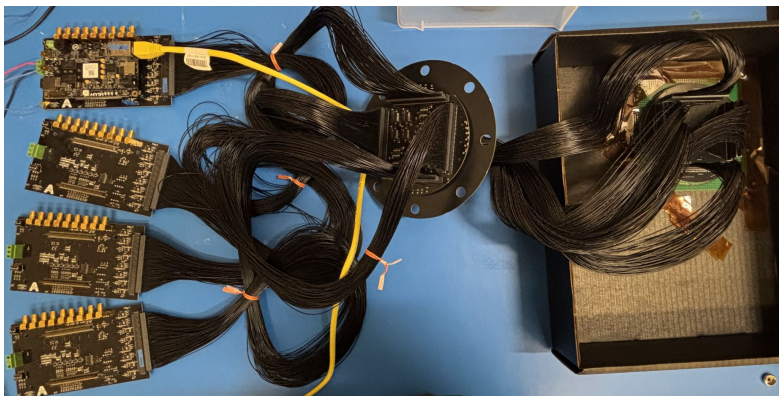
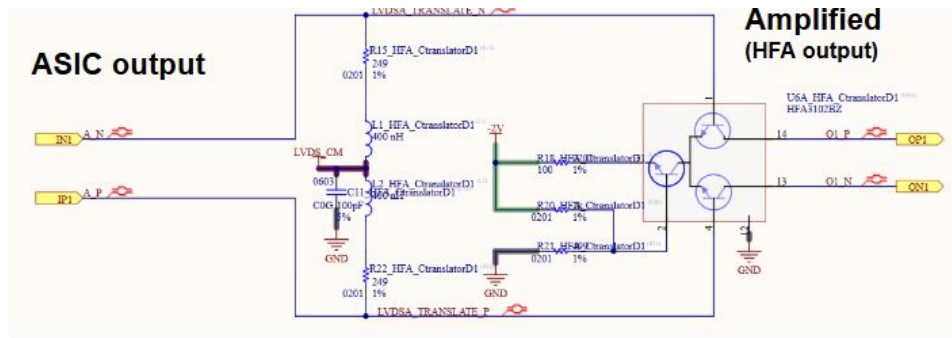
When we apply the -2.7V (2V_{nn}) through the carrier board we were seeing the V3p3 at the LVDS DAC reduced from 3.3V to 1.88V and the LVDS_CM voltage set to -0.88V and no longer controllable via I2C. dV_{dd} was also reduced from 1.6V to 1.16V (problematic since this is a voltage which does go down to ASIC)

Connecting all 4 carrier boards (even if three of them are unpowered) and the 4 chip ASIC board isolates the -2Vnn voltage from the rest of the board again.

V3p3 at the LVDS_CM DAC is again 3.3V. dVdd is again 1.6V.

In this configuration LVDS_CM is 0V and not controllable via I2C.

-2Vnn problem is solved by terminating all HFA differential pairs

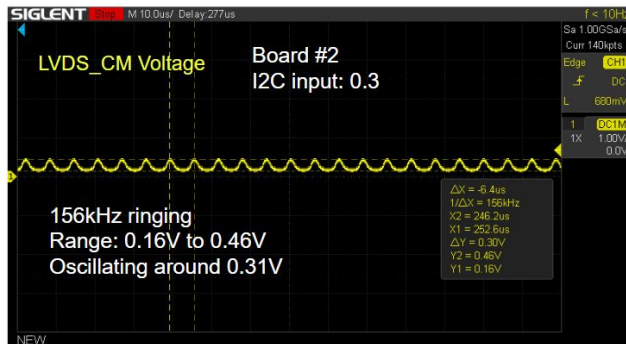
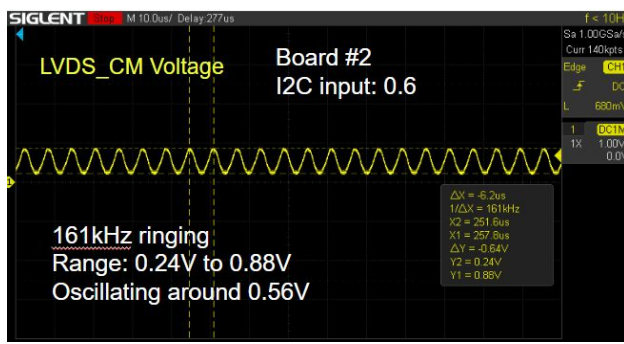
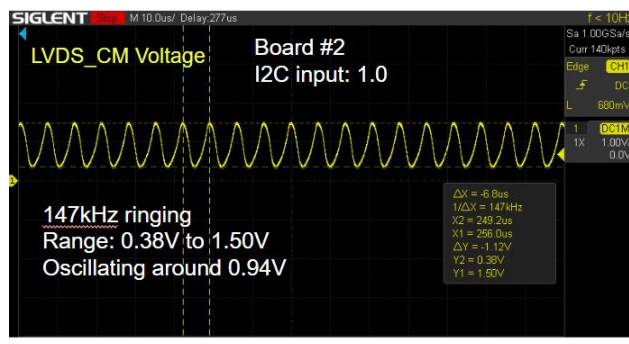
Carrier (+5V) + ZTurn + HFA + (Feedthrough & ASIC Mount) + 1 Chip ASIC Board

The LVDS DAC had an unexplained ringing in its voltage output.
We see later that connecting all four carrier boards sets the voltage to undefined and it rests at 0V

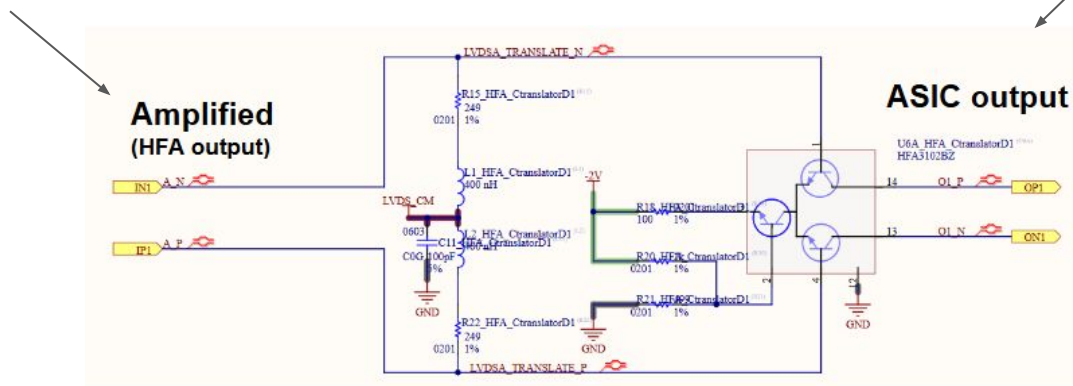
Otherwise we were seeing connection between -2Vnn (-2.7V) and LVDS_CM, dVdd, and V3p3

The diff pairs connected to the carrier boards need to be defined

All HFAs must be connected to carrier boards

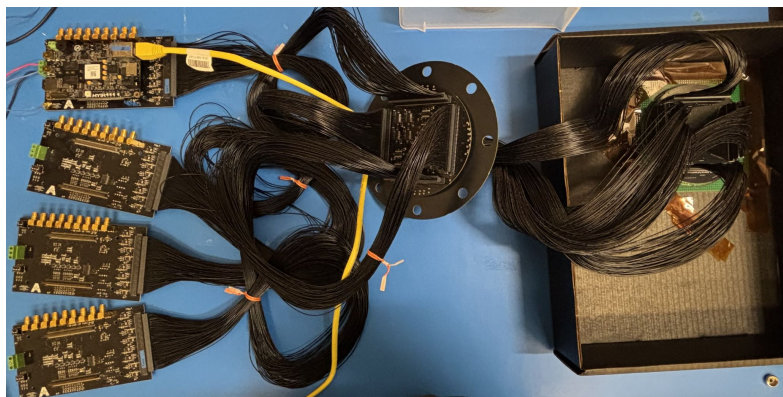
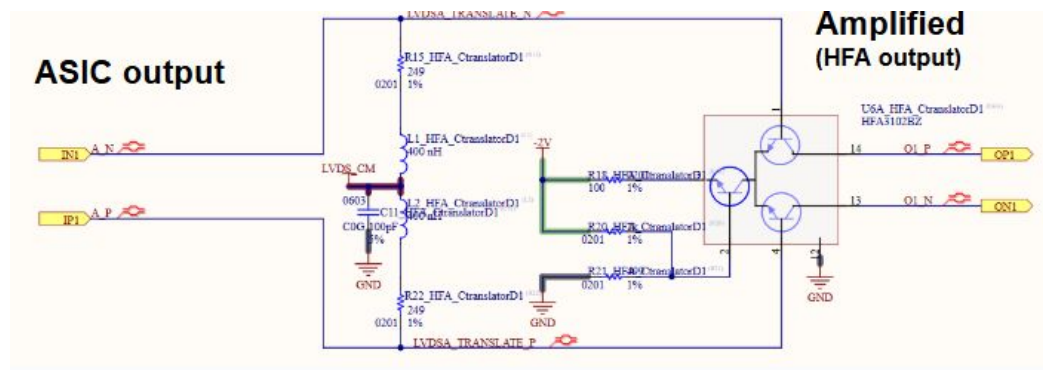
Connecting all 4 carrier boards (even if three of them are unpowered) and the 4 chip ASIC board isolates the -2Vnn voltage from the rest of the board again.

V3p3 at the LVDS_CM DAC is again 3.3V. dVdd is again 1.6V.

In this configuration LVDS_CM is 0V (but isolated from ground) and not controllable via I2C.

-2Vnn connection problem is solved by terminating all HFA differential pairs

Although LVDS_CM=0V, it can be set by an external power supply (i.e. we could adjust it by applying a voltage on a wire from the power supply)

It looks like this will have to be the case, connecting a wire to some LVDS_CM point on the board and controlling the voltage from the supply.
