# Project update 03/06/26

Mathias Zurbriggen

# Monochromator update

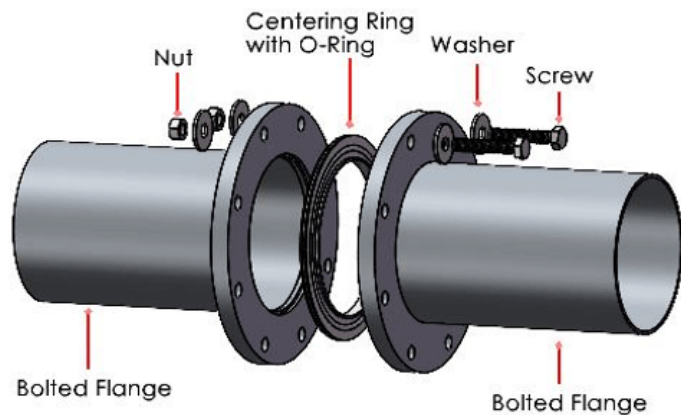
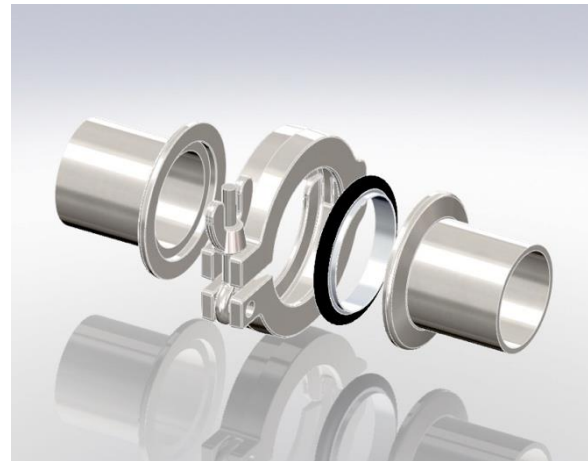
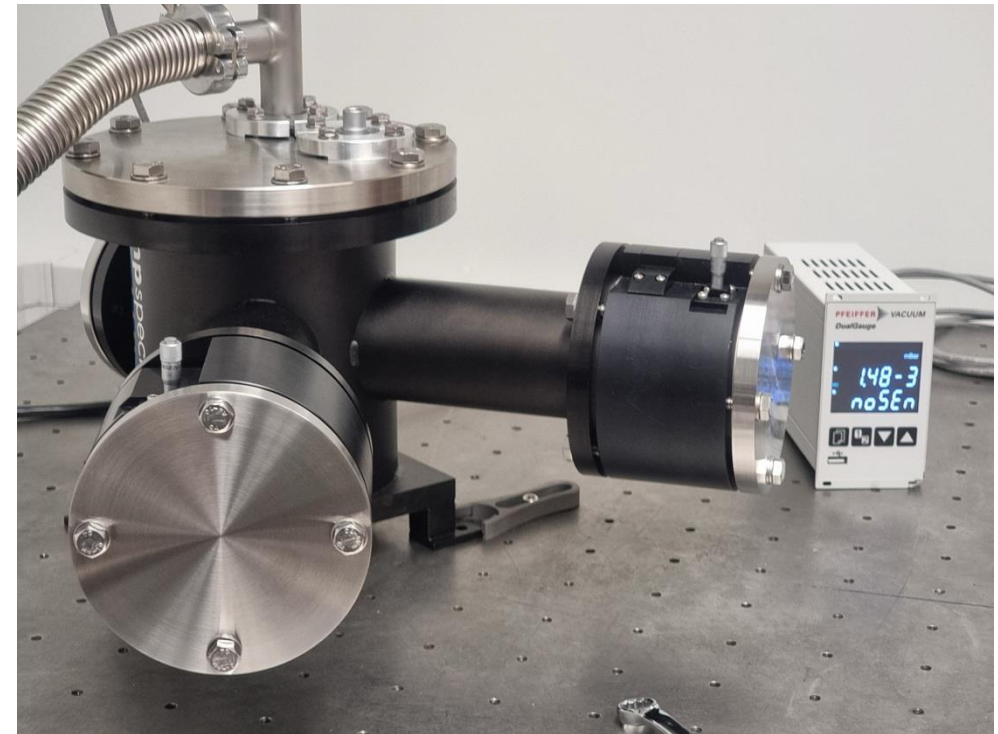
- Optical grating taken off and kept safe for vacuum tests
- Initial vacuum pump test: A mere  $10^{-3}$  mbar
- Initial leak tests showed many leaks
  - All ISO-K and some KF flanges

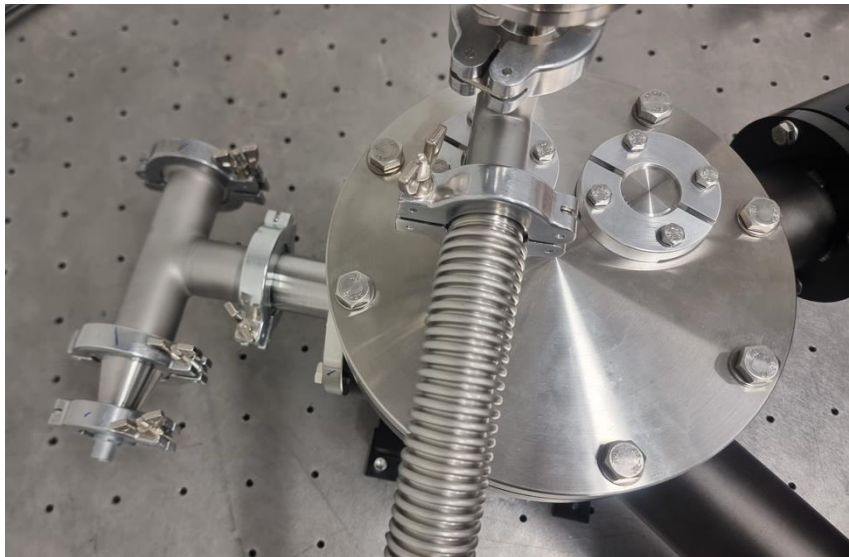
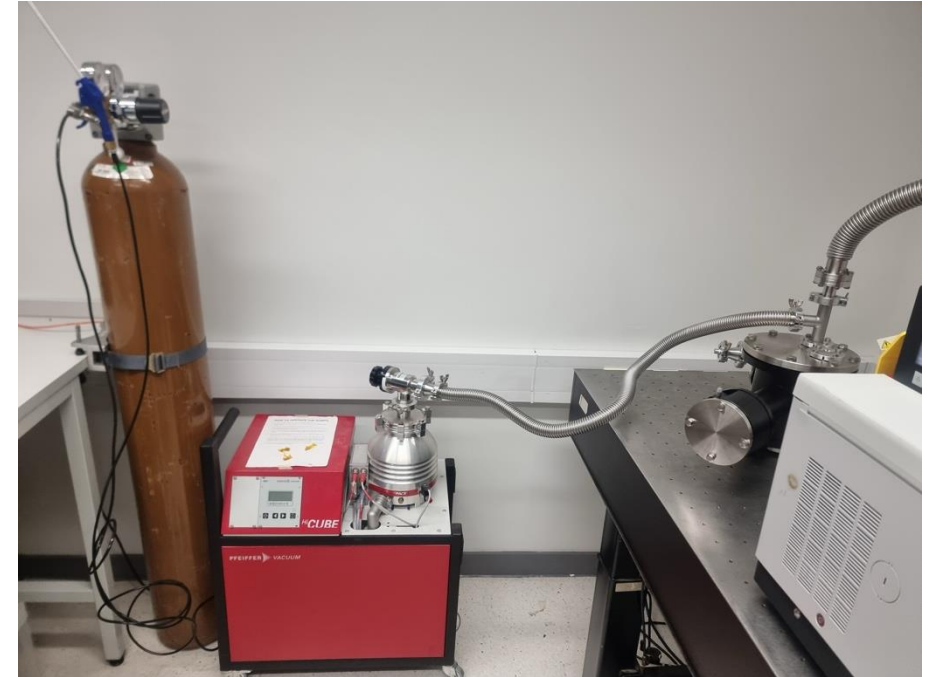
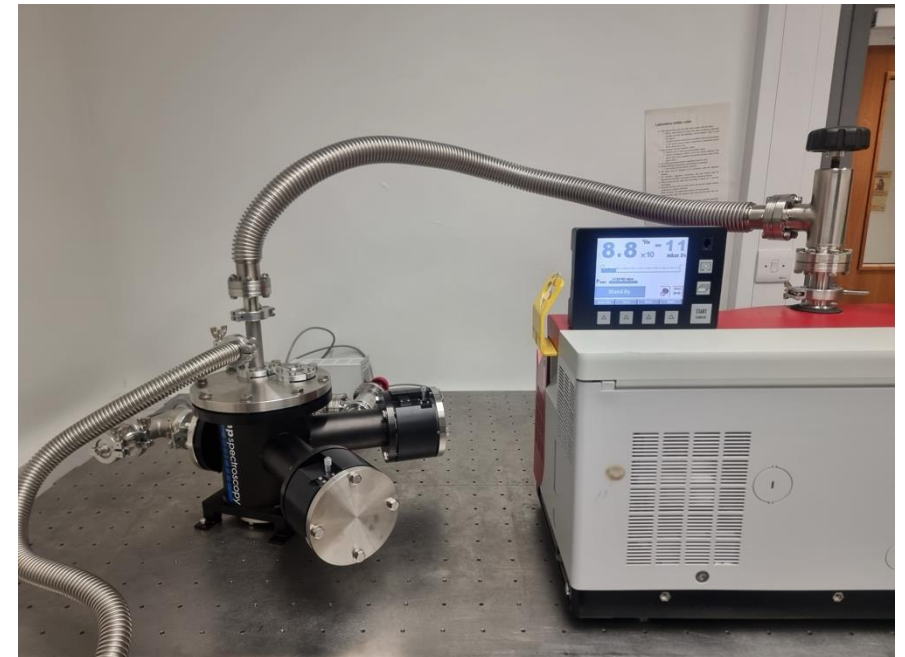
- Helium cylinder moved to dark room
- Wire feedthrough relocated
- All seals cleaned but some still leaking
- Need to add vacuum grease to those
