Design and Prototype Performance of Macro-Pixel Sub-Assemblies for the CMS Outer Tracker Upgrade

Jennet Dickinson, Fermi National Accelerator Laboratory – PSD12, September 2021

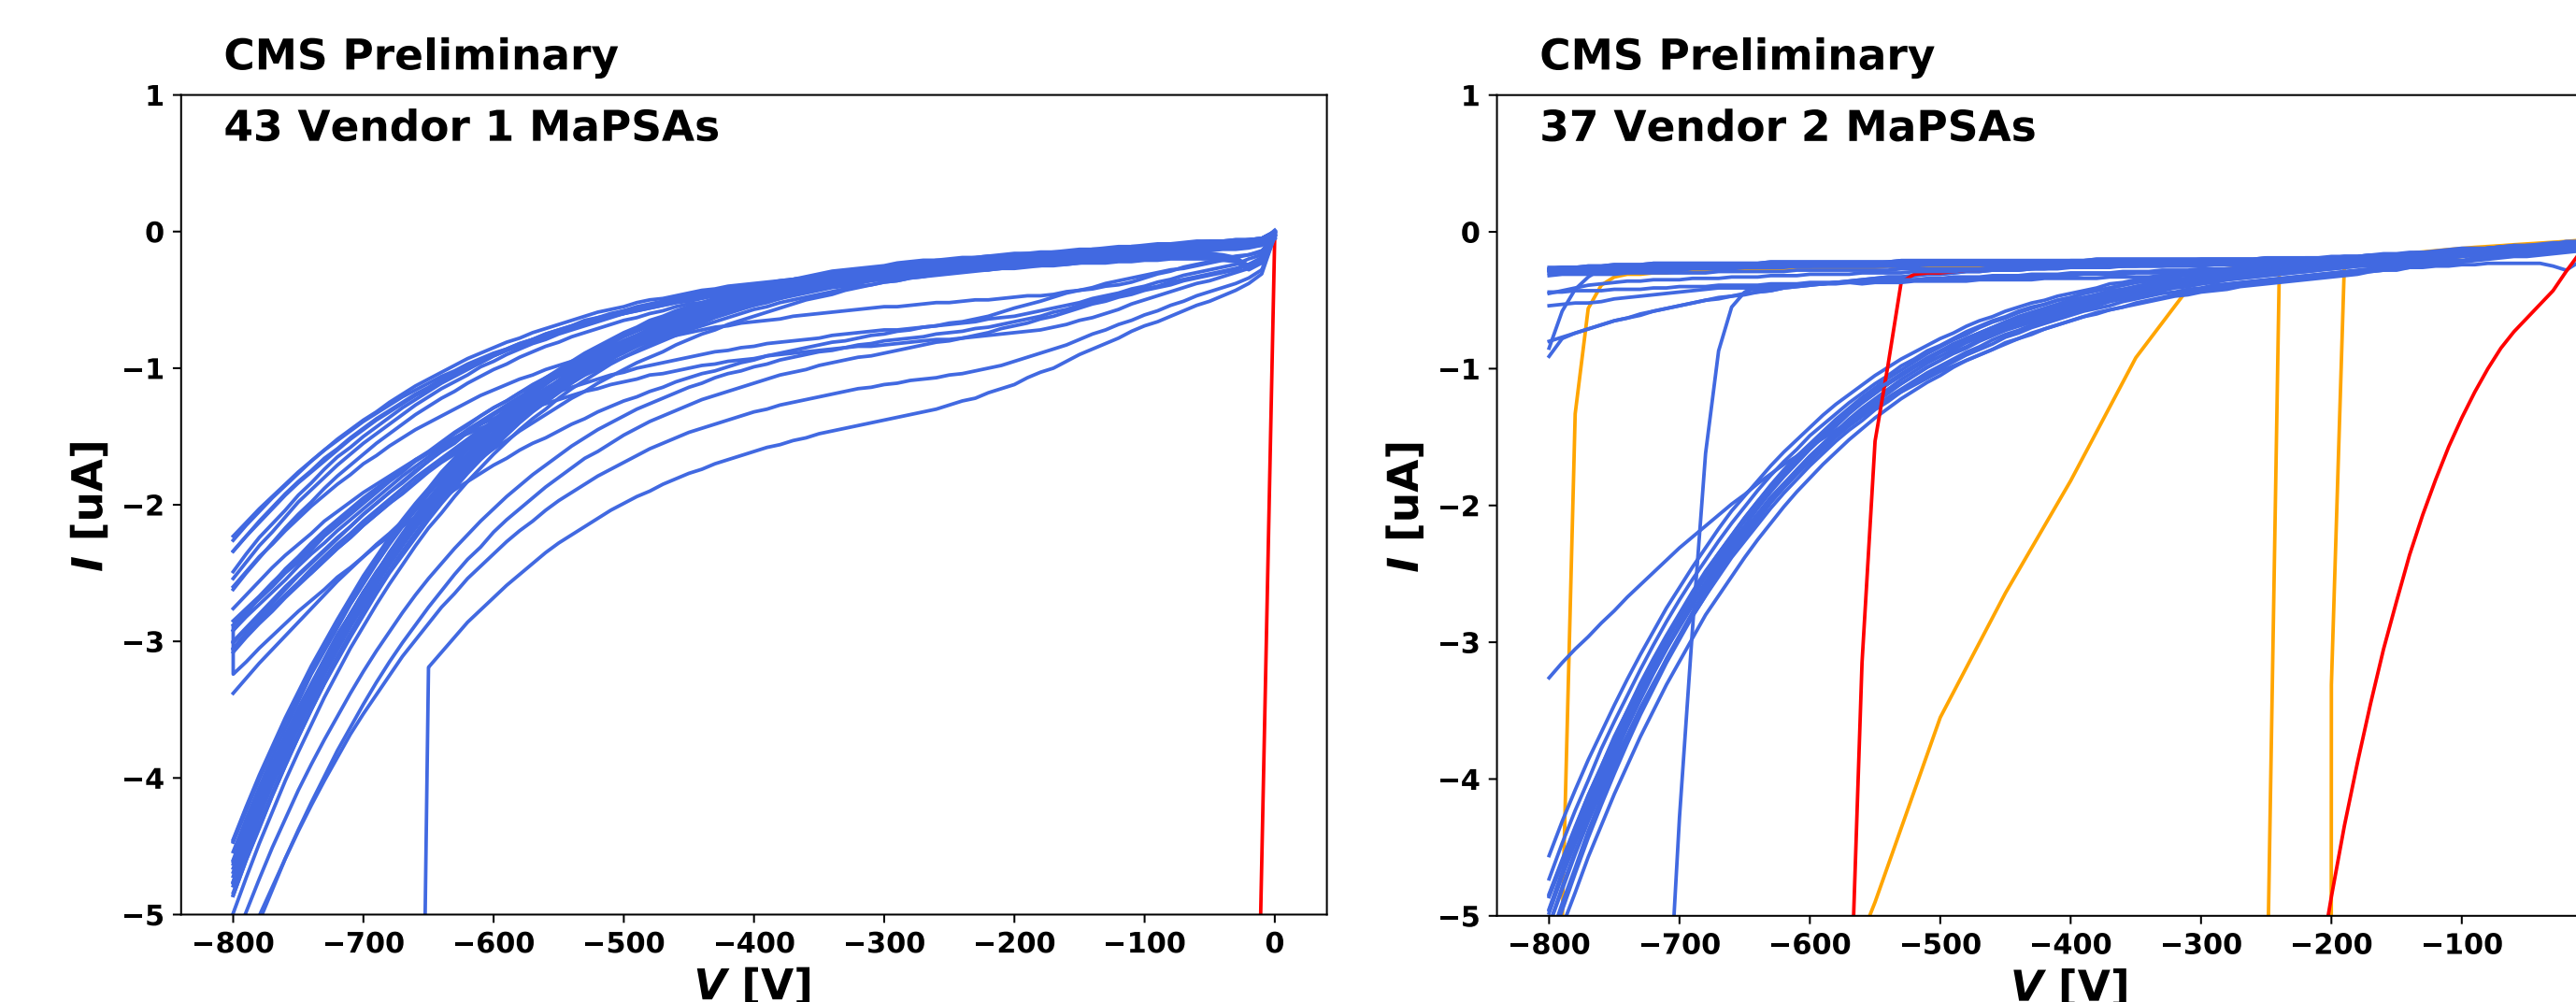
★ **IV curves: Leakage current** measured as a function of bias voltage. Perfect MaPSAs have $I < 10\mu A$ at 600V. Slightly earlier breakdown → OK MaPSA

Summary of the IV scan results
Red curves: MaPSA failed the requirement of $I < 10\mu A$ at 600V.
Orange curves: earliest prototypes from Vendor 2
Leakage current is dominated by probe card, but sensor breakdowns are still evident

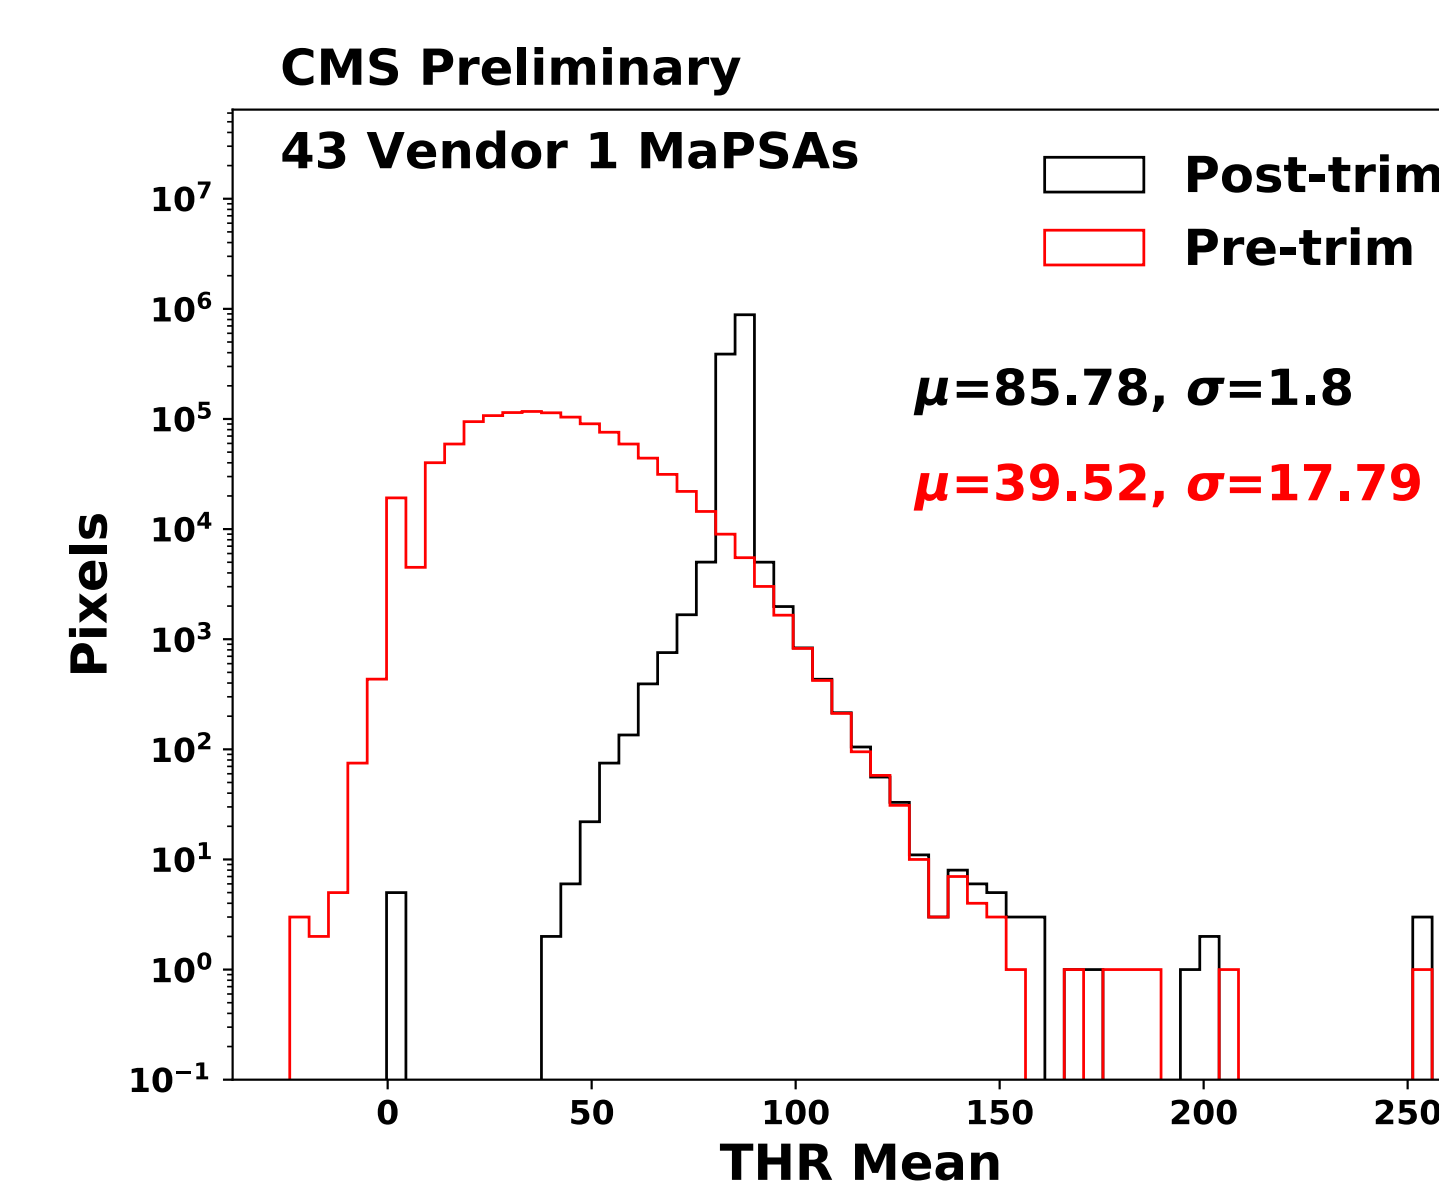
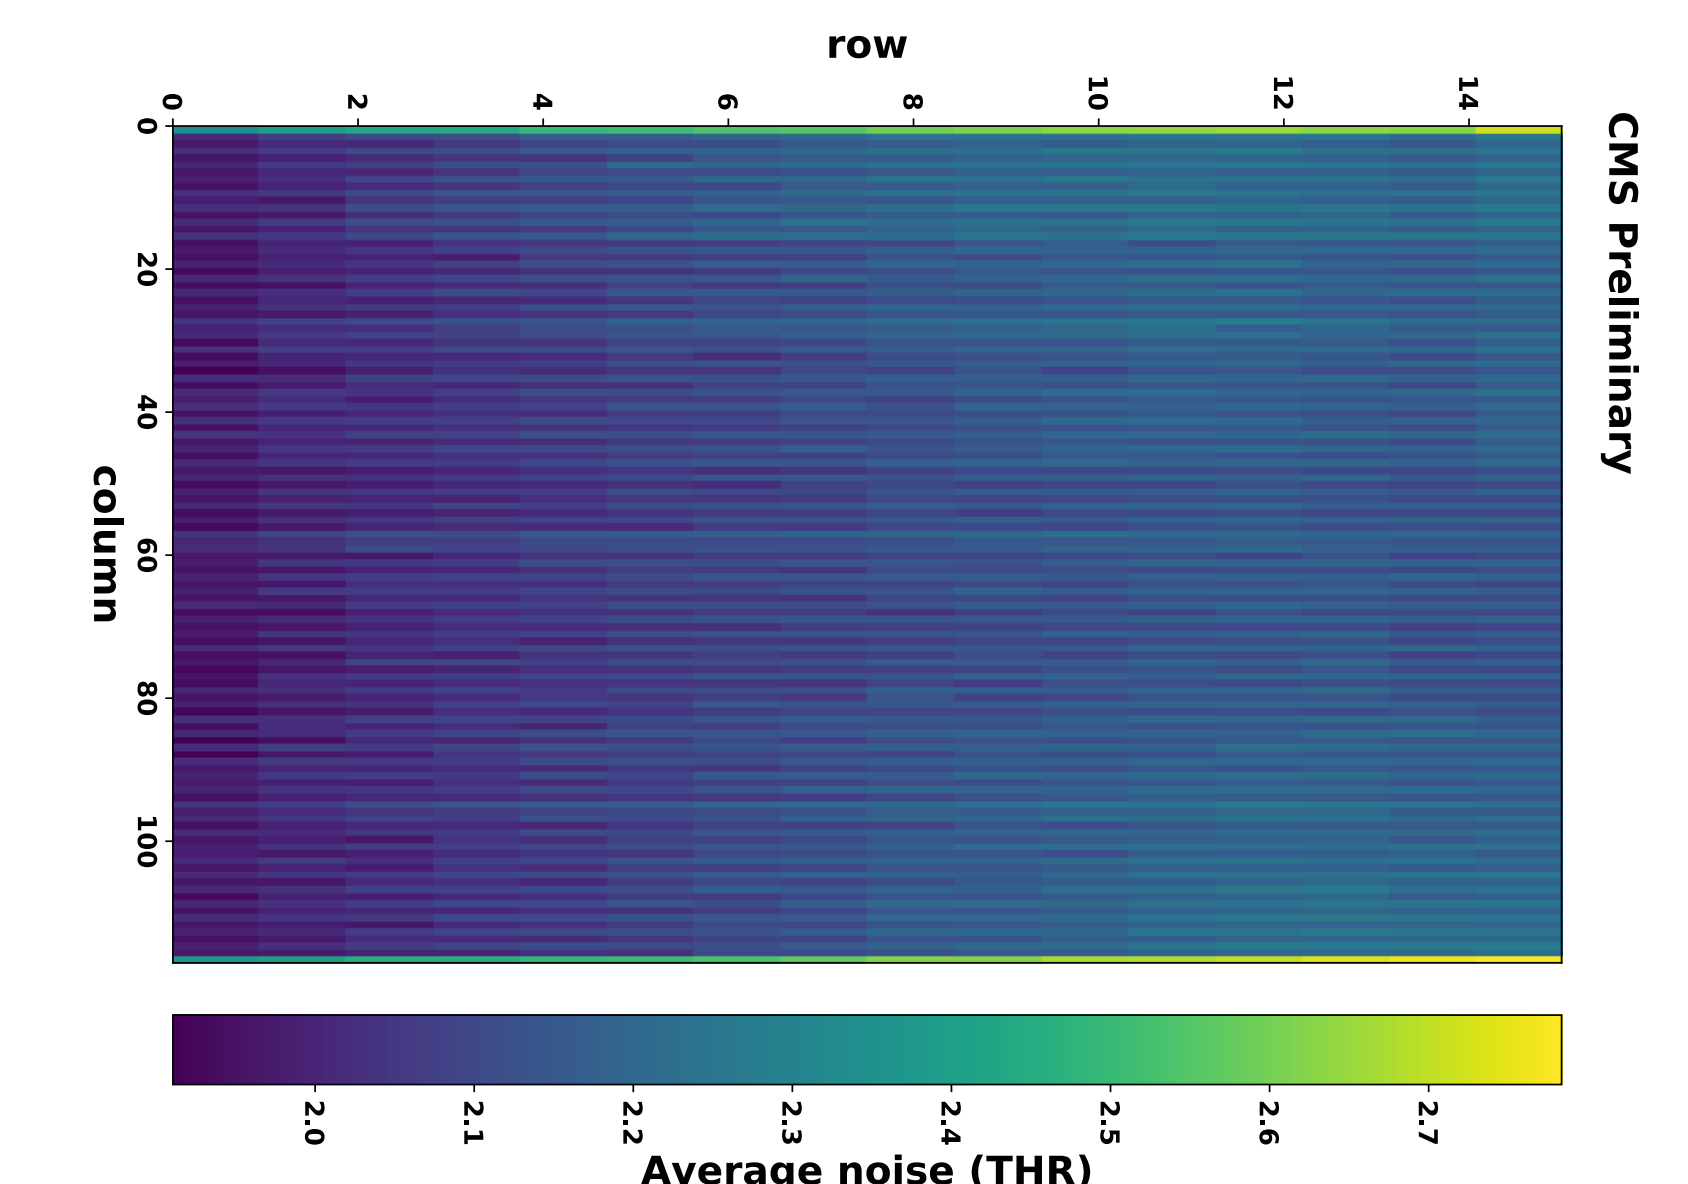
Left: **Pixel threshold (THR)**
Red: before trimming. Black: after trimming.

Right: **Average pixel noise (THR)** at each location on the MPA chip.

Shown for Vendor 1 only. Similar results are obtained for both vendors

MaPSAs with MPAs containing regions of high noise are designated as OK.
