Discoloration of RF antenna coil surface after long-term operation of J-PARC ion source

T Shibata^{1,+}, K Shinto², K Nanmo¹, K Ohkoshi², K Ikegami¹, H Oguri², M Ishida¹ and M. Wada³

¹ High Energy Accelerator Research Organization (KEK)/² Japan Atomic Energy Agency (JAEA)/³ Doshisha University

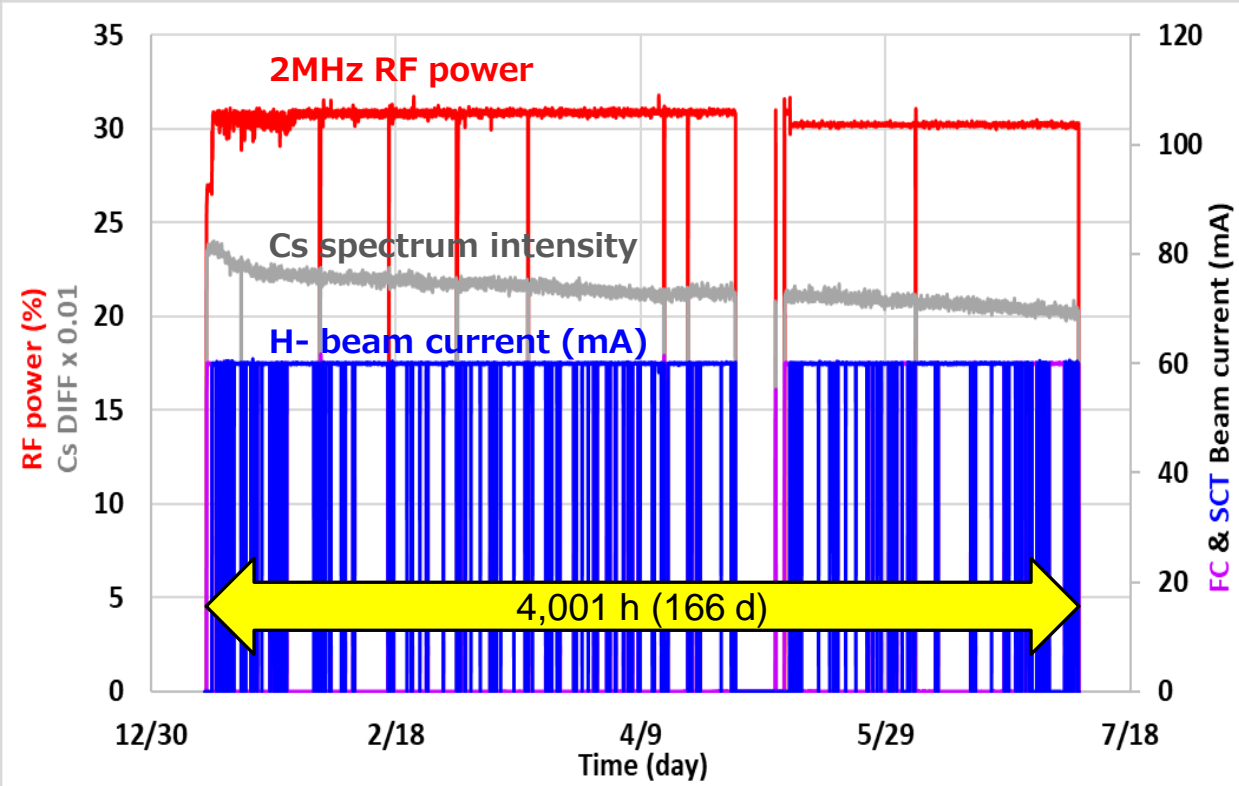
Trend of the RF ion source parameters in J-PARC user operation RUN#89 (10th Jan. 2022 – 8th Jul. 2022)

- Continuous operation duration of 4,001 hours (5.5 months) was achieved by J-PARC RF ion source in the user operation 10th Jan. – 8th Jul. 2022.
- For further extension of the operation time, soundness evaluation of the RF antenna coil after the long-run was performed.

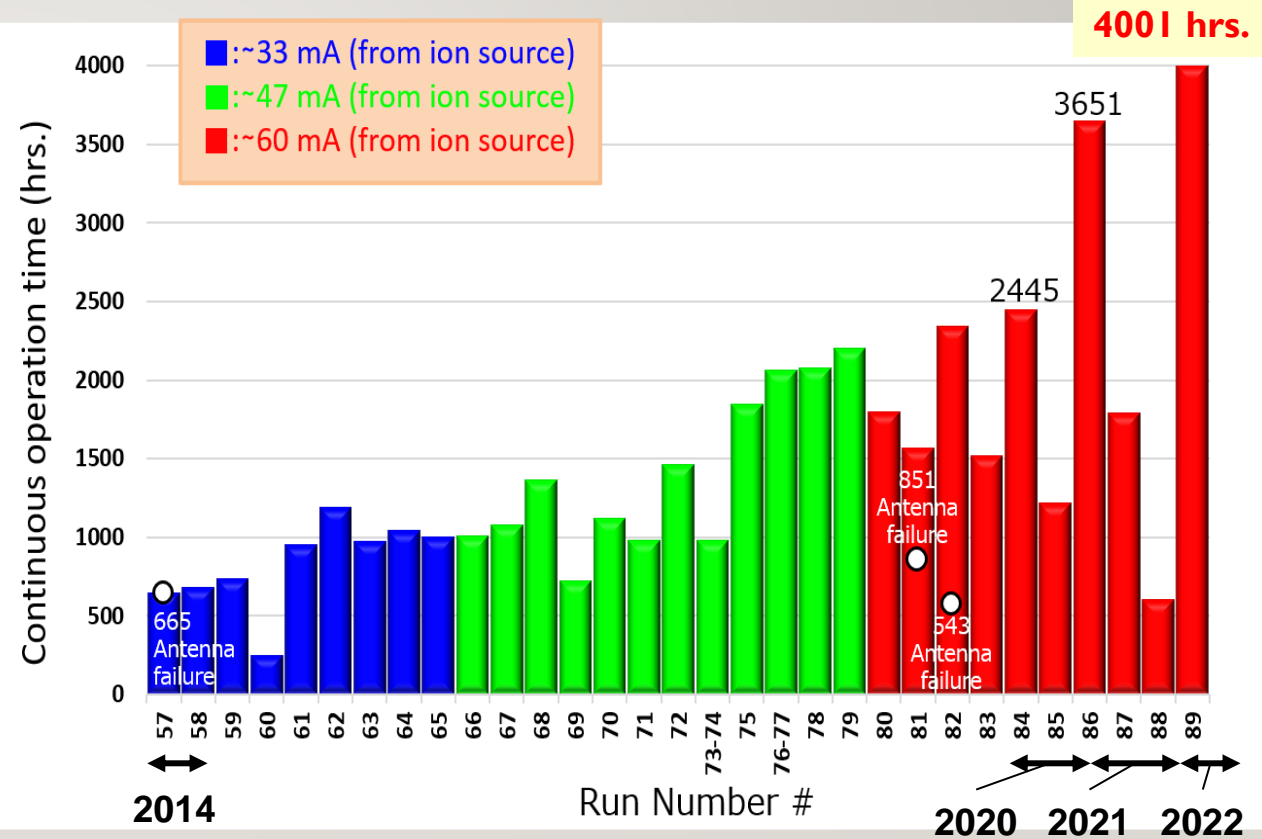
History of continuous operation duration of J-PARC RF ion source

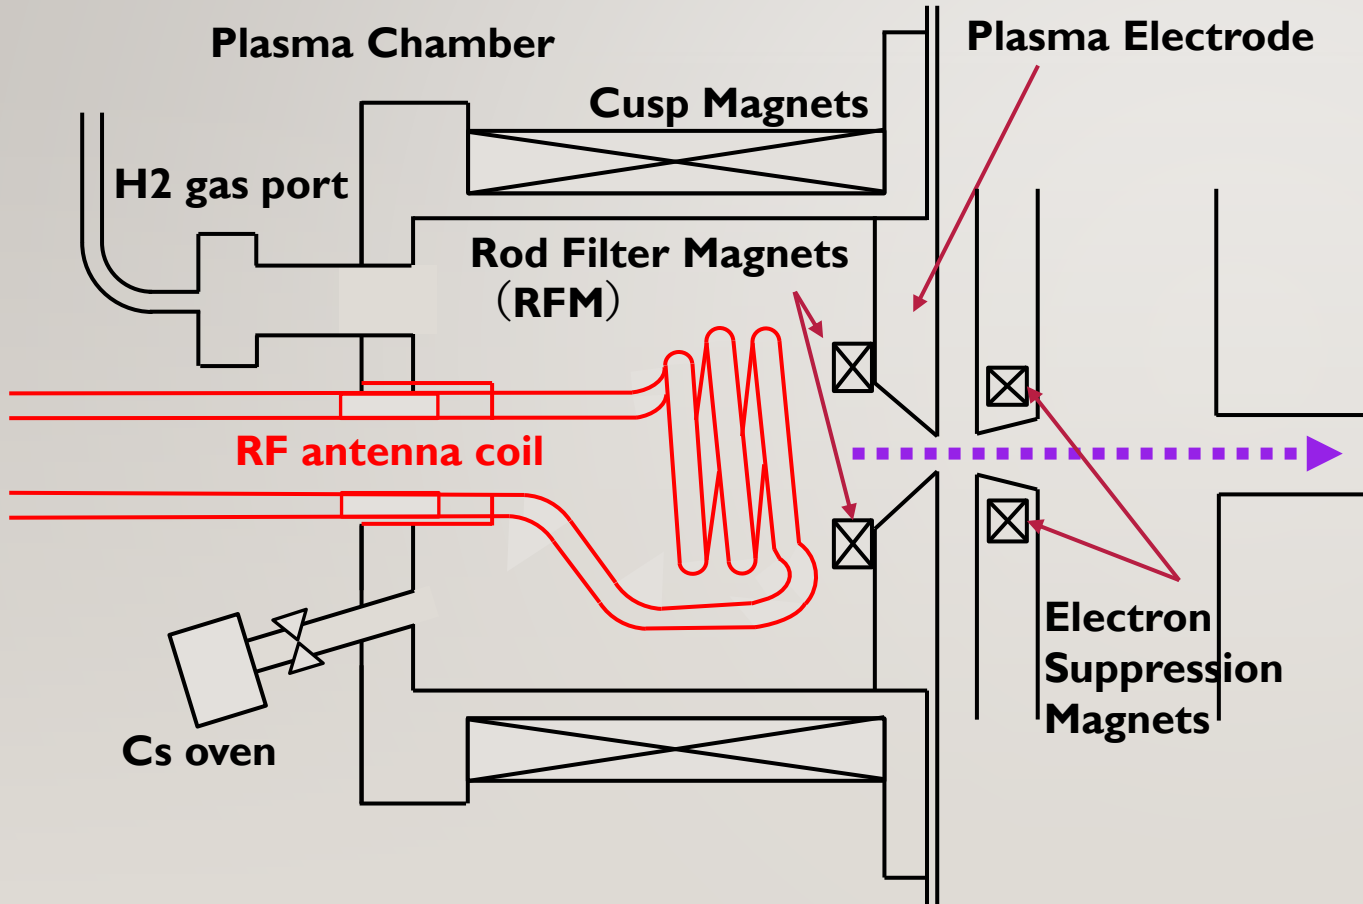
- The RF antenna coil is a copper pipe with enamel coating for insulation.
- Condition of the antenna coil surface after 5 month operation was investigated.

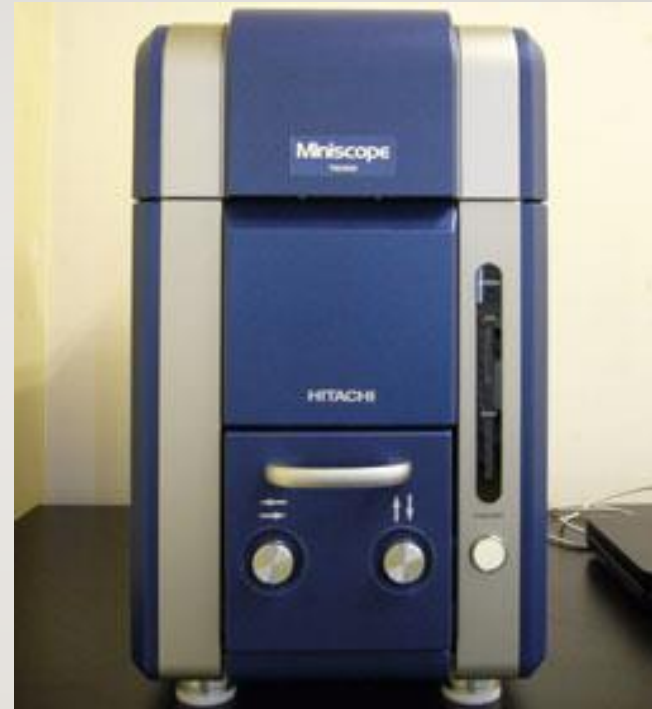
Tabletop Microscope TM3000 (Hitachi)

- **Accelerating Voltage : 15 kV**

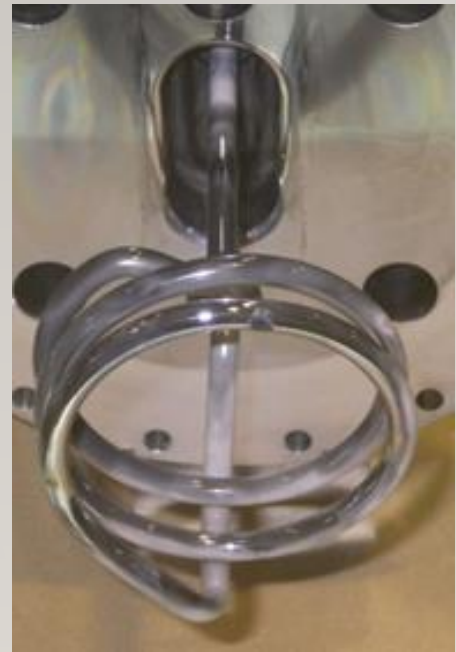
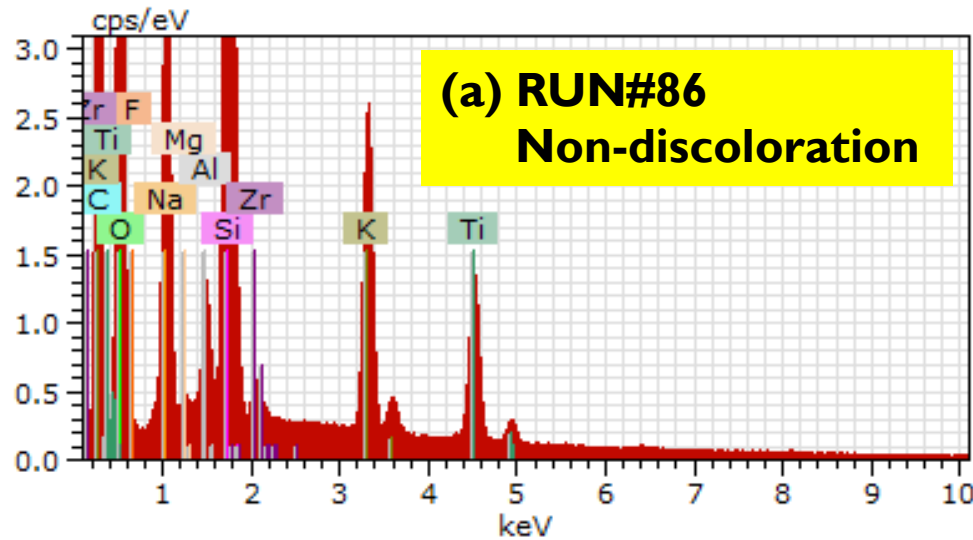
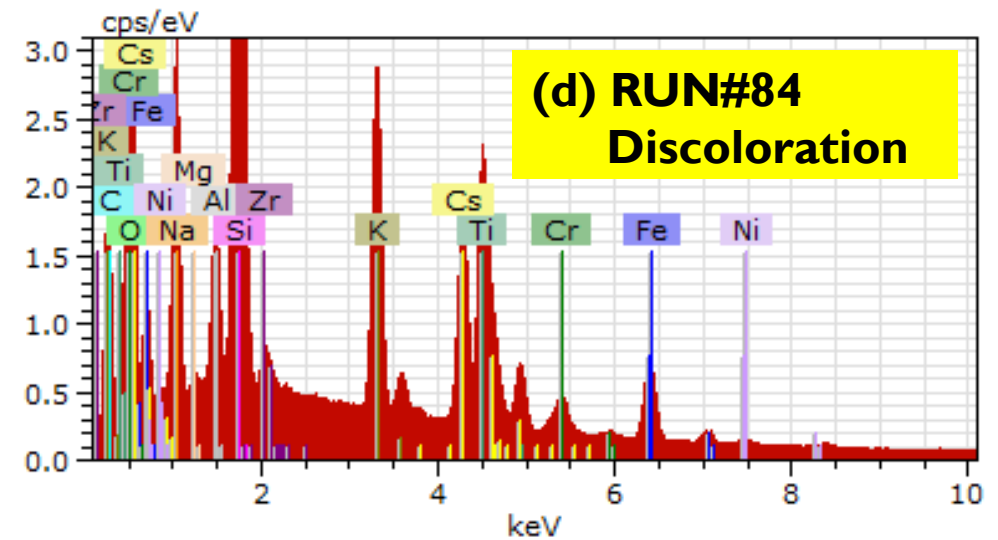
- **Characteristic X-ray spectra** are obtained from the EDS measurements for the RF antenna coils used in 5 month (RUN#86) and 3.5 month (RUN#84) operations.
- Line spectrums of **Cs, Fe, Cr and Ni** are detected only on **the discoloration fragments**.

- Focusing on Fe, Ni and Cr (depositions except Cs) on the discoloration fragments, mass ratio of these 3 materials was **Fe:71%、Cr:12 – 16 %、Ni:10 – 16%**.
- This ratio matches well with that of **stainless metal composition** which is used as the ion source chamber components.
- Difference of few months in the continuous operation duration does not lead to significant difference of the antenna surface condition.

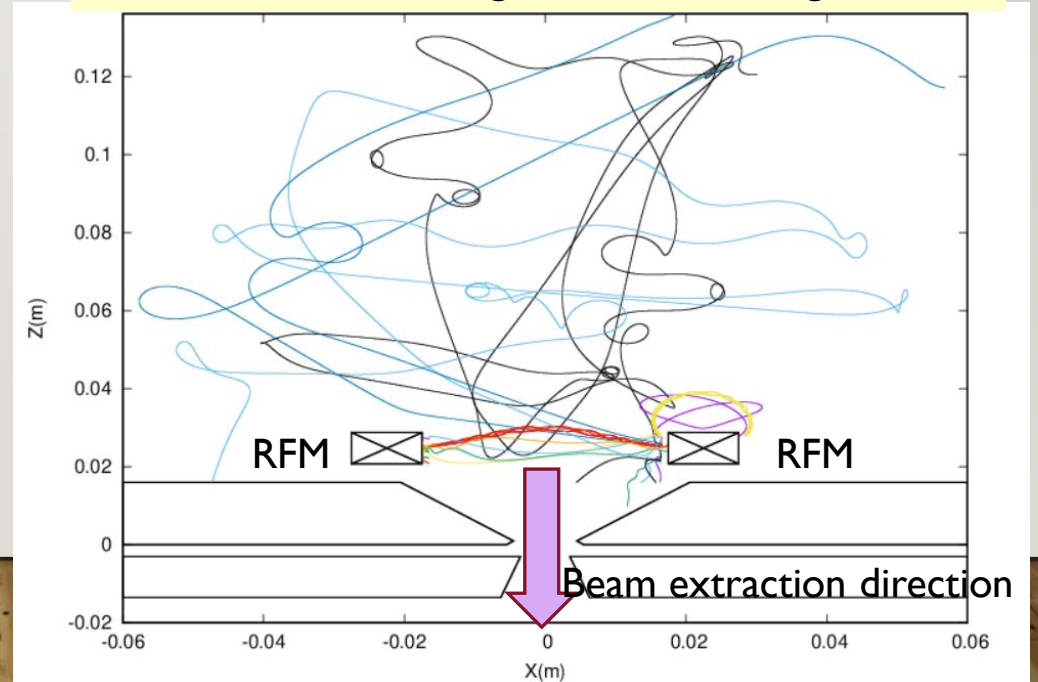
Fe^{2+} orbits in the magnetic field configuration

- Excessive coverage of the antenna by stainless steel may cause extra heat load.
- Discoloration of the RFM cases was observed.
→ Main source of the deposition?
- Injection of heavy ions such as Cs^+ leads to 'semi-' prompt redepositions of the stainless materials and to the RFM sputtering.

- However, the excessive deposition may result in extra heat load via eddy current on the antenna surface. Measures to the plasma sputtering of the RFM cases (for example, coating of RFM cases with plasma sputtering resistant materials) can be one of the method to extend the ion source lifetime.
