8th International symposium on Negative Ions, Beams and Sources - NIBS'22

Summary of caesium evaporation and deposition during SPIDER first campaign

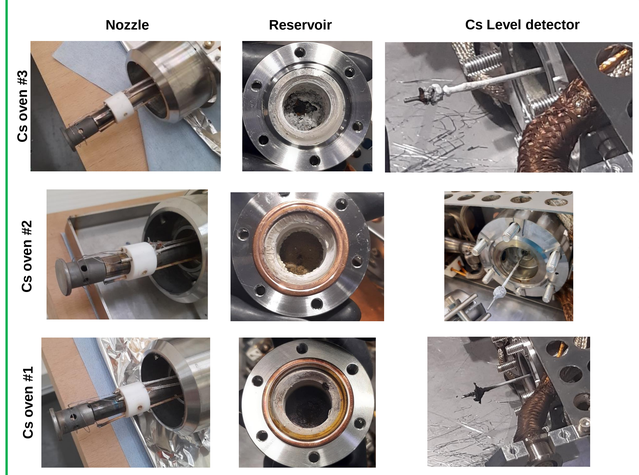
SPIDER Cs Ovens inspection

- After water leak incident, Cs contaminated in all the reservoirs
- NOTE to REMEMBER: Cs Oven #3 have been switched and placed at the bottom where the leak occurred

- From the top to the bottom Cs seemed less contaminated by water vapor: Cs hydroxide (white compound) is the same formed in CATS facility where uncontrolled impurities flew in the vessel [1]. Cs oxide (yellow compound) has been found after long evaporation campaign even in CATS

- In this condition it is impossible to verify SID measurement in terms of Cs mass evaporated with a simple weighing of the ovens, but SID measurement is reliable [1]

- From SID diagnostic, the total Cs consumed in 172h of evaporation has been **2,411 g (Oven#1: 0,763 g Oven#2: 0,783 g Oven#3: 0,866g)**
- NOTE: as soon as we placed Cs compounds outside the Glove Box, the compounds started to adsorb the air humidity. Droplets began to form and most of the surfaces cleaned themselves in less than 2h

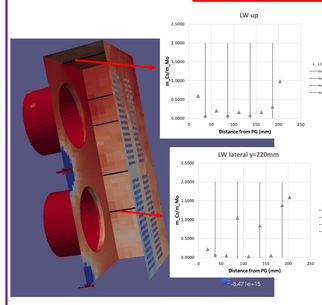
Cs on Lateral Wall

Plasma touched the surface

- Lateral wall (LW) of BS has 4 permanent magnets installed on its back.
- Looking at the surfaces, it is possible to identify the regions where the plasma "touched" the wall and where it has been shielded
- Inductively Coupled Plasma Mass Spectrometr (ICP-MS) chemical analyses on 5% nitric acid solution impregnated swabs taken in several spots of the surface to determine the Cs deposited
- Top part of the LW "behaves" as thought since there is less Cs where there are the magnets and therefore where the plasma touched the wall
- Lateral part of LW is different. Plasma density changes because of the RF driver location and non uniformity of magnetic field [4]. Cs+ is deposited in the permanent magnet area
