Kalindi Gosine

Spring 2025 Updates

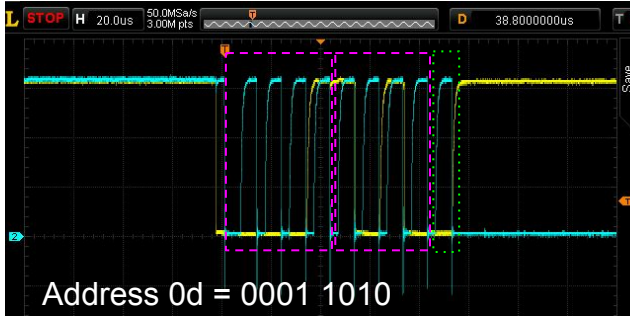
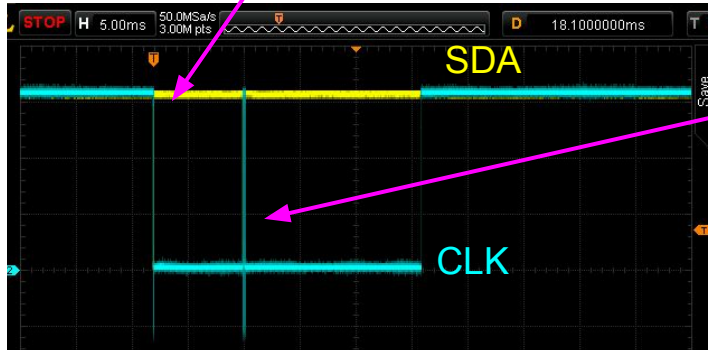
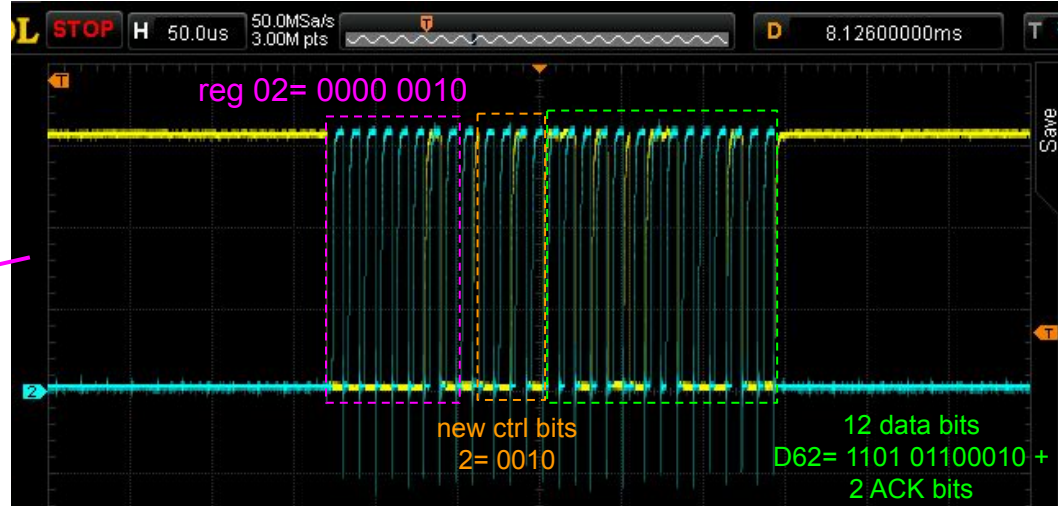
Updated DAC Commands

Voltages correctly set by I2C

- The control bits must be set to 0010=0x2 (calls to update both registers on a chip after every command, even if only writing to one of them)
- Register can be written into data line 'no reg'. 8 bit reg also works

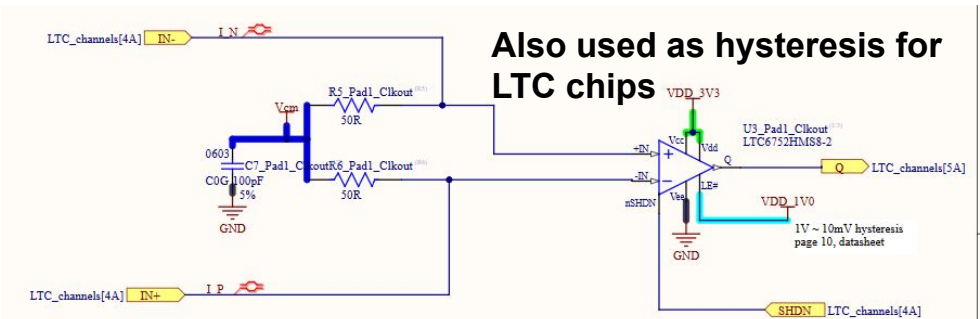
The VDD_1V0 Issue

VDD_1V0= 1.00V

Pin 3 on shunt voltage reference must be disconnected from pad (desoldered, kapton tape, resolder pins 1&2)

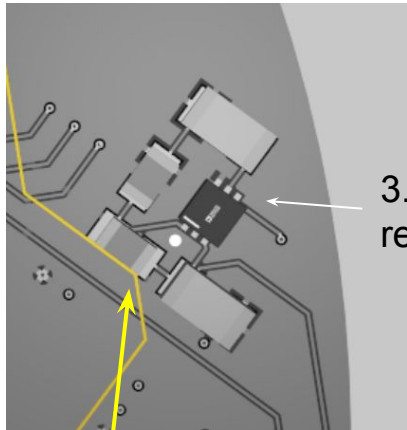
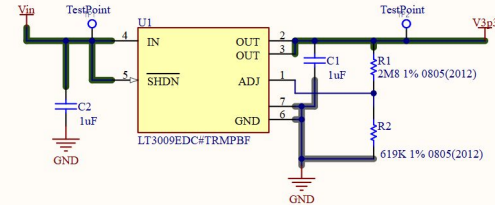
3.3V
regulator

According to [3.3V regulator datasheet](#), the output should be 3.3V based on the resistor combination and the ADJ pin should be maintained at 600mV.

V_{dd} >= 3.75V

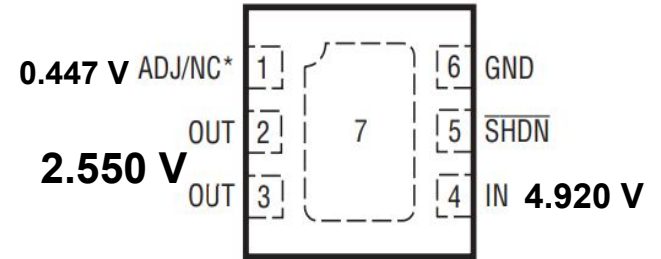
+5V & -2.6V

Confirmed the stagnant voltage on V3p3 when only -2Vnn is ON varies linearly with the value of -2Vnn (-2Vnn=-2.6V, V3p3= -0.619 → -2Vnn= -1.8V, V3p3 = -0.500 V)

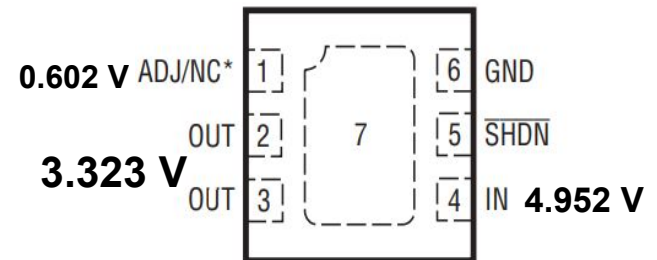
+5V only

Powered with only +5V and measured 3.324V pin3 and 0.602V at pin1

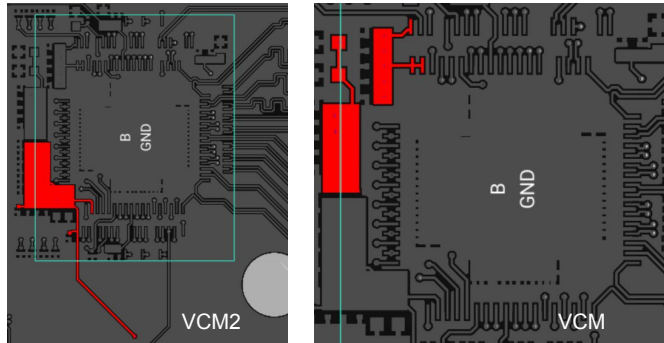
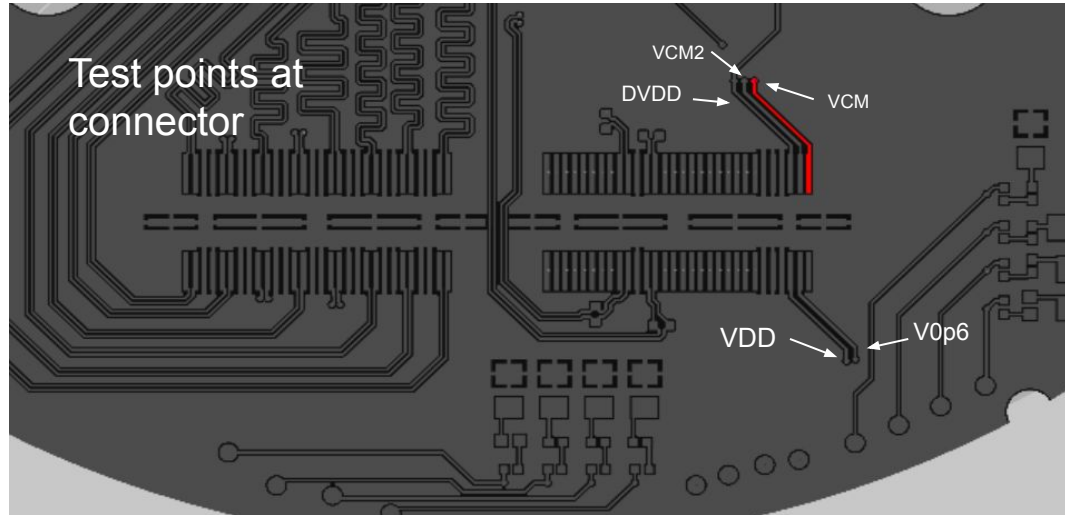
Confirmed ASIC voltages not connected to ground

They are isolated from the board ground and test points near connector are connected to pads at ASIC

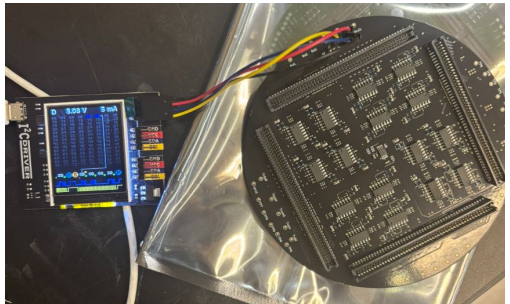
Re: LVDS_CM ringing, I2C Driver + HFA Test

Repeated our previous test of just I2C driver and HFA board to see LVDS_CM control.

When we tested this in Jan/Feb, we saw LVDS_CM (and VCM1 and VCM2) voltages controlled well by the driver. The issue is that we tested using a multimeter, making us blind to the ringing which does time average to the correct voltage.

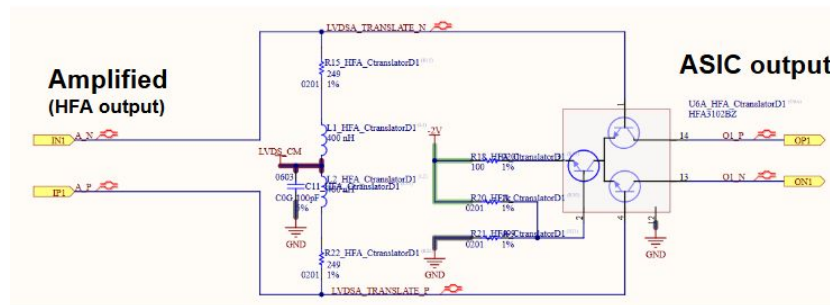
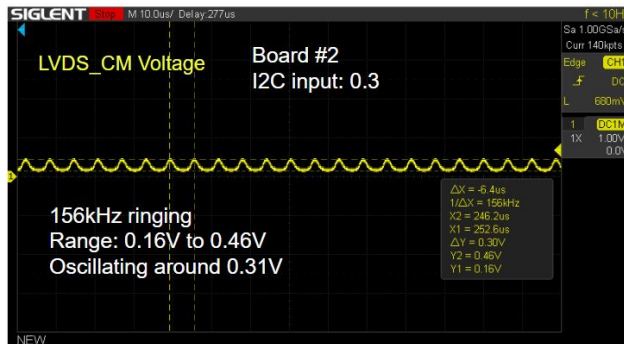
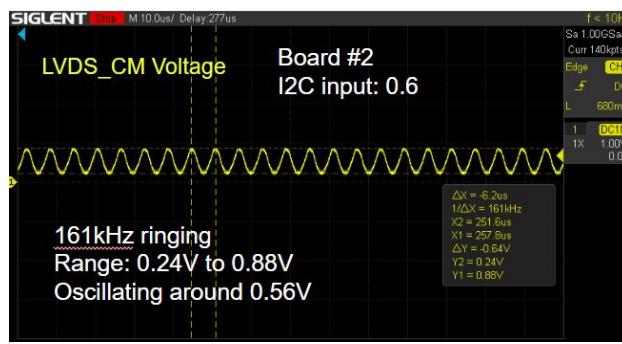
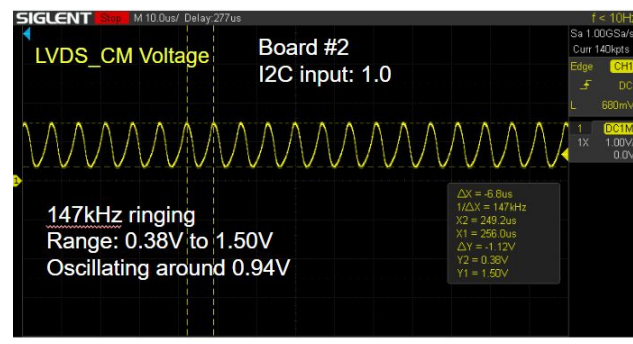
Carrier (+5V) + ZTurn + HFA + (Feedthrough & ASIC Mount) + 1 Chip ASIC Board

The idea was that maybe the HFA doesn't like its ASIC differential pair floating so connecting the ASIC would fix this.
