SuperKEKB Accelerator Status

Makoto Tobiya
KEK Accelerator Laboratory
(on behalf of SuperKEKB Accelerator Team)

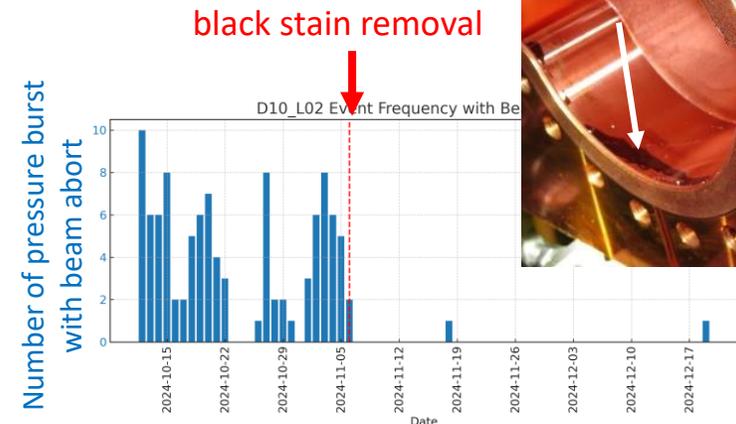
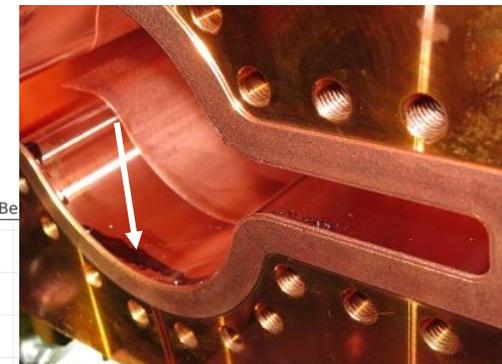
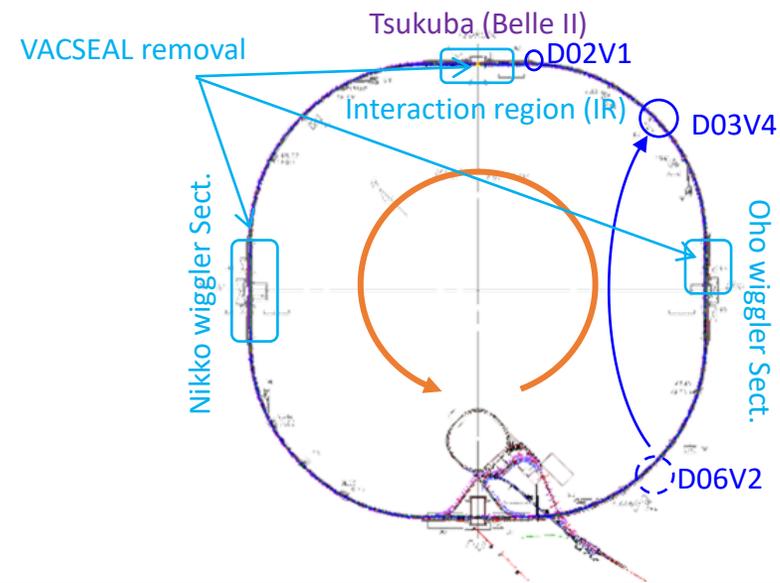
- SBL is the most critical obstacle to achieving stable operation.
 - Part of the beam is suddenly lost within a few turns.
 - It is difficult to prevent uncontrollable beam from damaging Belle II and collimators.

- **Removal of VASCEAL contamination** ← **Last shutdown**
 - **All MO-type flange connections likely used VACSEAL were checked and fully cleaned during the previous shutdown.**
- SBL mitigation effect of VACSEAL removal was confirmed during 2024c run.

➡ **Significant reduction in SBL events**

- Collimator relocation ← **Last shutdown**
 - D06V2 -> D03V4 (to protect IR (Belle II, QCS, D02V1 collimator) from uncontrollable beam)
- Additional beam loss monitors and acoustic sensors
- Faster beam abort system

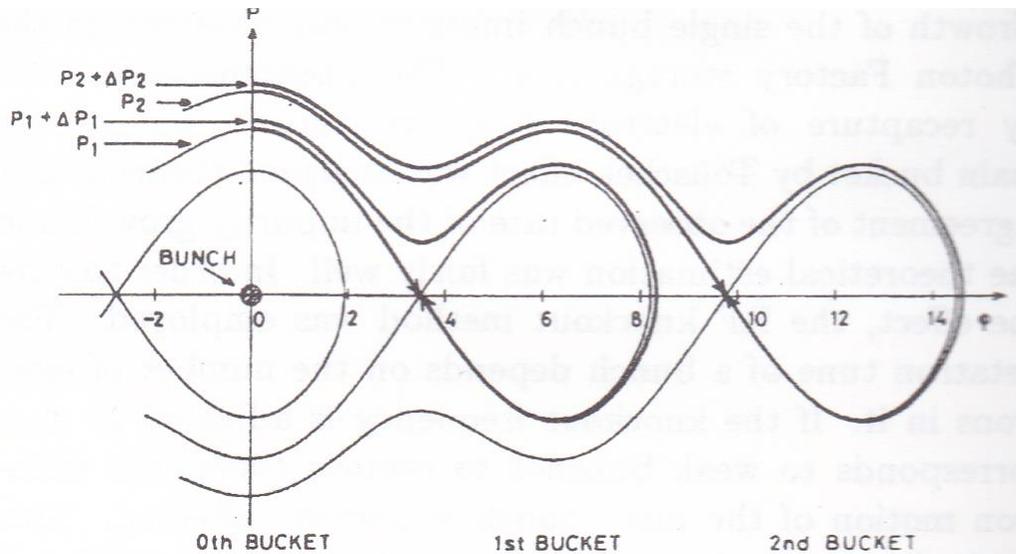
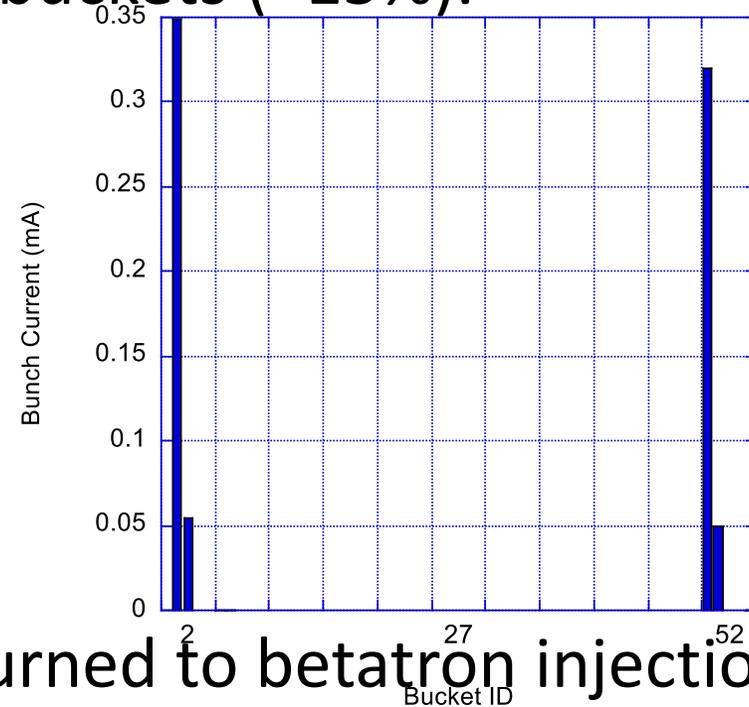
- For the collision optics with $\beta^* \sim 8$ mm to 1 mm, we have struggled to get a good injection efficiency, but it did not work out for a higher repetition rate of larger than 12.5Hz.
- Significant charge leak to the following buckets ($\sim 15\%$).

- Given up synchrotron injection and returned to betatron injection.

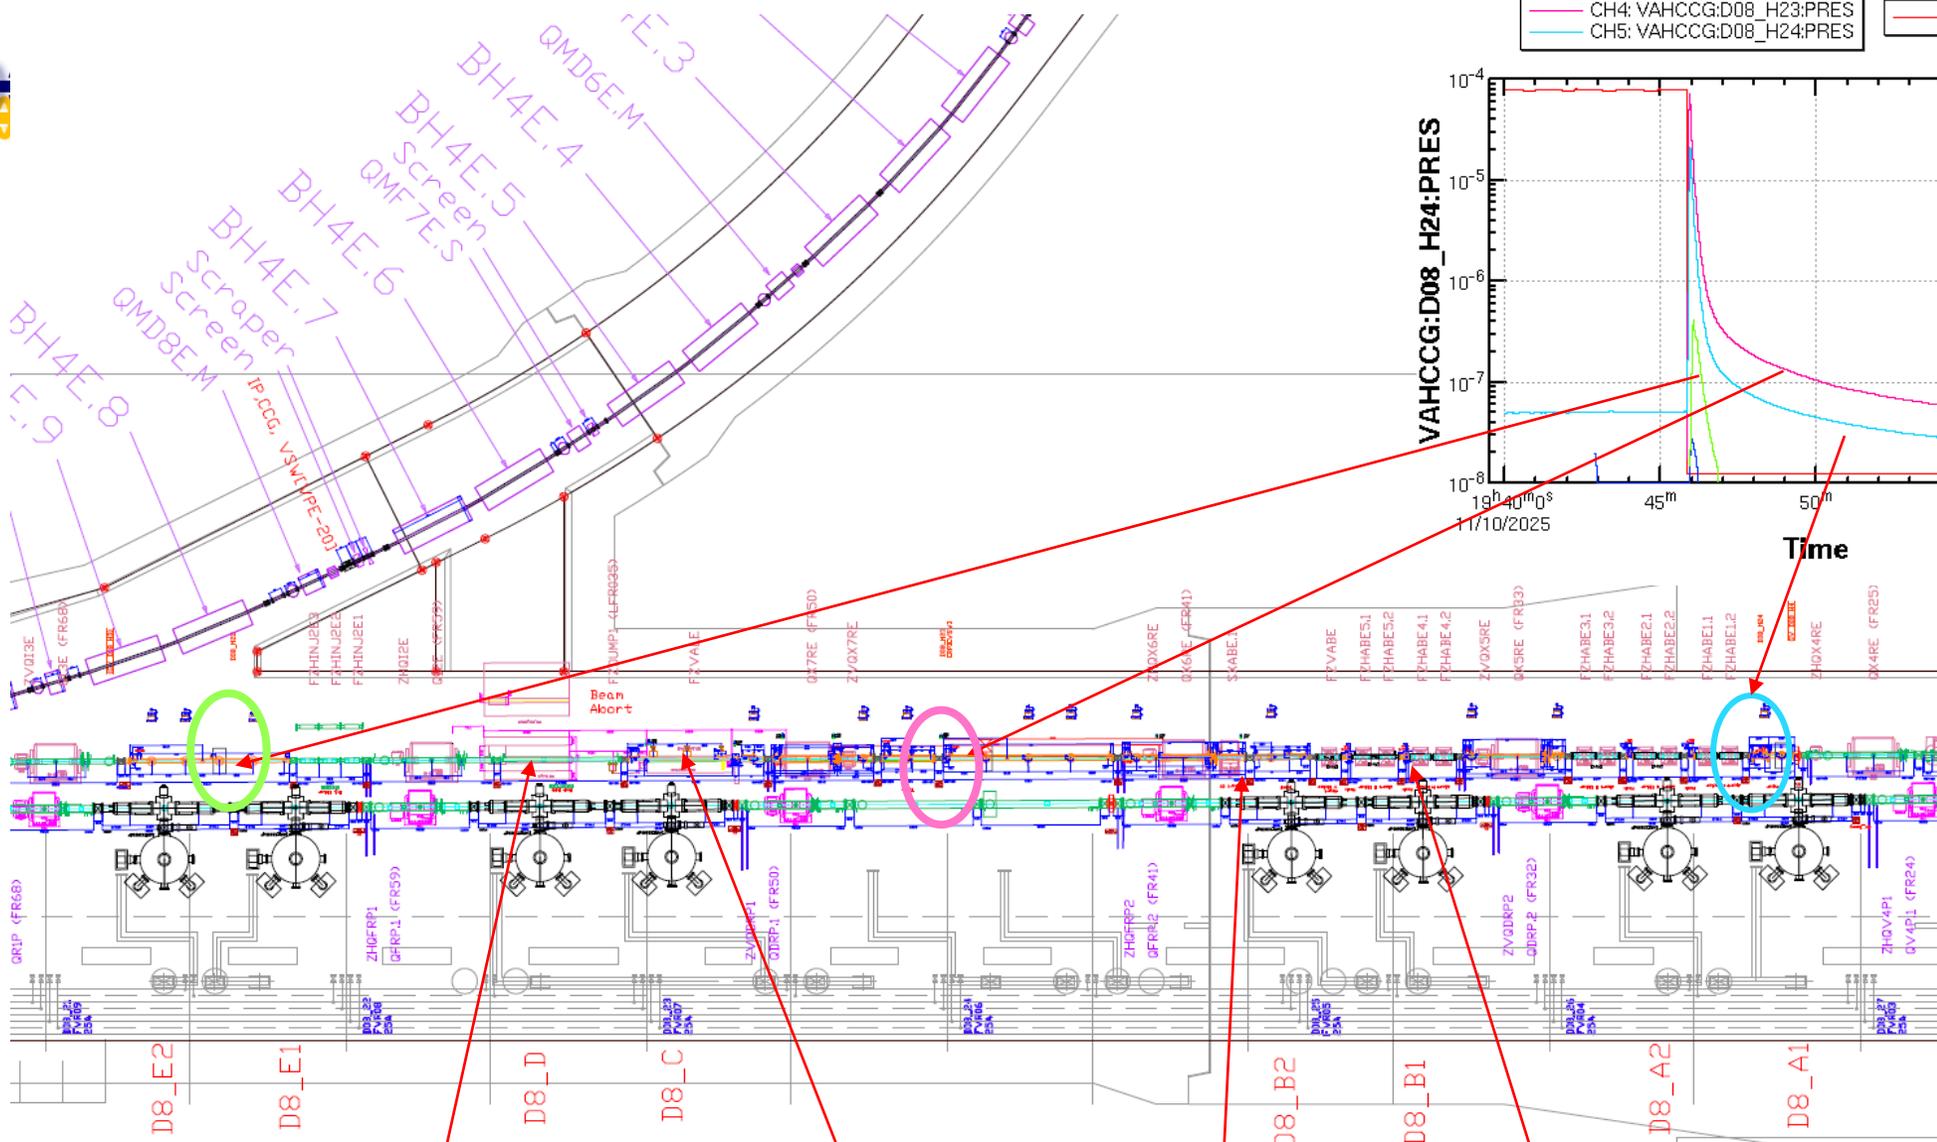
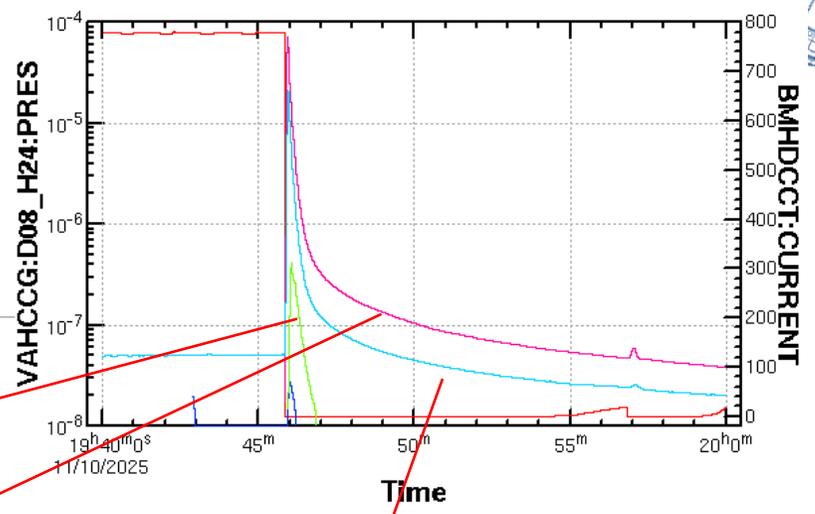
- Successfully with the detuned optics, but
 - Damage the vacuum chamber wall (and flange) around the beam dump due to the aborted beam, which resulted in a large vacuum leak after one day of operation.
 - The issue was temporarily resolved by re-examining the trajectory of the abort beam and modifying it to maintain sufficient distance from the chamber wall.

- CH2: VAHCCG:D08_H21:PRES
- CH3: VAHCCG:D08_H22:PRES
- CH4: VAHCCG:D08_H23:PRES
- CH5: VAHCCG:D08_H24:PRES
- CH1: BMHDCCT:CURRENT

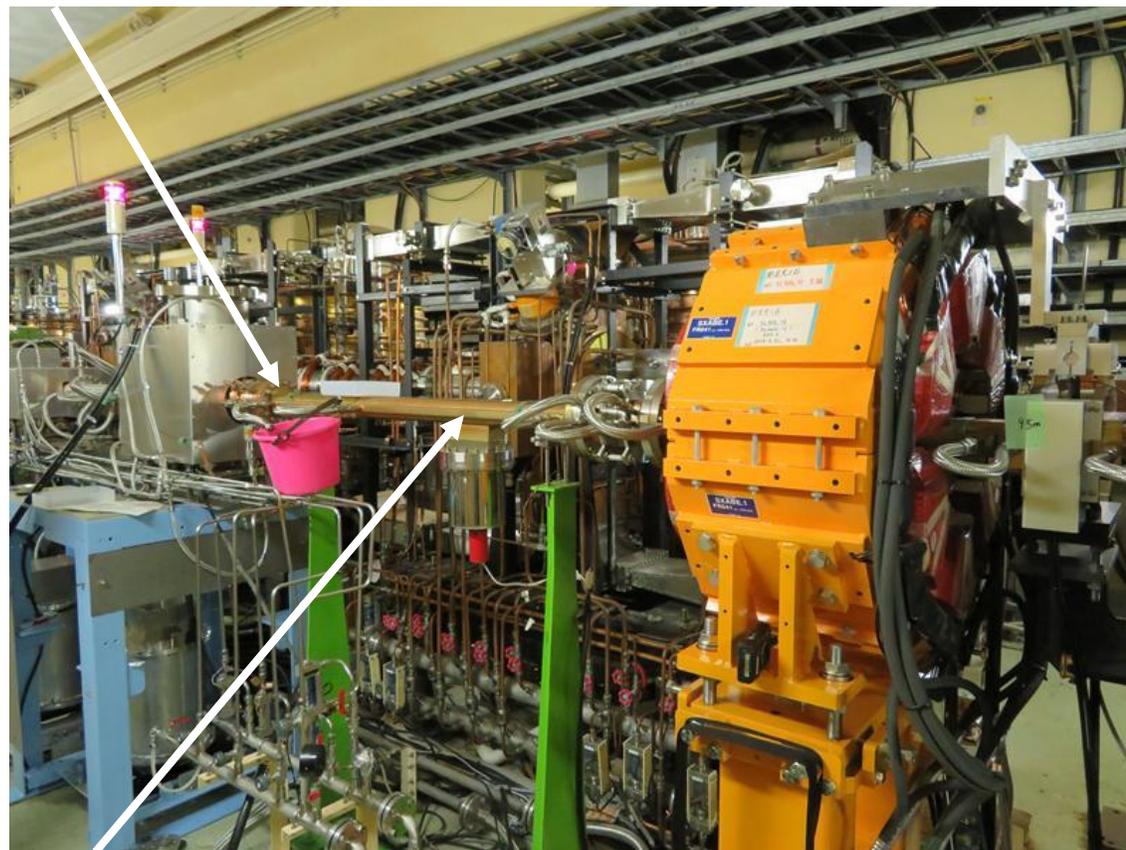
テーパ chambers

この chambers で H60 x V40 から H104 x V50 に変換

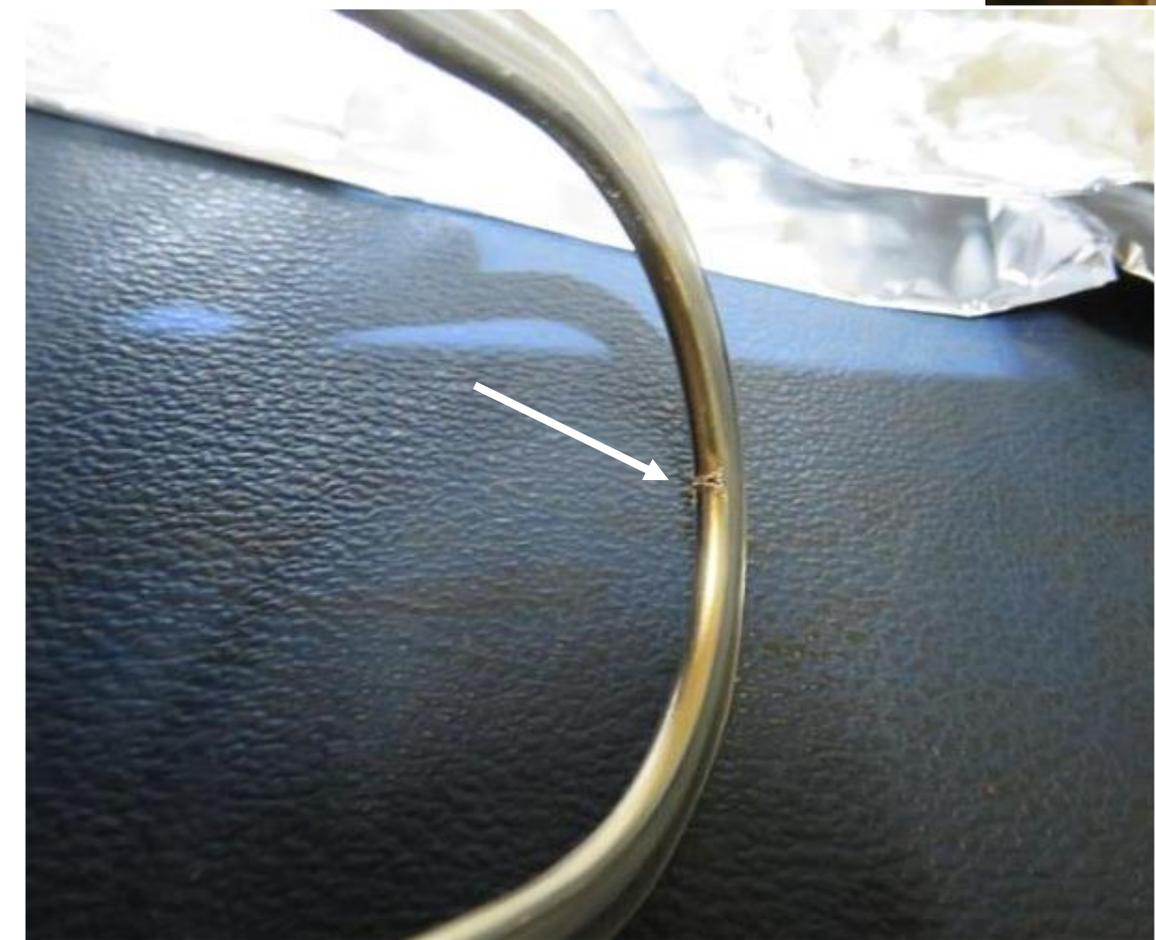
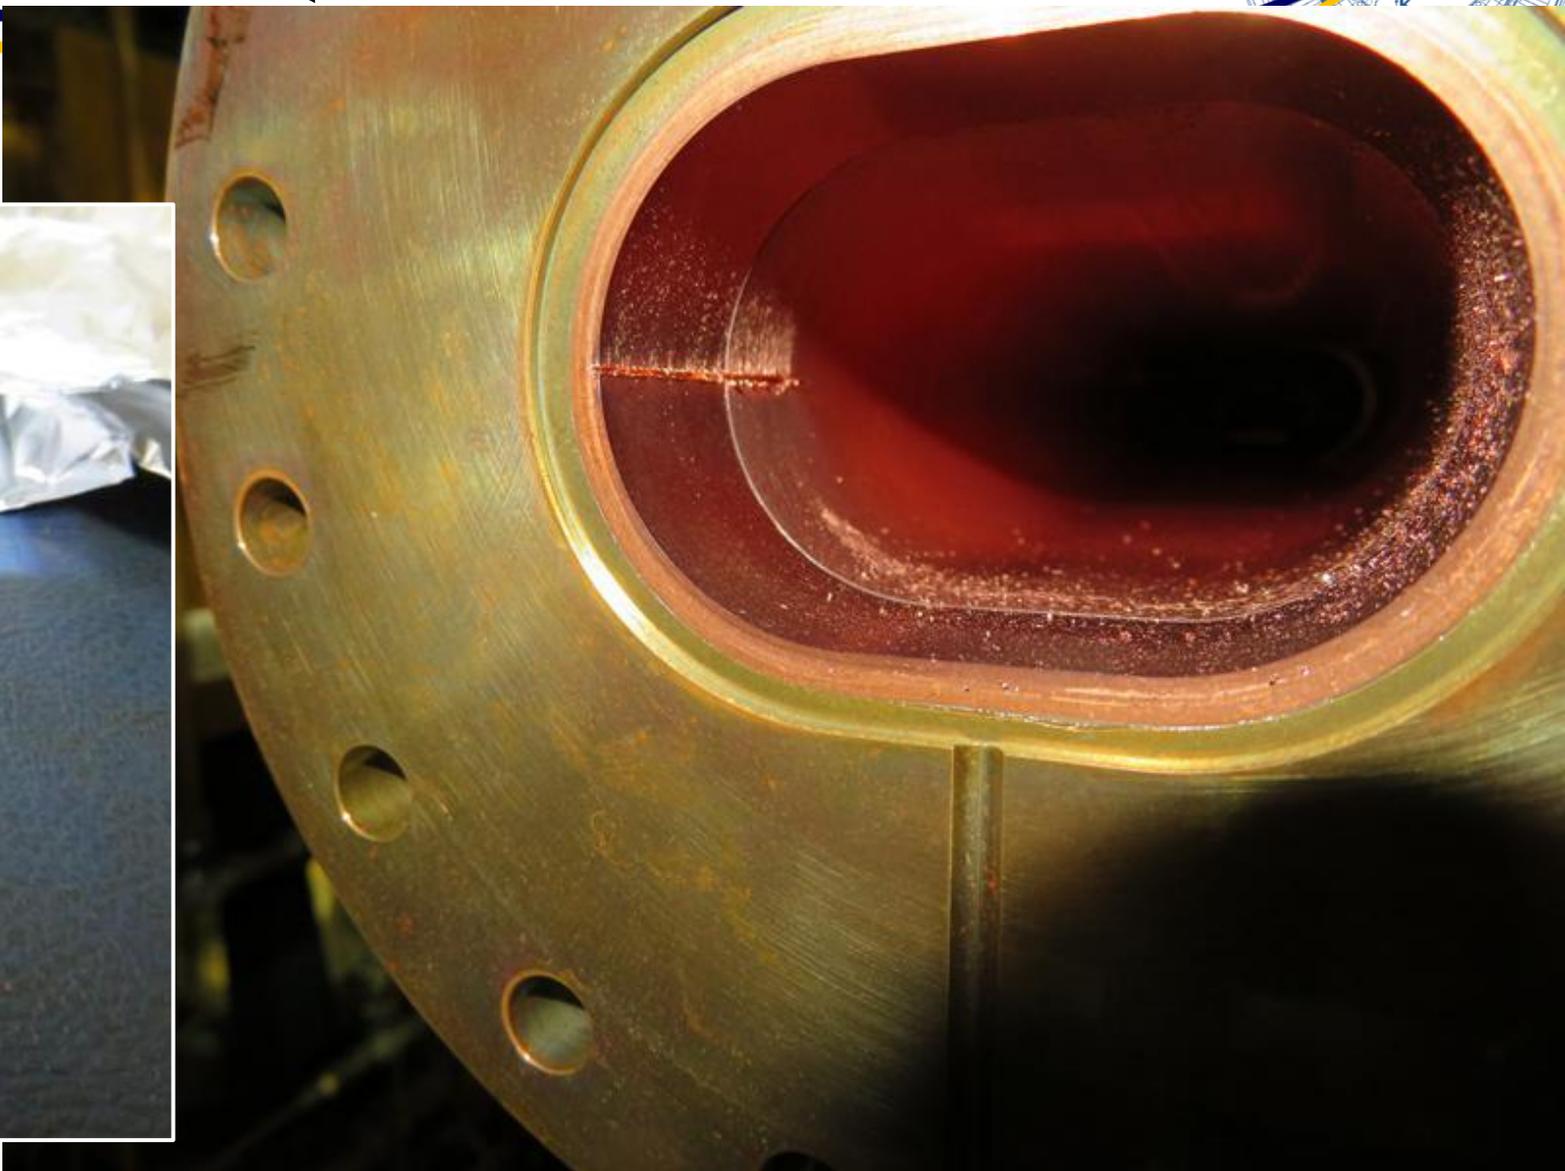
リークしたフランジの
ヘリコフレックスガスケット

リークしたフランジ側から見たテーパードレンジャー

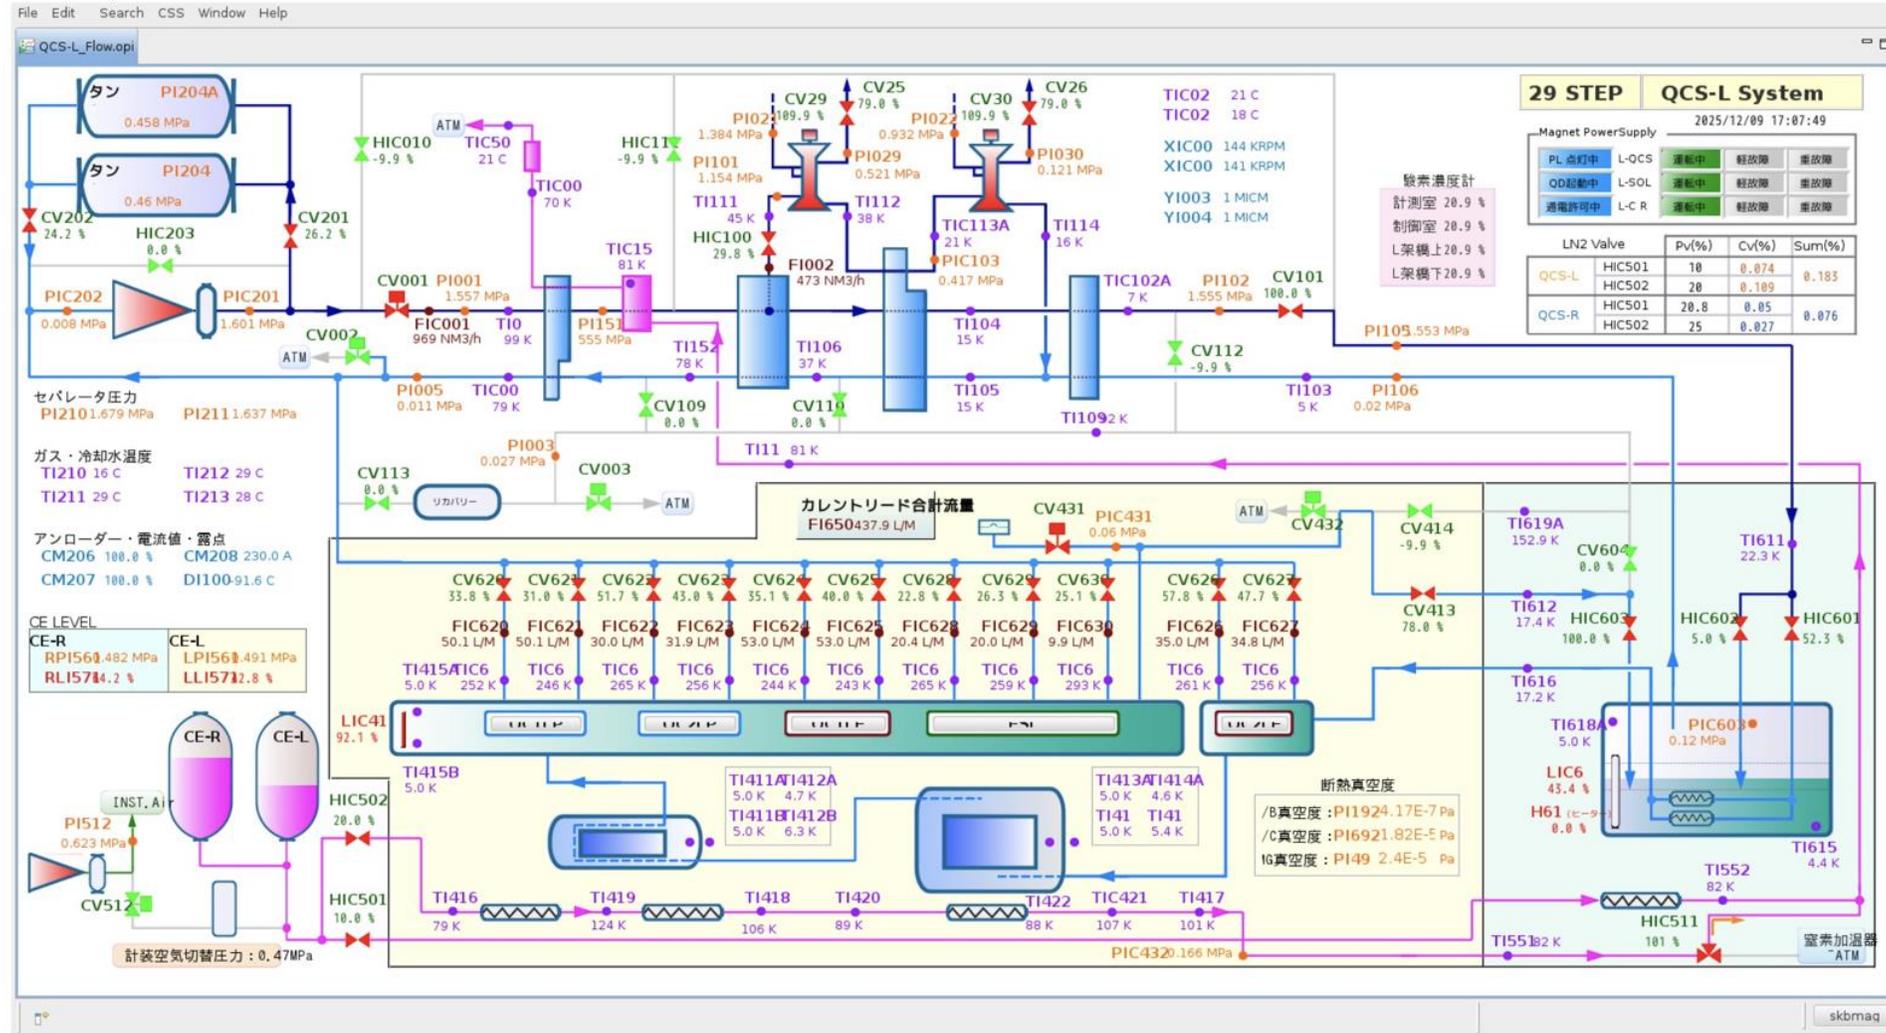
L-Side QCS Li-He reserve level

- The heat load of the QCS cryostat has increased.
 - Air leak in the thermal vacuum chamber.
 - Air leakage may have occurred due to deterioration of the O-ring at the cryostat tip, potentially causing air to condense on the surface of the liquid helium container.

- Following the liquid He level rise operation on December 16, we were able to keep the liquid He Level constant (82%) by tuning the Liquid He refrigerator. Consequently, the nearly weekly shutdowns of operations and the rise in liquid He level operations conducted since early December were no longer necessary.
- By the inspection of residual molecular components in the thermal insulation vessel after heating the cryostat, we have confirmed that there were no (additional) vacuum leaks in the thermal vessel.
- We will restart the operation as early as possible, starting 26/Jan

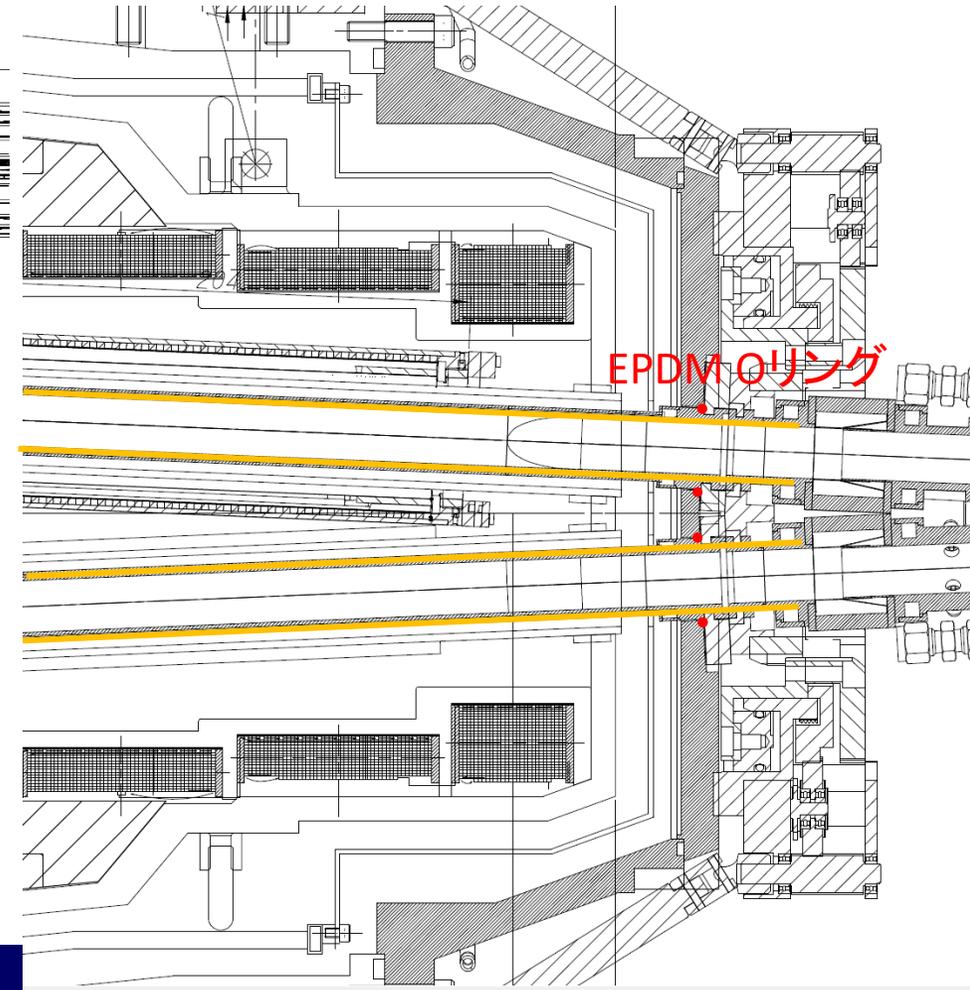
EPDM O-ring

The vacuum vessel (vacuum layer) of the QCS cryostat is sealed from the atmosphere using the end face of the vacuum vessel and the outer circumference of the beam pipe.
