# Prototype Troubleshooting

22/10/2025

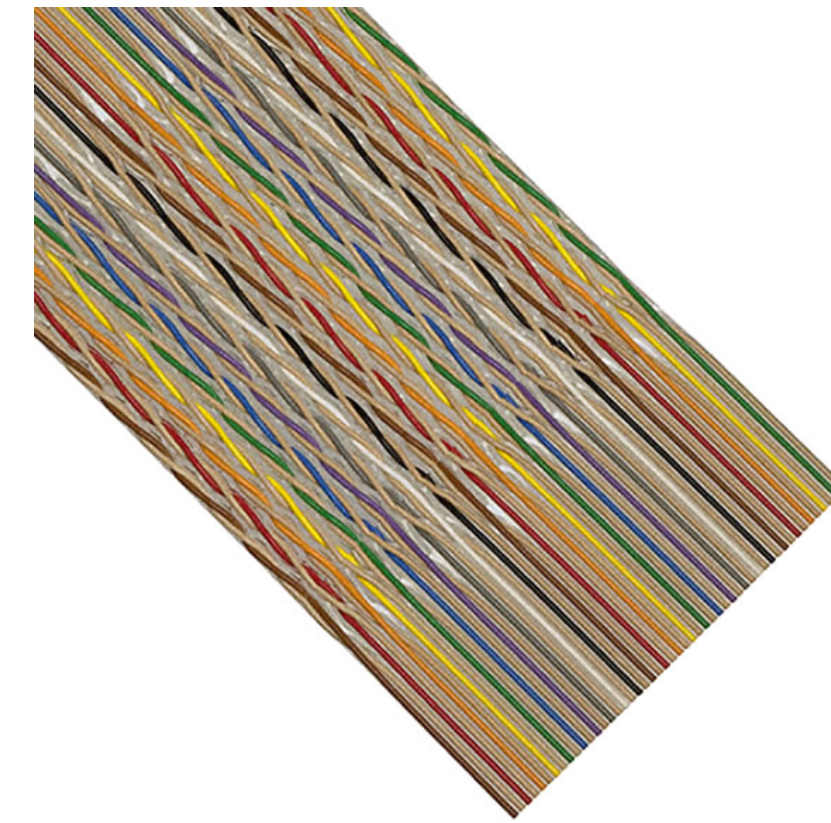
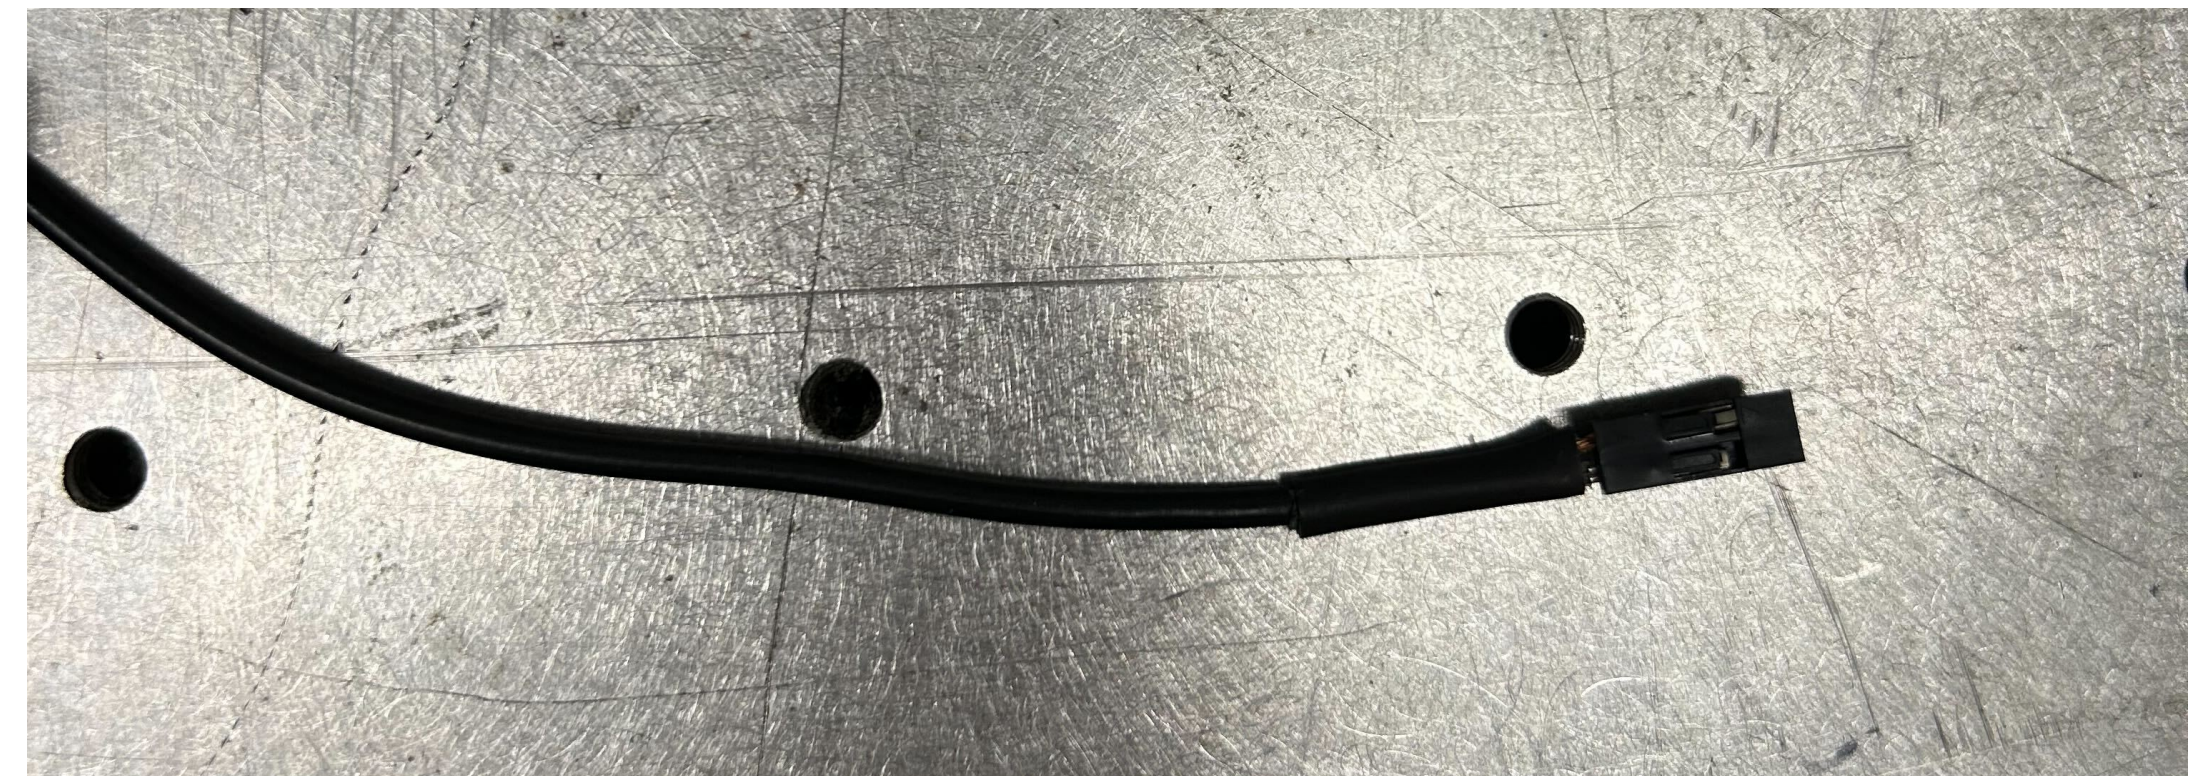
- Need to determine where the crosstalk is happening
- Take the illuminated SiPM and one other
- Replace the ribbon cable with two coaxial cables, kept separate from each other
- The output signal should give us a strong indication whether the cross talk is in the board or the cables
- Report this to the engineers?
- Any other thoughts?
