PRR: FSCD prototype comments and updates

First stage clock distribution

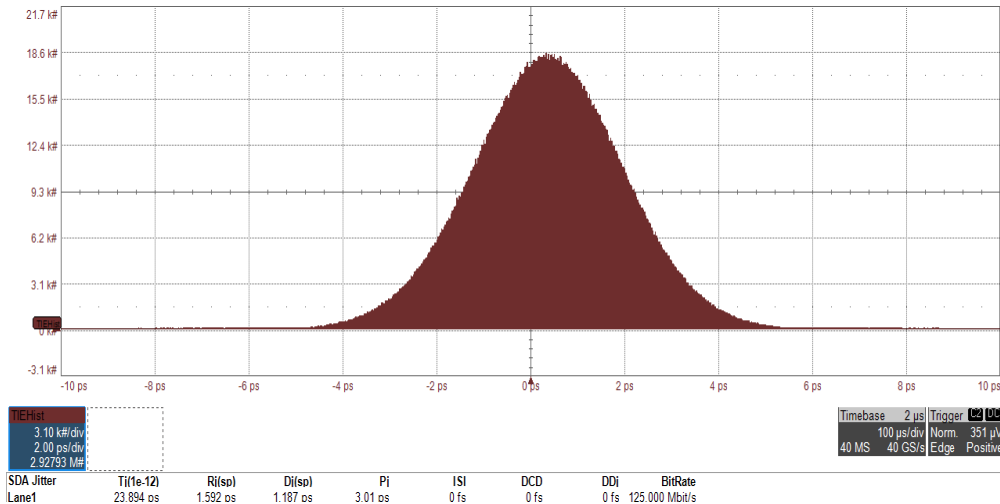
FSCD Port	Rj (ps rms)	Dj (ps rms)
0	1.59	1.19
1	1.67	0.92
2	1.67	0.75
3	1.70	1.13
4	1.62	1.79
5	1.73	1.03
6	1.68	1.40
7	1.60	1.17

- All outputs of the main clock group have below **2 ps rms** of random and deterministic jitter.
- This quality is reached by having sending the PLL clock signal through fanout chip and directly to the SFP.
- **15 ps** of delay variation upon reset
- 90% eye opening in synchronous data transmission of PRBS at 500 Mbps.

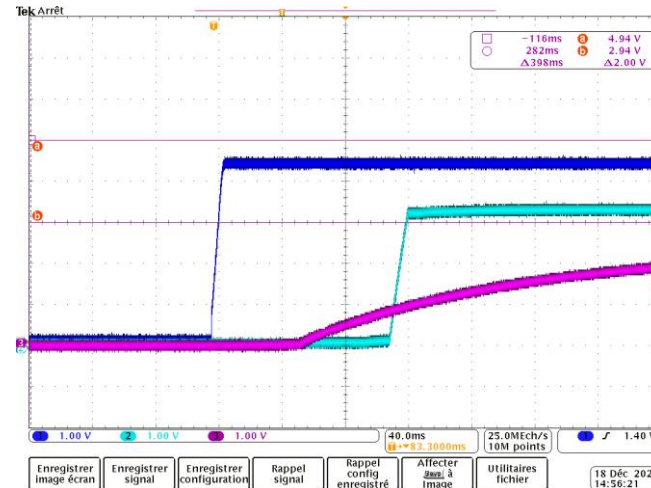
- V_POW
- 3V3_IO
- unused

2 different power issues during boot sequence:

- Power delay on Vpow
- Screen reverse powering FPGA bank

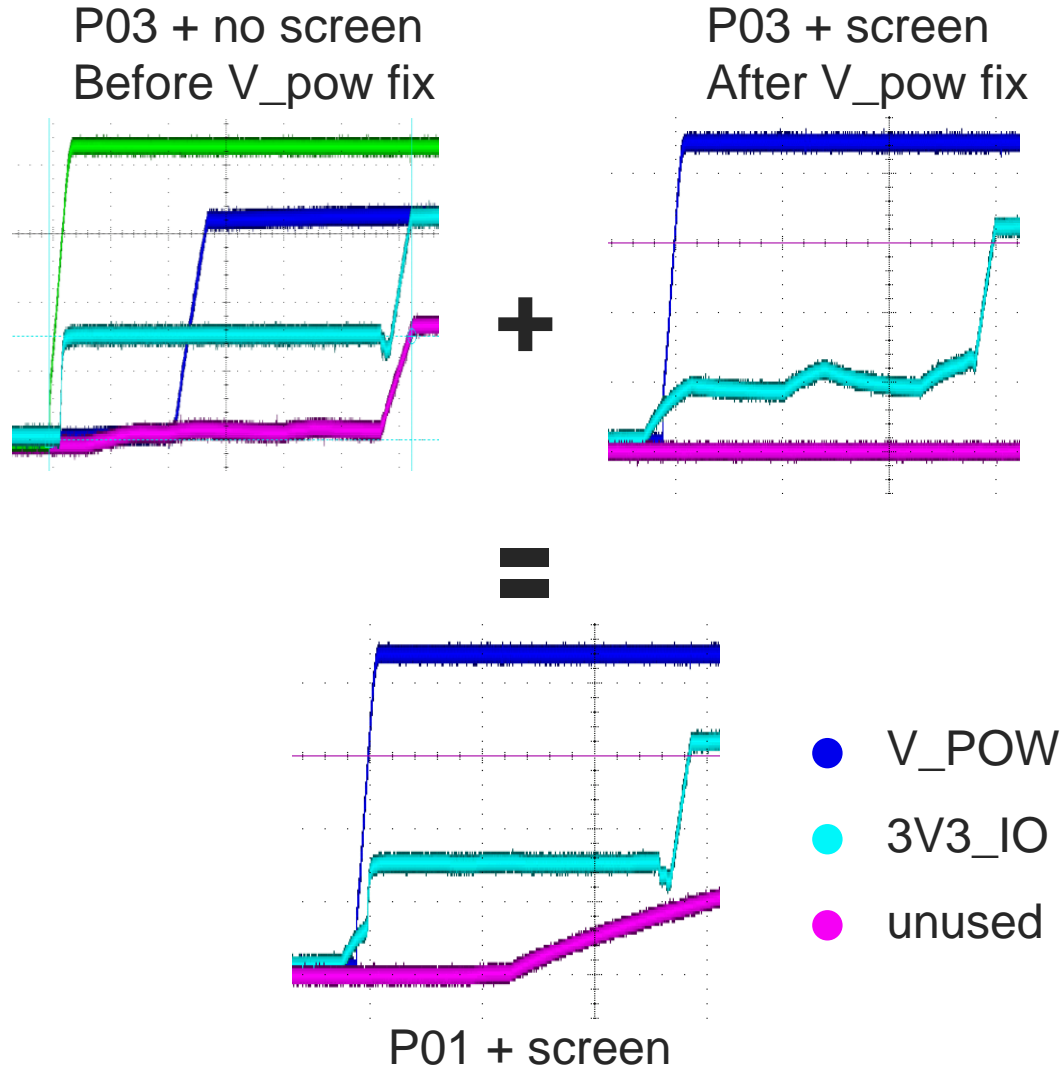
Power sequencing

“Delay is introduced in the micro-controller software so that V_POW is started well after 24V_FS is established.” –Denis

First issue can be solved by updating the micro controller software.

The second issue was not mentioned by Denis. It seems to come from a reverse powering of an FPGA bank.

Screen is powered before the FGPA, pulls up its communication line to the FPGA for a short duration. This line may be powering the FPGA bank hence seeing tension on 3V3_io line.

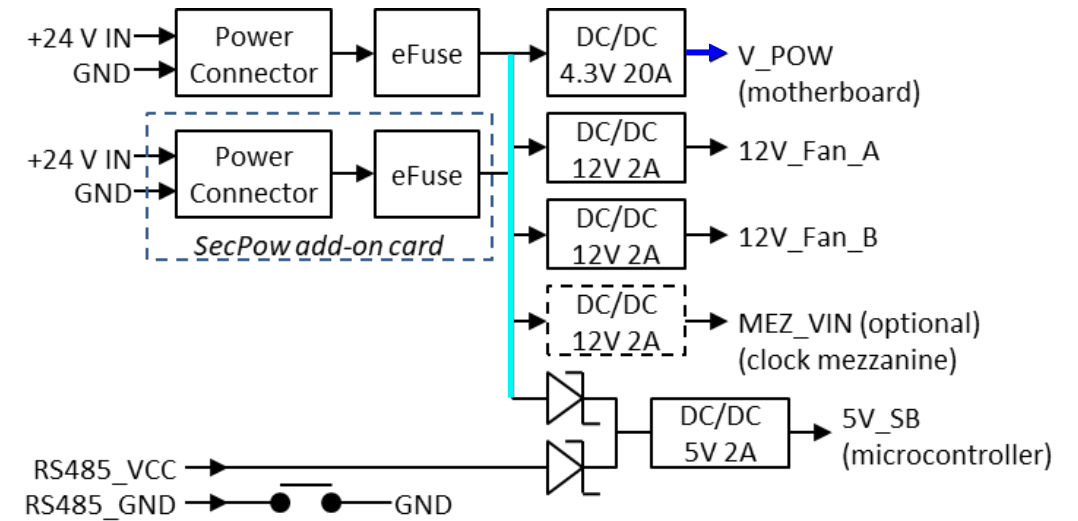
Redundant power supply

A transistor is used next to the eFuse to detect reverse voltage.

- The used power supply is the one with the highest voltage.

During run time, the main and spare power supply will be set at 24 V and 23 V respectively.

No power will be drawn from the spare power supply until the main is deactivated.

Automatic and seamless switch between power supplies.

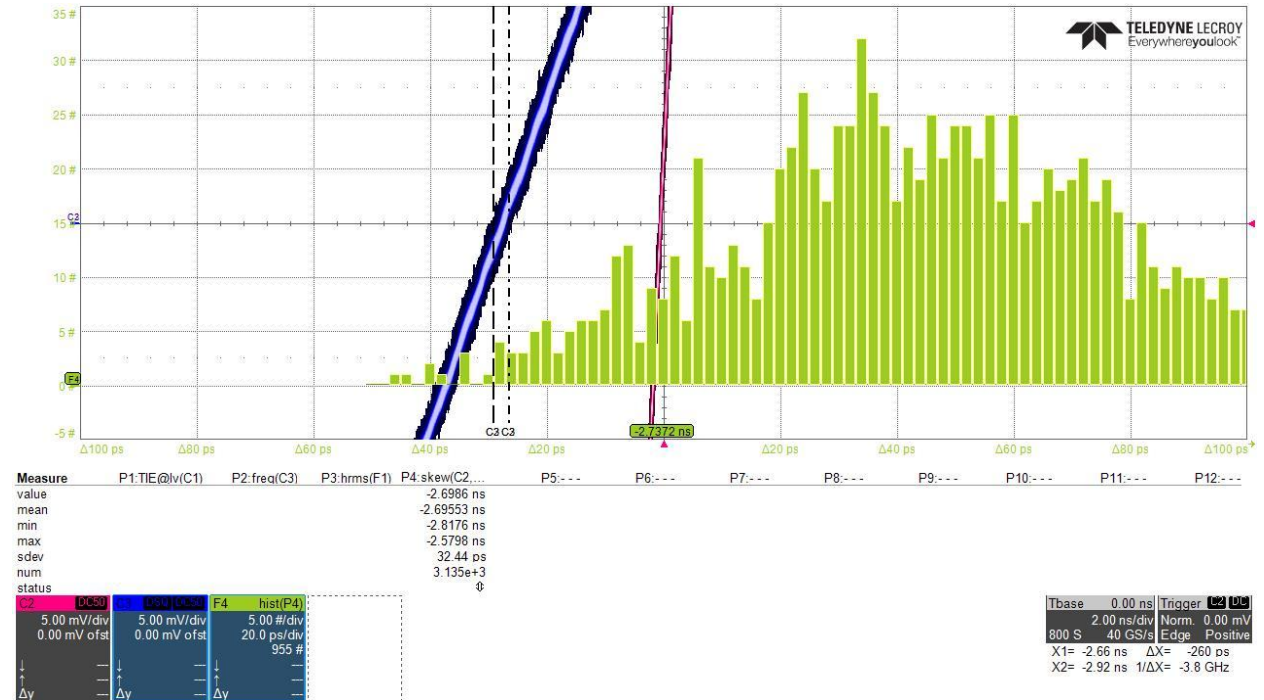
AWG output 1 : Square 5MHz 1Vpp
AWG output 2 : Sinusoidal 5MHz 1Vpp

Phase offset between the square and sinusoidal clock output of the arbitrary waveform generator.

Std dev = 32.44 ps

Pk-pk = 238 ps

Even with a large vertical scale, the oscilloscope cannot perform a precise measurement.

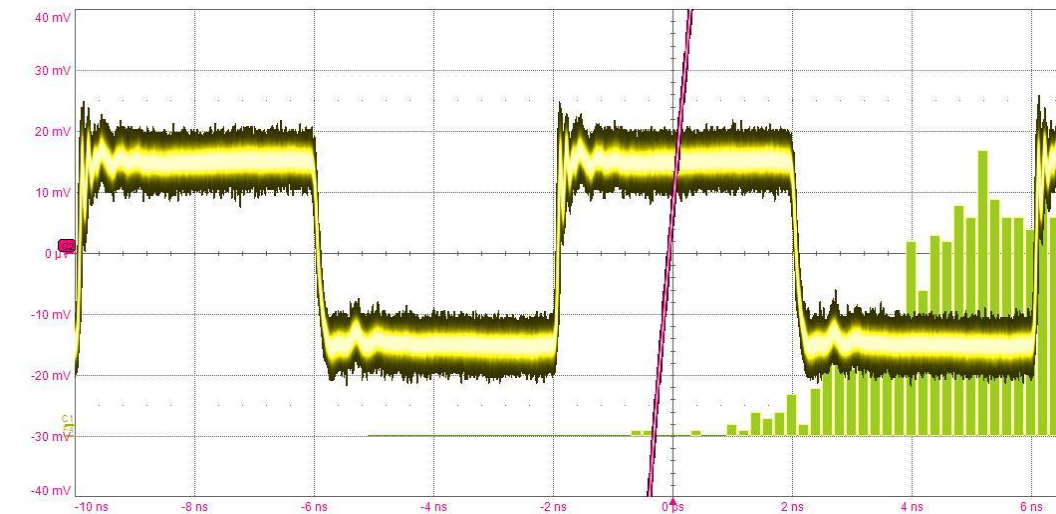
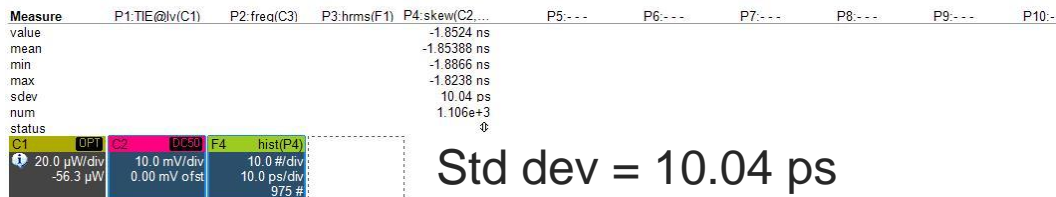
Retesting sinusoidal input on FSCD

AWG output 1 : Square 5MHz 1Vpp -> Oscilloscope
 AWG output 2 : Sinusoidal 5MHz 1Vpp -> FSCD mezz clk input

Std dev = 10.04 ps
 Pk-pk = 63 ps

reset	avg skew [ns]	std dev [ps]
1	-1.855	10.1
2	-1.853	10.04
3	-1.859	9.48
4	-1.862	9.17
5	-1.856	9.5
6	-1.861	9.15
7	-1.864	9.18
8	-1.865	9.88
9	-1.864	9.48
10	-1.87	9.62

Upon 10 reset, FSCD always find the same offset compared to the 5MHz clock though it is using the sinusoidal input. If it had issue I would expect a far larger phase variation than the 17 ps peak to peak here.
 ➤ Therefore I think the scope struggles to find the rising edge of a slow signal (sinusoidal).

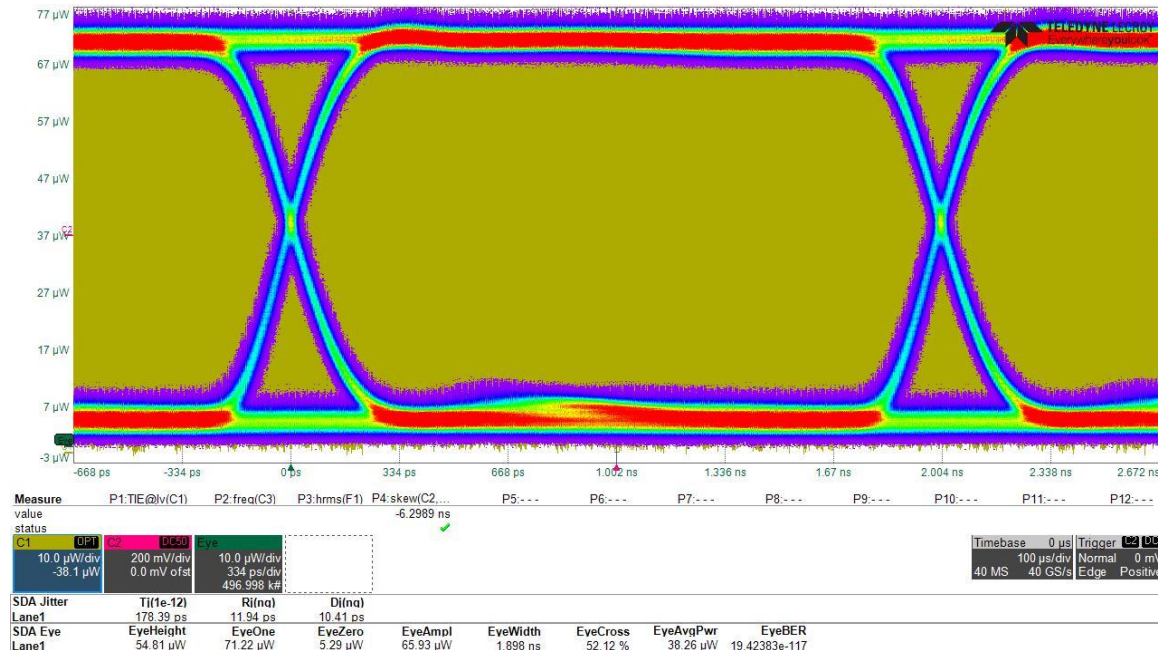
Eye diagram of the sync data link with PRBS

PRBS 15 at 500 Mbps
SFP 80km through 2x32 splitter
Optical probe

Eye width : 1.898 ns

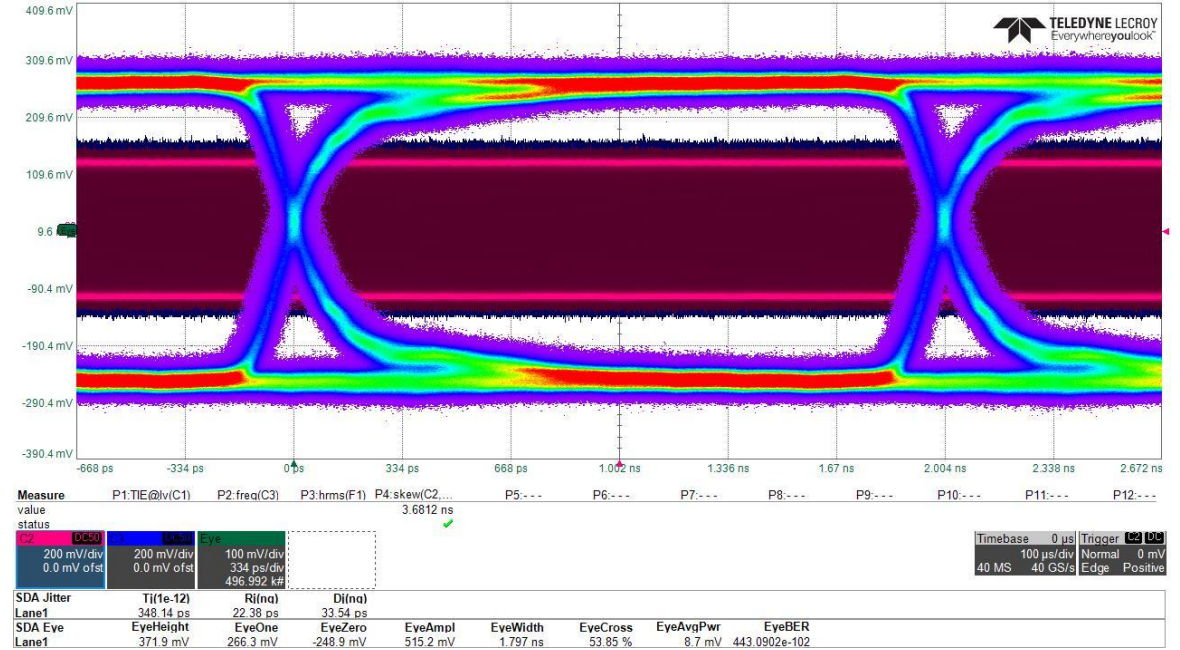
PRBS 15 at 500 Mbps
SFP 80km through 2x32 splitter
SFP I/O board

Eye width : 1.797 ns

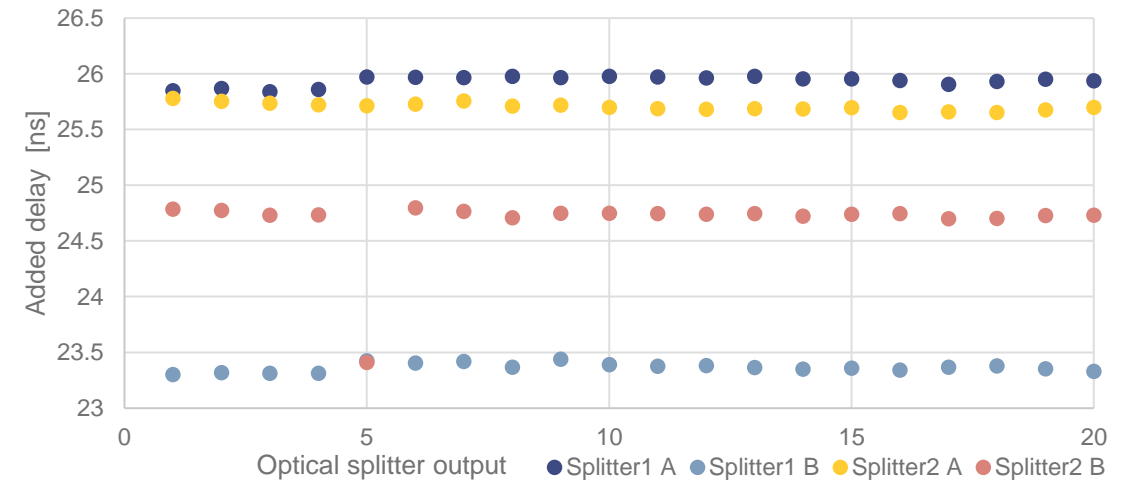
ACPhotonics 2 – 1x20 PLC splitter

3 ACPhotonics procured for testing, custom built optical splitters

- ~5 dB margin
- 3 ns transmission delay difference between splitters
- Splitters output are not aligned

Transmission delay of four optical splitters

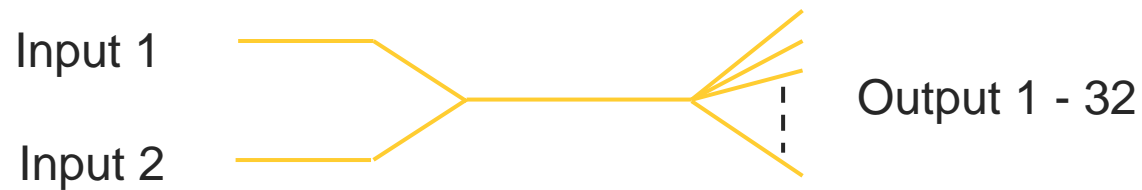
FS.com PLC 2x32

2x32 means 2 input to 32 output

The 2 input are merged into one and then splitted into 32 output.

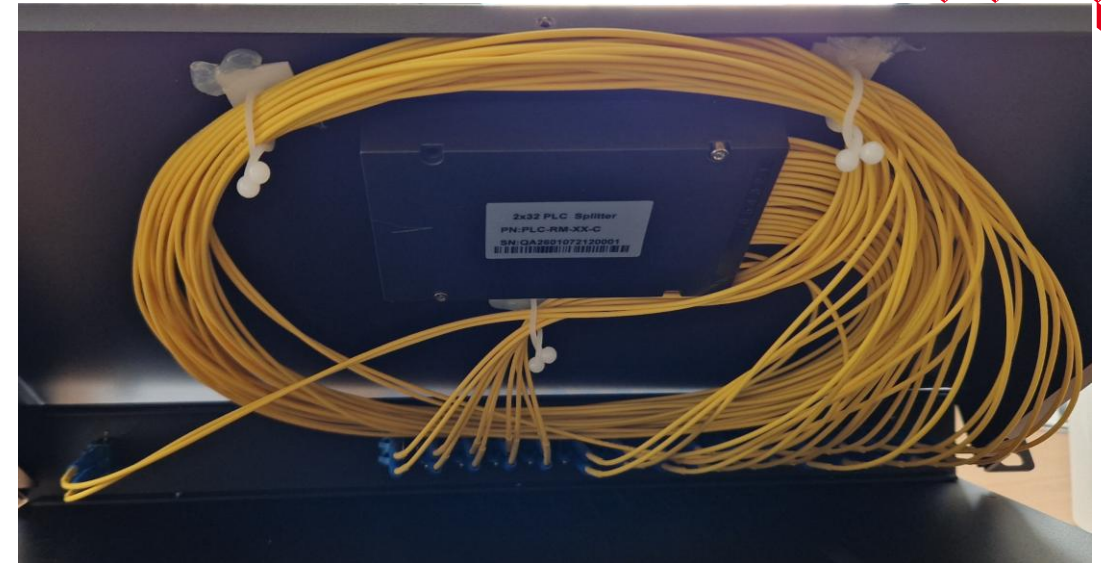
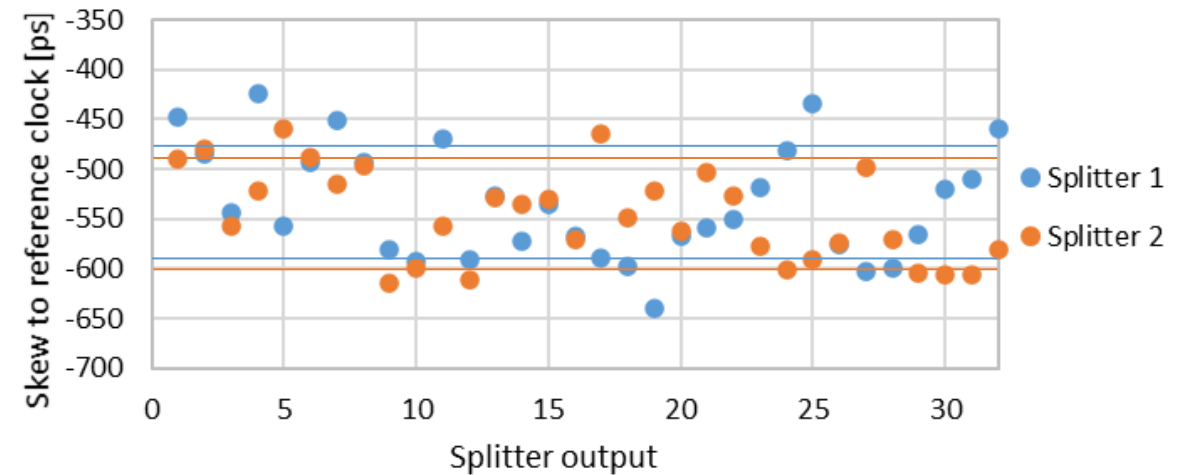
- 215ps, and 154ps maximum variation of skew between splitter output and reference clock, and 110 ps when selected.
- 2nd inputs of the splitters has a 30ps and 15ps offset with the 1st input.

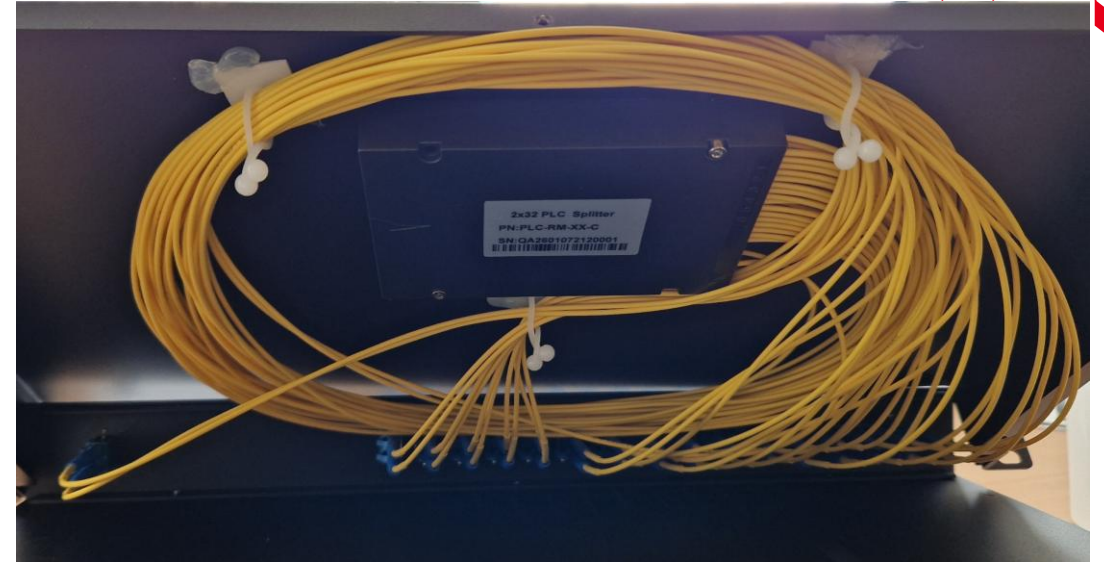
Optical splitter PLC 2X32

Power budget:

80 km SFP : 0 – 5 dBm

Optical splitter : -17 dB (theoretical -15 dB)

Fiber and connectors : <1 dB

10km SFP receiver detection : -20 dBm

➤ 2 dB margin

This is the expected safety margin by the end of life of the components.

The additional outputs can be used if one fiber inside is broken and for a direct feedback loop to FSCD to monitor phase and optical power.

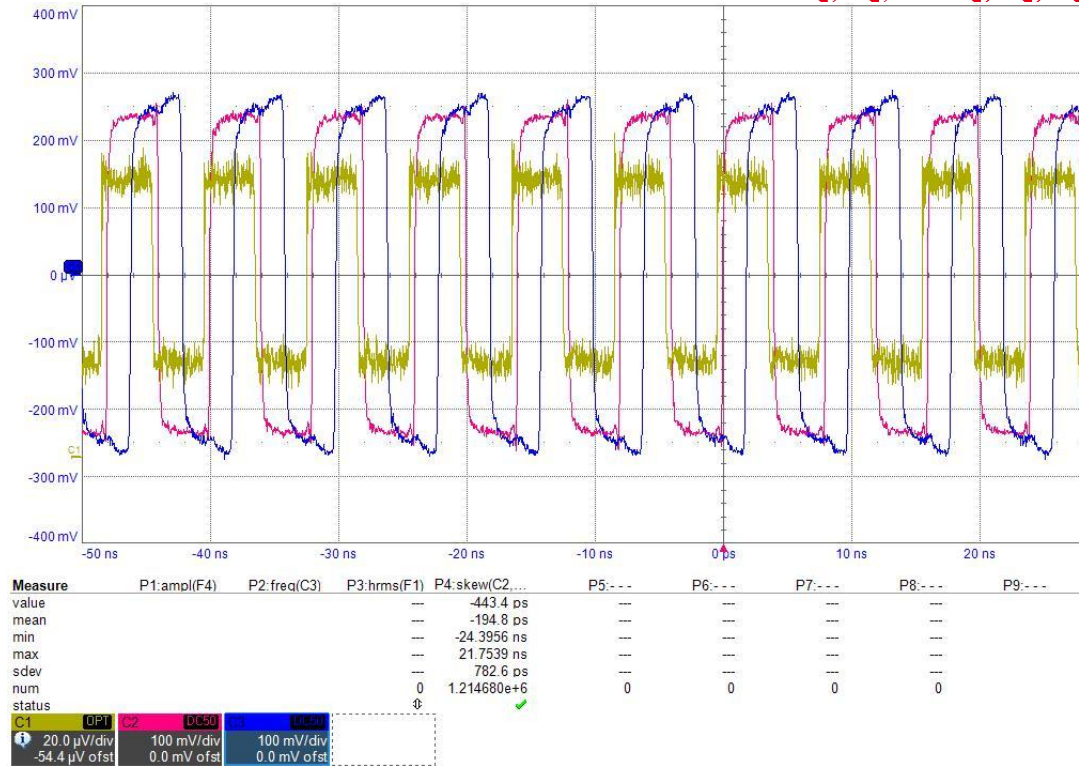
output	1->20 splitter	2x32 splitter Input 1	2x32 splitter Input 2
1	-11.49 dBm	-13.61 dBm	-14.36 dBm
2	-12.21 dBm	-13.94 dBm	-14.28 dBm
3	-11.93 dBm	-13.83 dBm	-14.31 dBm
4		-14.2 dBm	-14.8 dBm

- ~3dB more of attenuation with new splitter but we are still far from SFP detection minimum
- Below 10 ps jitter measured on SFP output with -24dBm of power. 22 ps jitter measured with -29 dBm power.
- Attenuation should not be an issue with such a splitter, and can be monitored, with an alarm raised if power is too low.

- Ref clock from SMA
- Optical probe
- SFP I/O board

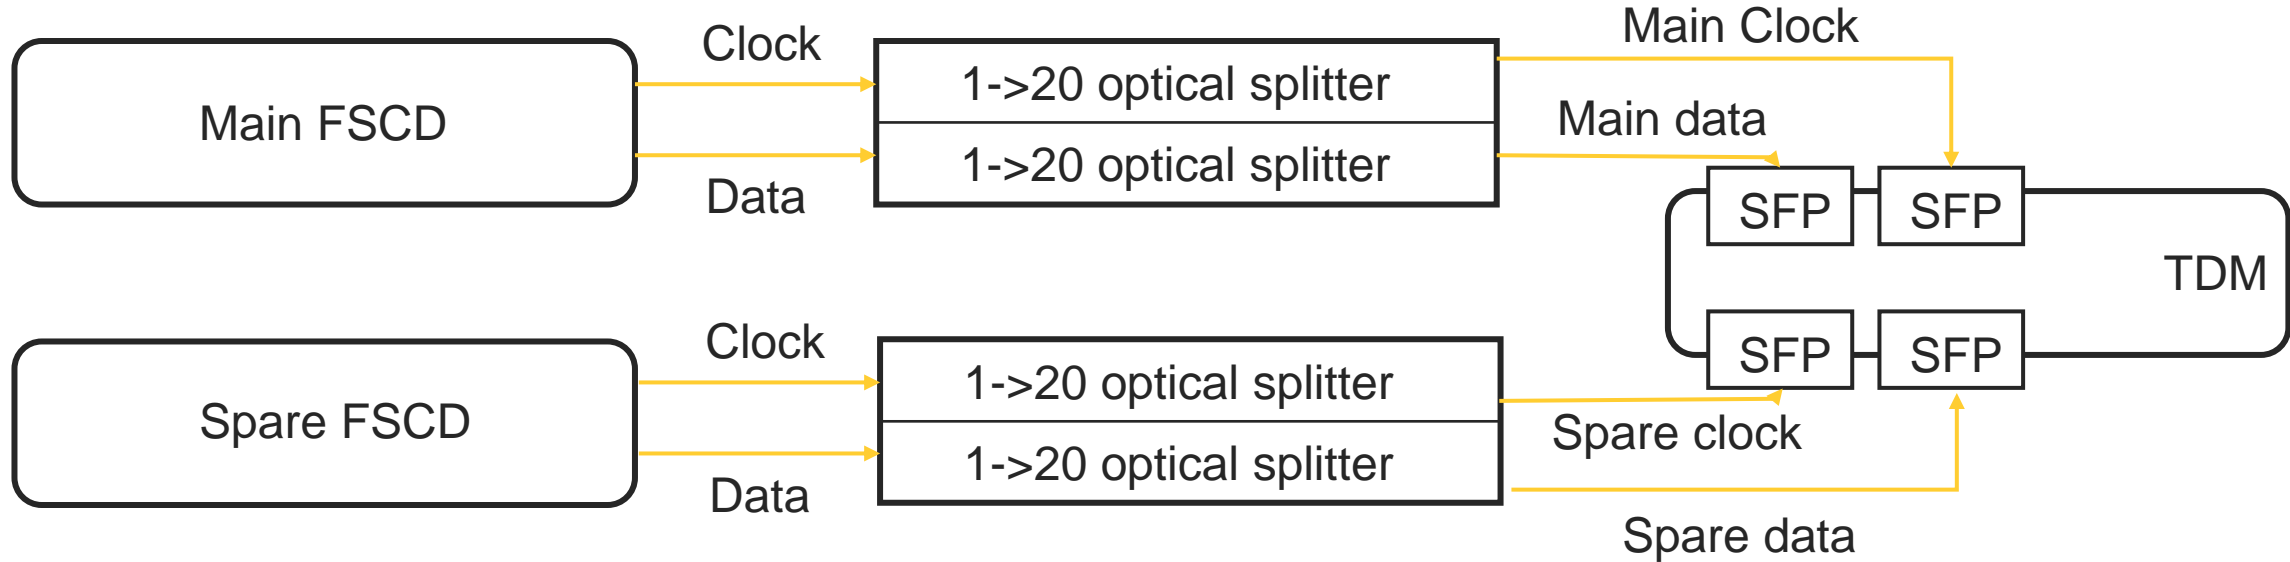
Current clock distribution topology

Unknown procedure for switching FSCD in case of failure.

But requires actions from TDM board, switching PLL input from one SFP to another.

➤ We can slightly modify this architecture using 2x32 optical splitters.

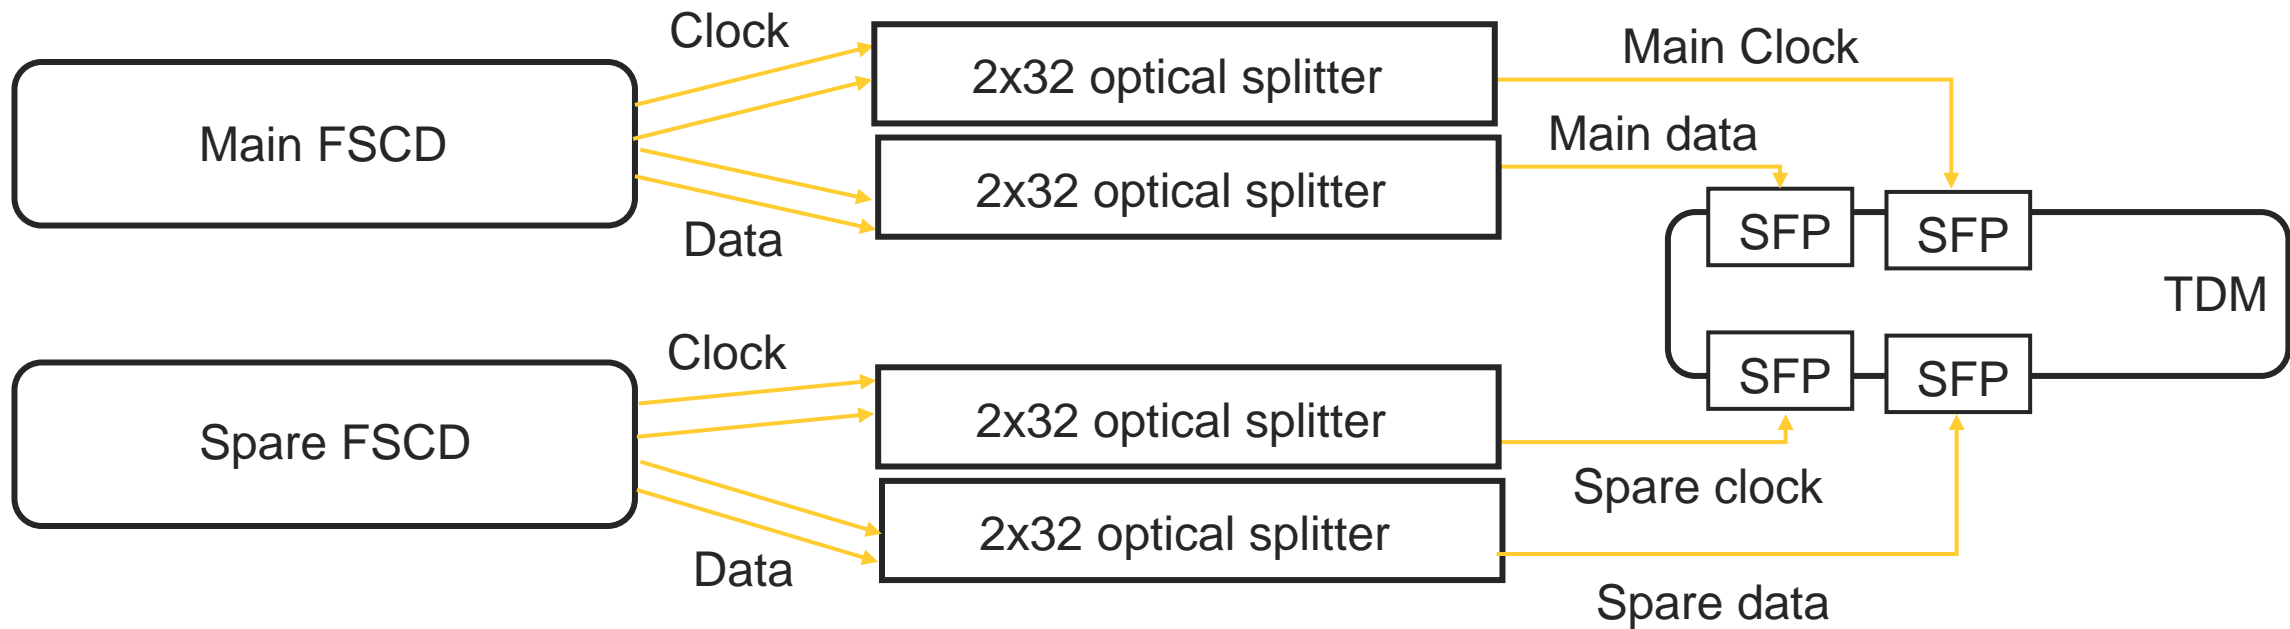
Proposed clock distribution topology

➤ Using the second input of the splitter for a backup SFP.

Only 1 SFP emitting light per optical splitter, the other laser should not age.

Allow for redundancy before switching to secondary FSCD board.

There may be a 150 ps phase shift when switching splitter input. (~100ps SFP + 30 ps splitter input)

Uses 4 units of space in the side hut rack.

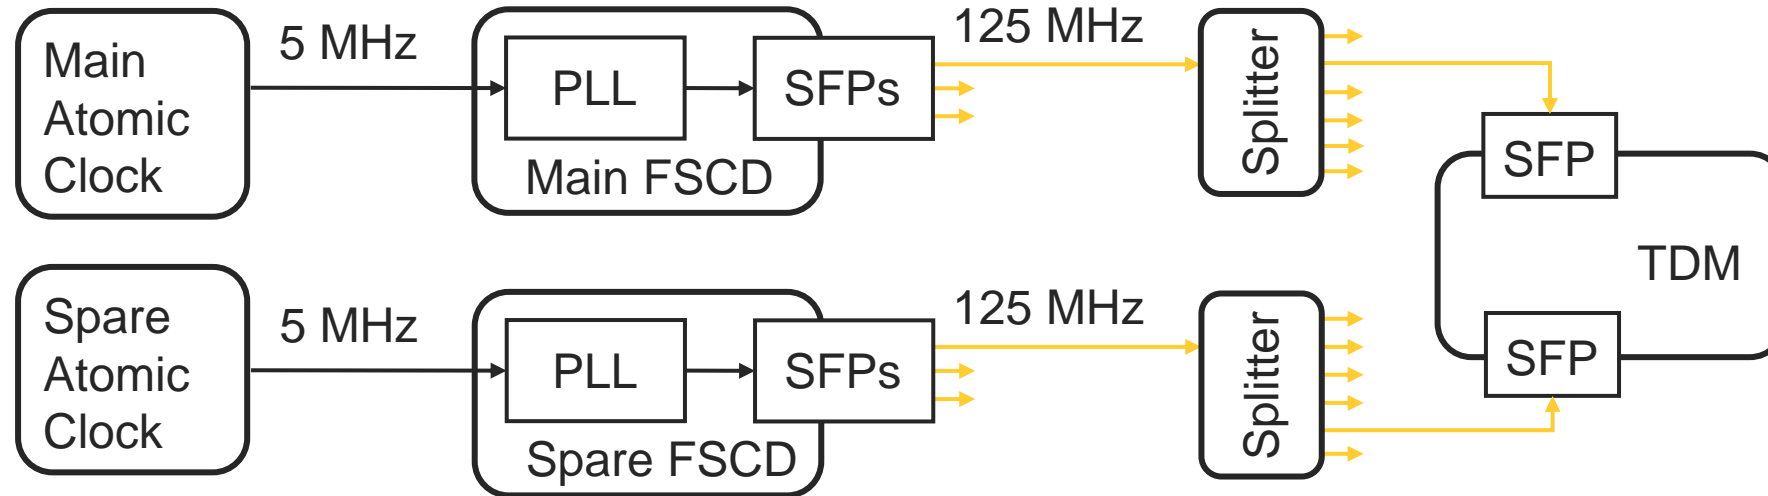
Fixed phase offset

Each TDM boards will have an unknown phase with the reference clock due a small variability in the delay added by each components in the clock distribution:

- PCB trace adds **150 ps** delay difference.
- SFP Tx adds **100 ps** delay difference.
- Optical splitter adds **~200 ps** (100 ps with selection) of delay difference.
- Optical fibers adds **50 ps** of delay difference if length are matched to 1 cm.
- SFP Rx adds **150 ps** delay difference.

- Source of the power bug is understood, and should be fixed with different software in components.
- A fixed phase after reset was observed using a sinusoidal input to the FSCD.
- The Tx clock signal is not deteriorated when receiving a monitored clock.
- 90% eye opening in the synchronous data transmission at 500 Mbps
- New optical tested, introducing below 200 ps fixed phase variation.
- Low power safety margin at end of life of components, but the power can be monitored.
- Updated and improved optical architecture enabling low impact change instead of moving to spare clock distribution.
- Around 700 ps fixed phase difference at TDM level, below the 1 ns target.
